--WOODBURY POND DAM--
PHASE I
INSPECTION / EVALUATION REPORT

Dam Name: Woodbury Pond Dam
NID ID#: MA01179
Owner: Town of Sutton
Town: Sutton, Massachusetts
Consultant: Weston & Sampson Engineers, Inc.
Date of Inspection: November 22, 2019

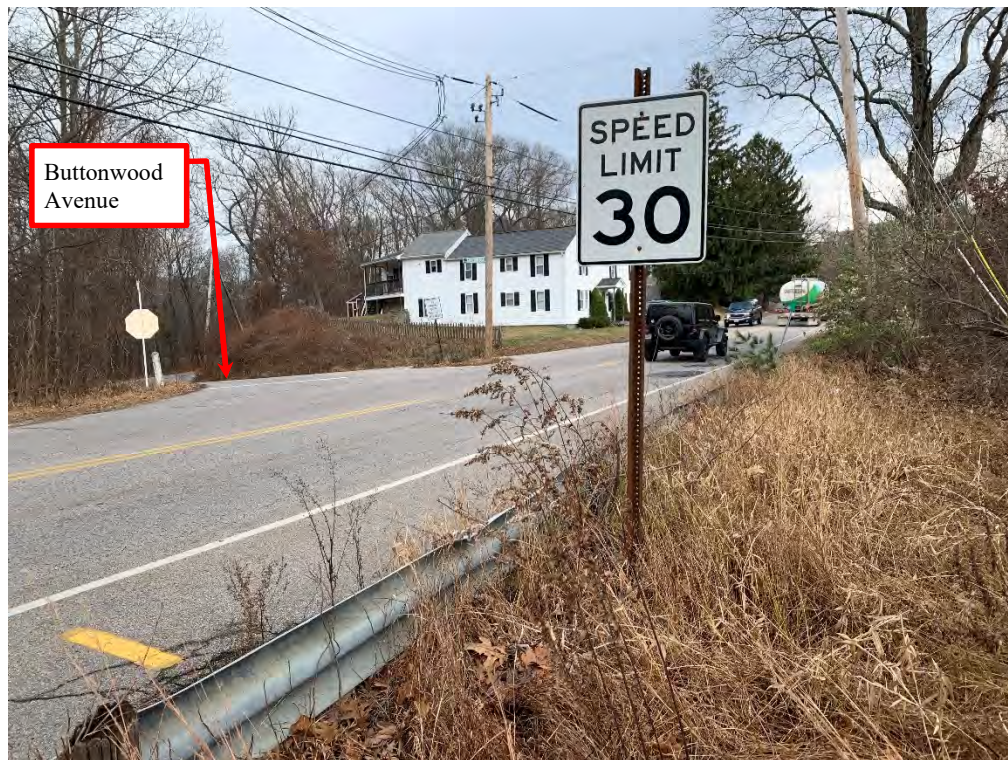
- The abutment/crest contacts appeared sound with no evidence of unusual movement or transverse cracking. General pavement distress in the vehicle wheel paths including occasional longitudinal and alligator cracking was observed in the vicinity of the abutment contacts and along other portions of the crest. See **Photo 1** and **Photo 2**.

Photo 1 - The right end of the dam where the embankment crest contacts the right abutment.

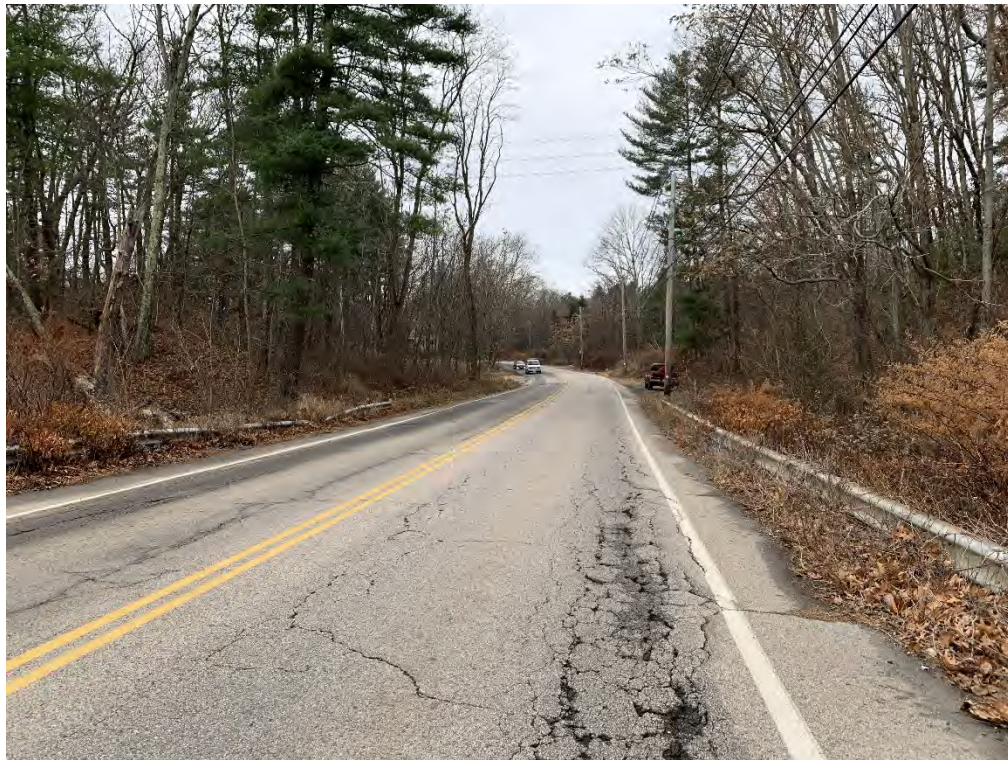
Photo 2 - The left end of the dam where the embankment crest contacts the left abutment.

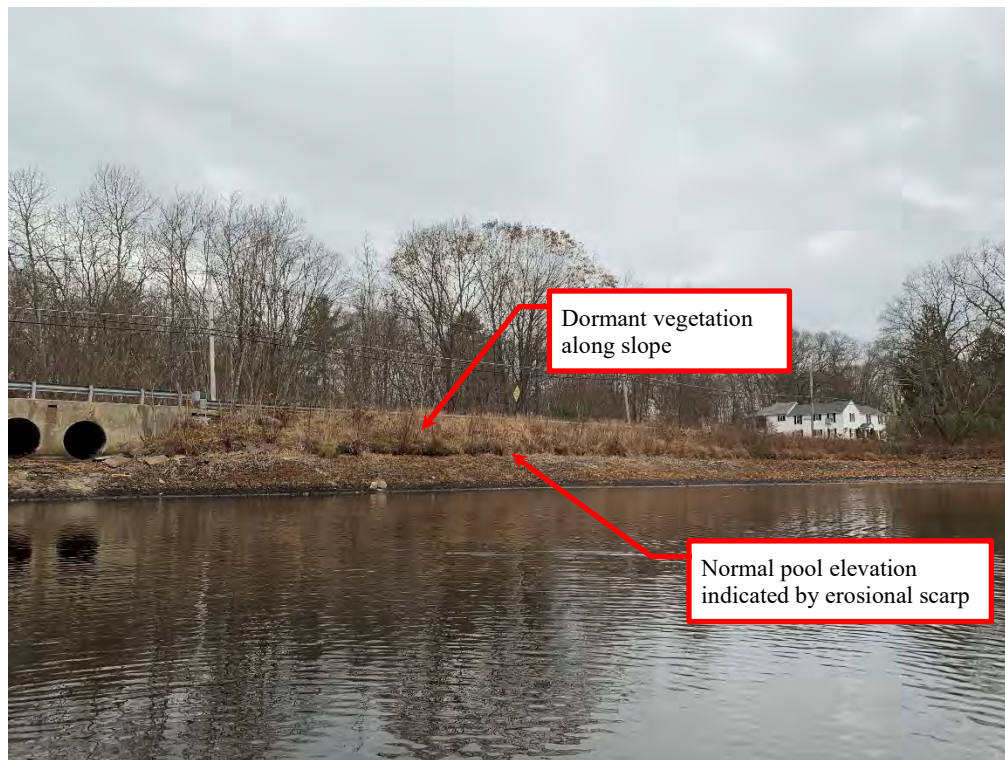
Photo 3 - Overview of the upstream slope (right of the spillway). Note the presence of dormant brush and saplings on the upper portion of the slope above the normal pool elevation.

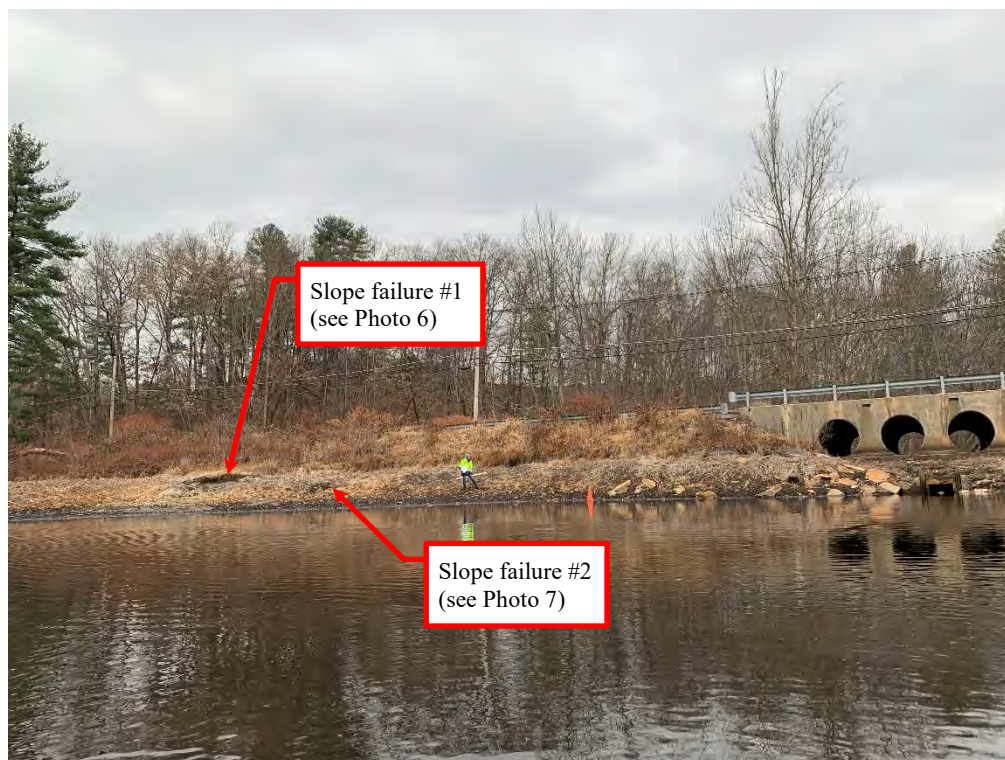
Photo 4 - Overview of the upstream slope (left of the spillway). Two isolated slope failures were observed below the normal pool elevation. Vegetation conditions were similar to those described in Photo 3.

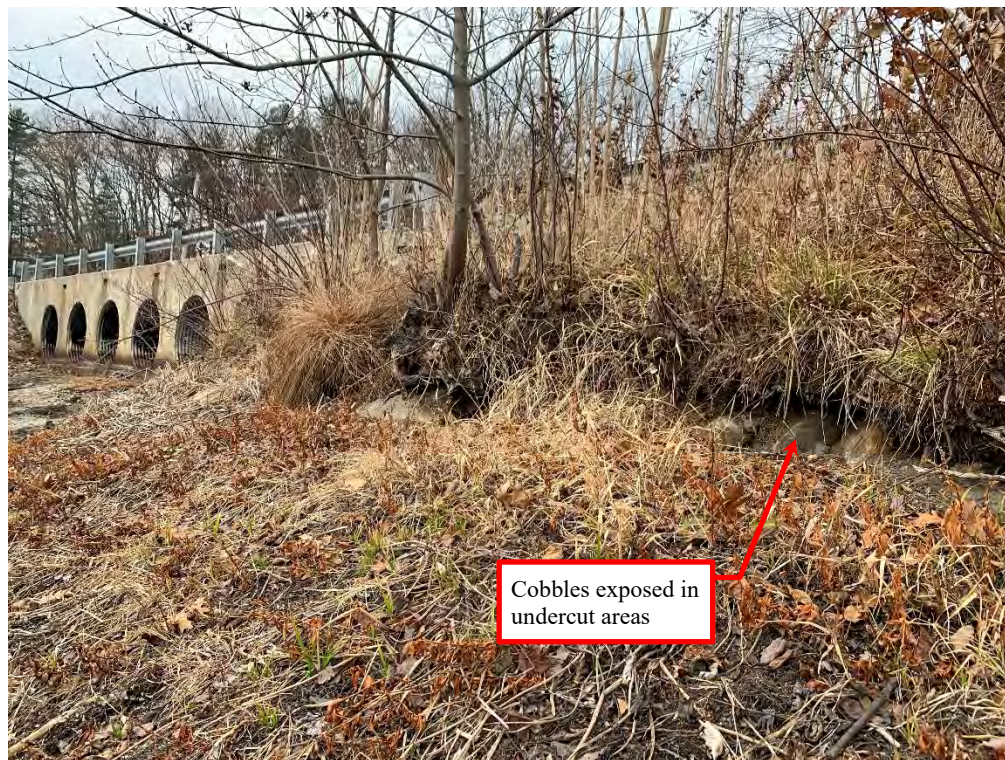
- An erosional scarp is present along the upstream slope at the normal pool elevation. Up to 12 inches of bank undercutting along the scarp was observed in several areas.

- Occasional riprap is present in the vicinity of the spillway but the majority of the upstream slope does not have consistent erosion protection. An erosional scarp line exists along the normal pool elevation for most of the slope length with a maximum scarp height of approximately 8 inches. Up to 12 inches of bank undercutting along the scarp line was also observed in several areas. Cobbles within the embankment fill are exposed in the undercut areas. See **Photo 5**.

Photo 5 - The upstream slope near the spillway. As noted in Photos 3 and 4, an erosional scarp is present on the upstream slope along the normal pool elevation. The maximum height of the scarp was approximately 8 inches. Up to 12 inches of slope undercutting along the scarp was observed in several areas.

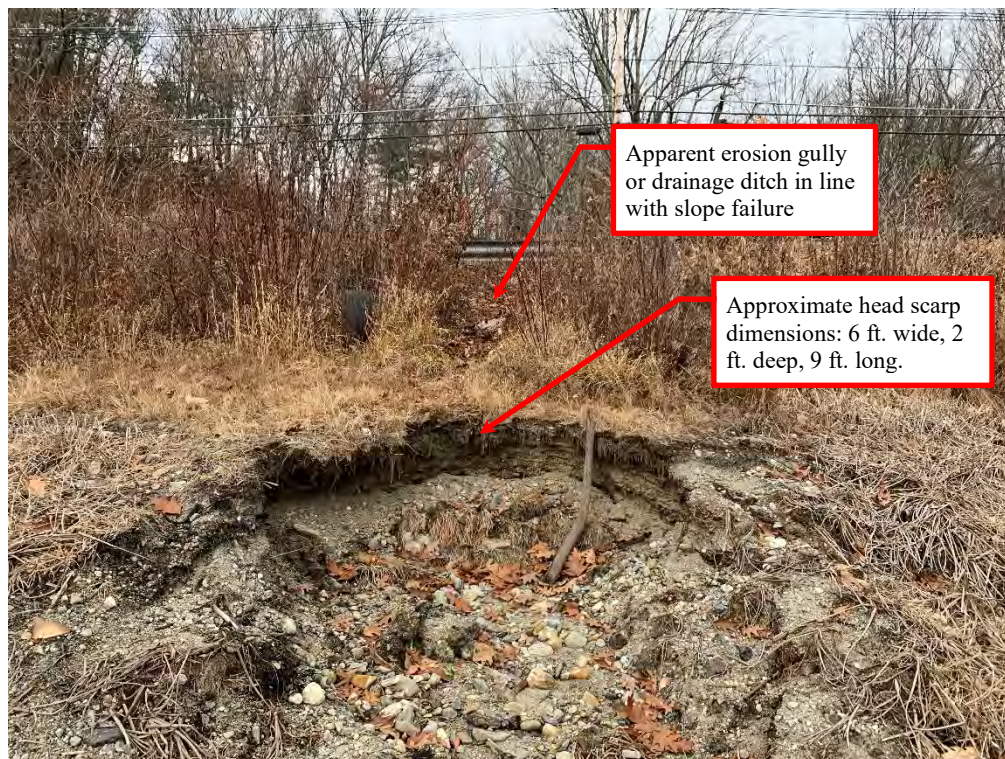
- Two slope failures (referred to as slope failure #1 and slope failure #2) were observed on the upstream slope below the normal pool elevation between the spillway and left abutment. The head scarp of slope failure #1 (leftmost failure) was approximately 6 ft. wide, 1 ft. deep, and 9 ft. long. The scarp resulting from slope failure #2 (rightmost failure) was less pronounced and measured 4 ft. wide, 0.5 ft. deep, and 5 ft. long. Debris fans consisting of transported embankment soil (sand and fine gravel) were observed downstream of both slope failures. Both failures appear to be the result of stormwater runoff onto/down the slope during a low impoundment stage. See **Photo 6** and **Photo 7**.

Photo 6 - Close-up view of slope failure #1 shown in Photo 4. An apparent erosion gully or drainage ditch is located above and in-line with the scarp.

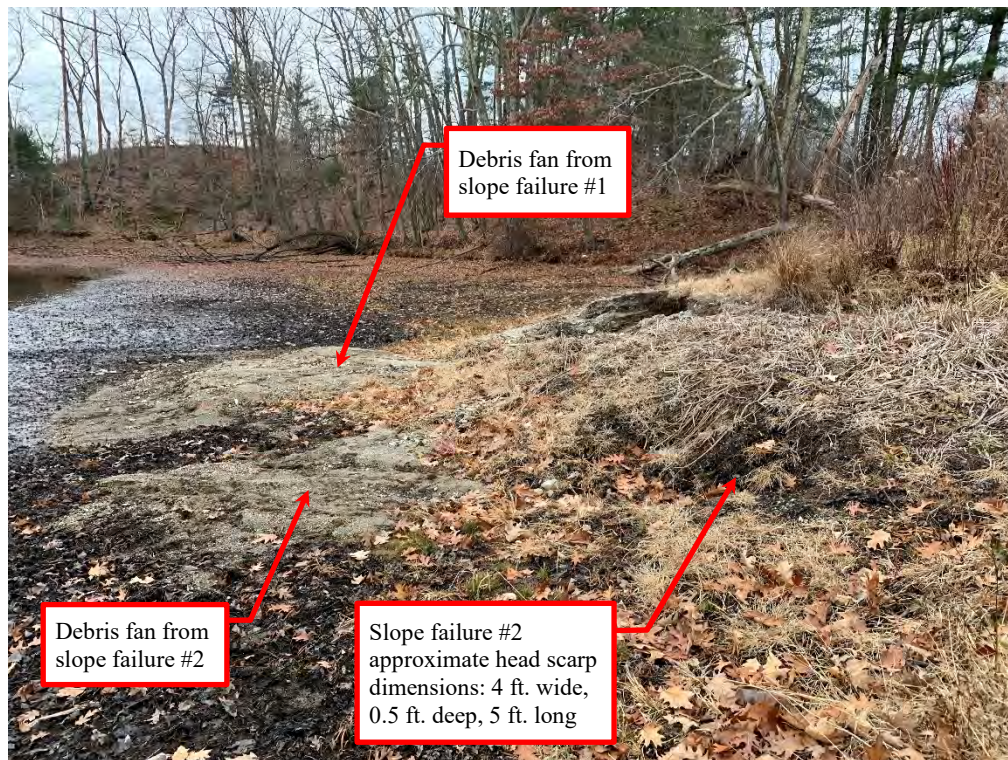
- Two isolated slope failures have occurred on the upstream slope below the normal pool elevation between the spillway and left abutment. Transported embankment soils were observed downslope of both areas. It appears these failures are the result of surface drainage from the roadway directed onto the slope. Continued drainage of stormwater onto the slope and surges in the impoundment stage could worsen this condition.

Photo 7 - Overview of two slope failures observed on the upstream slope between the spillway and left abutment.

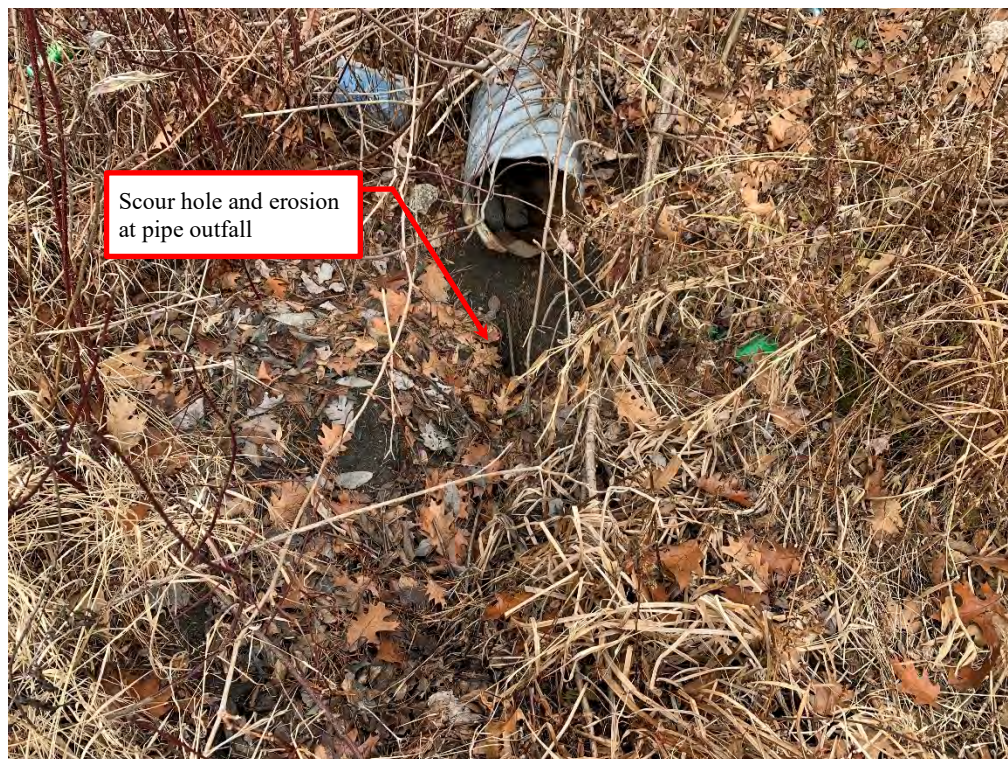
slope between the spillway and left abutment. A scour hole and small erosion gully were observed on the slope beneath the pipe outfall. See **Photo 8**.

Photo 8 - The outfall of a 12-inch corrugated metal stormwater drain pipe connected to a catch basin on the dam crest. This outfall is located on the upstream slope between the spillway and left abutment.

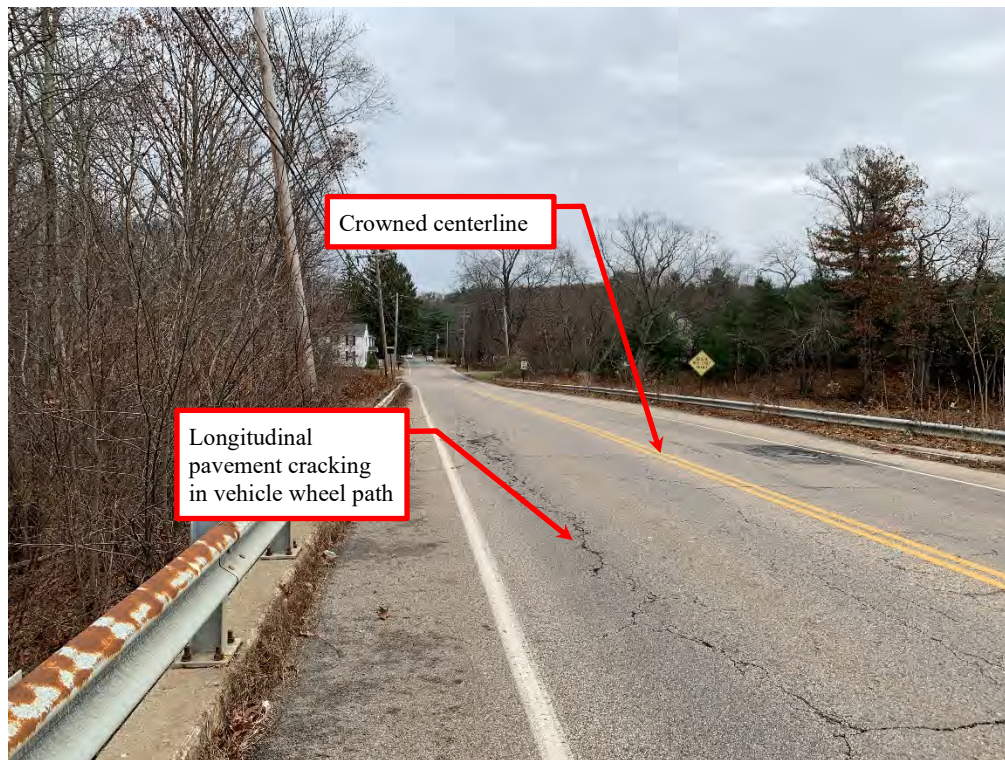
- Evidence of pavement distress including longitudinal cracking and occasional alligator cracking is present in the vehicle wheel paths of both travel lanes of Boston Road. See **Photo 9** and **Photo 10**.
- The dam crest (Boston Road) is crowned along its centerline, which appears to direct stormwater runoff onto the upstream and downstream slopes. The vertical alignment of the roadway also appears to form a high point above the spillway and low points to the left and right of the high point. Two catch basins located between the spillway and left abutment in the roadway gutter lines discharge into corrugated metal outfall pipes that daylight through the upstream and downstream slopes. See **Photo 10** and **Photo 11**. Observations related to the outfall pipes are provided in the *Upstream Slope* and *Downstream Slope* sections above and below, respectively.

Photo 9 - Overview of the dam crest (Boston Road) from the spillway, facing the right abutment.

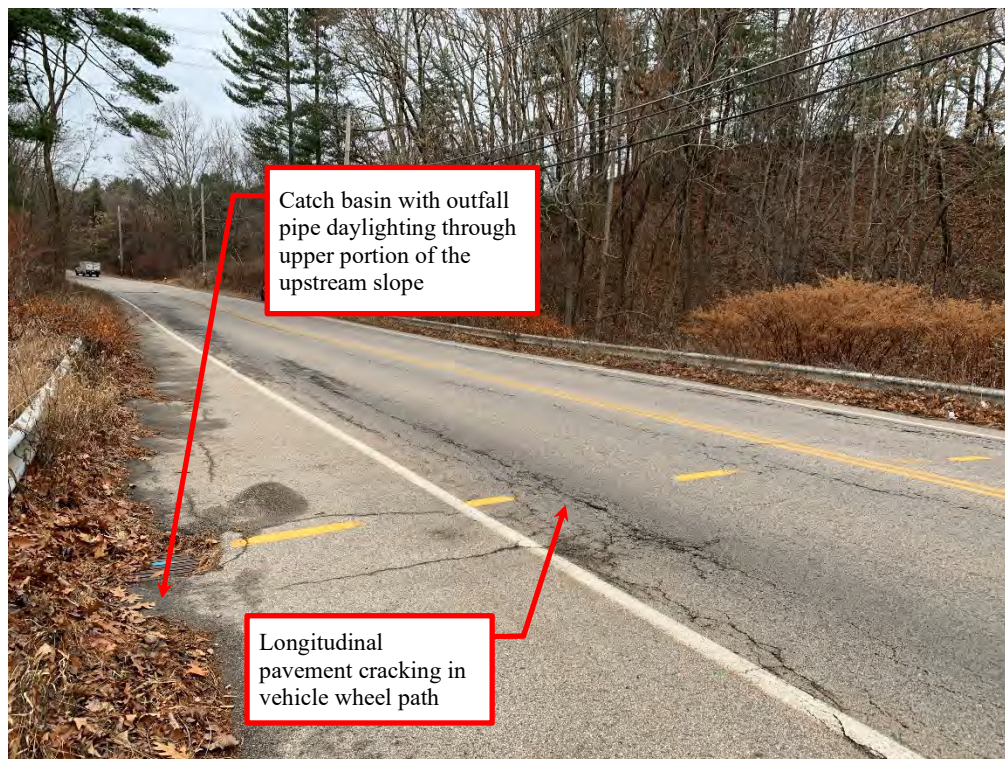
Photo 10 - Overview of the dam crest (Boston Road) from the spillway, facing the left abutment.

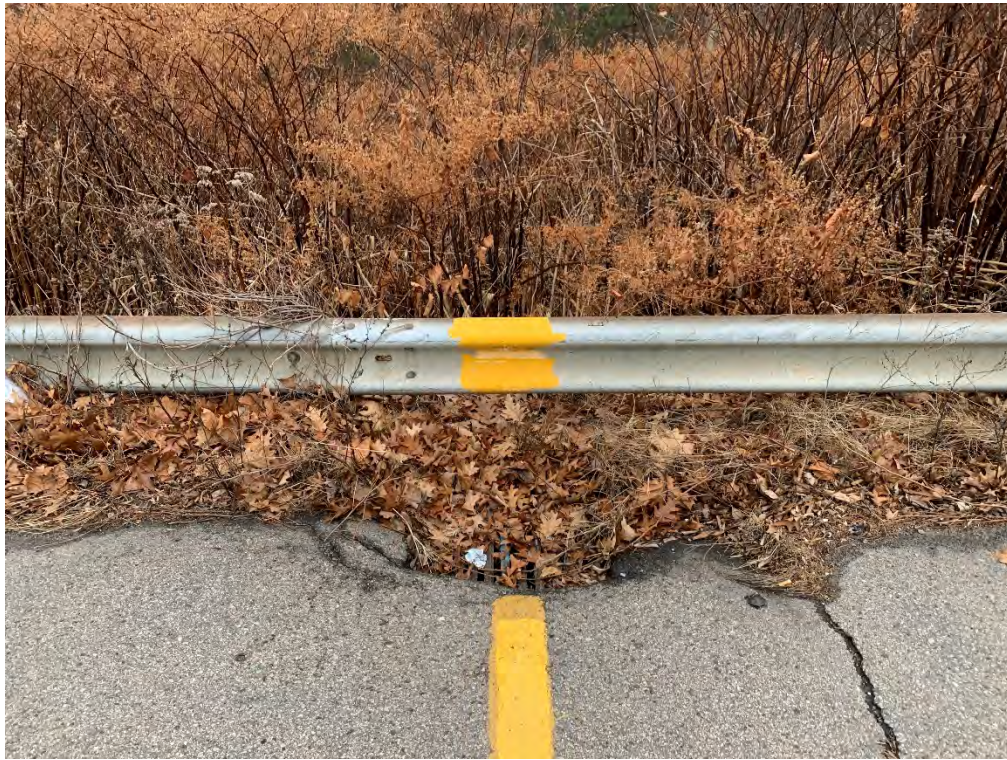
Photo 11 - Catch basin at the edge of pavement on the downstream side of the crest (opposite the catch basin shown in Photo 10). This catch basin discharges into an 18-inch diameter corrugated metal outfall pipe that daylights through the toe of the downstream slope (see Photo 16).

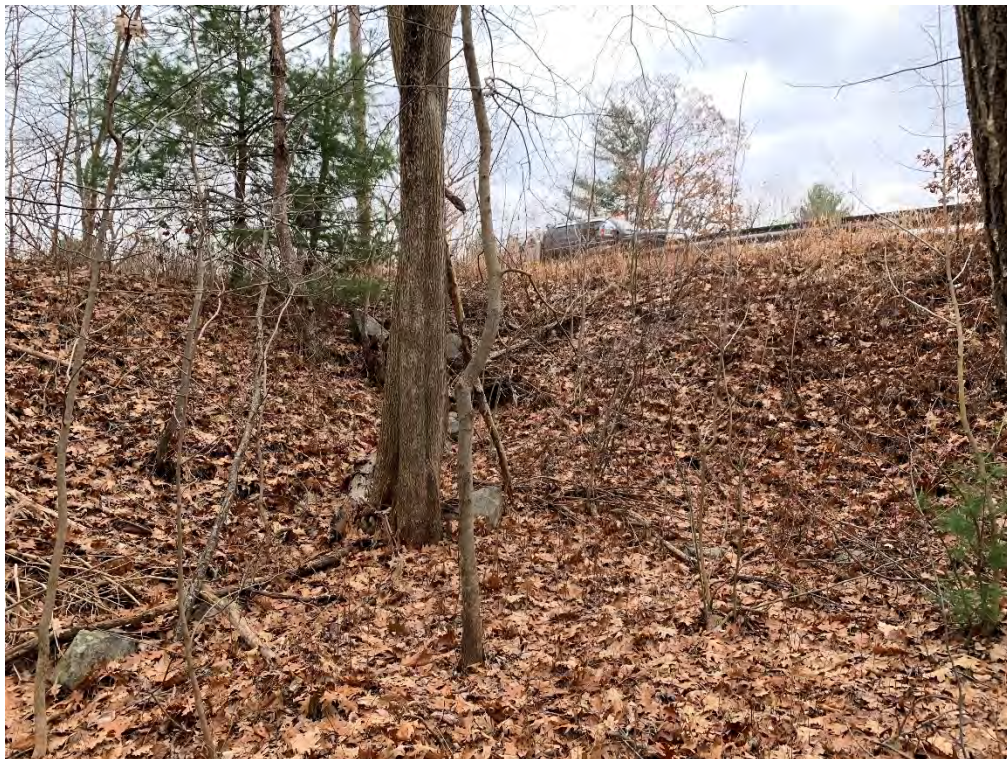
Photo 12 - The right end of the downstream slope where it contacts the right abutment (right downstream groin). Woody vegetation and large trees are present.

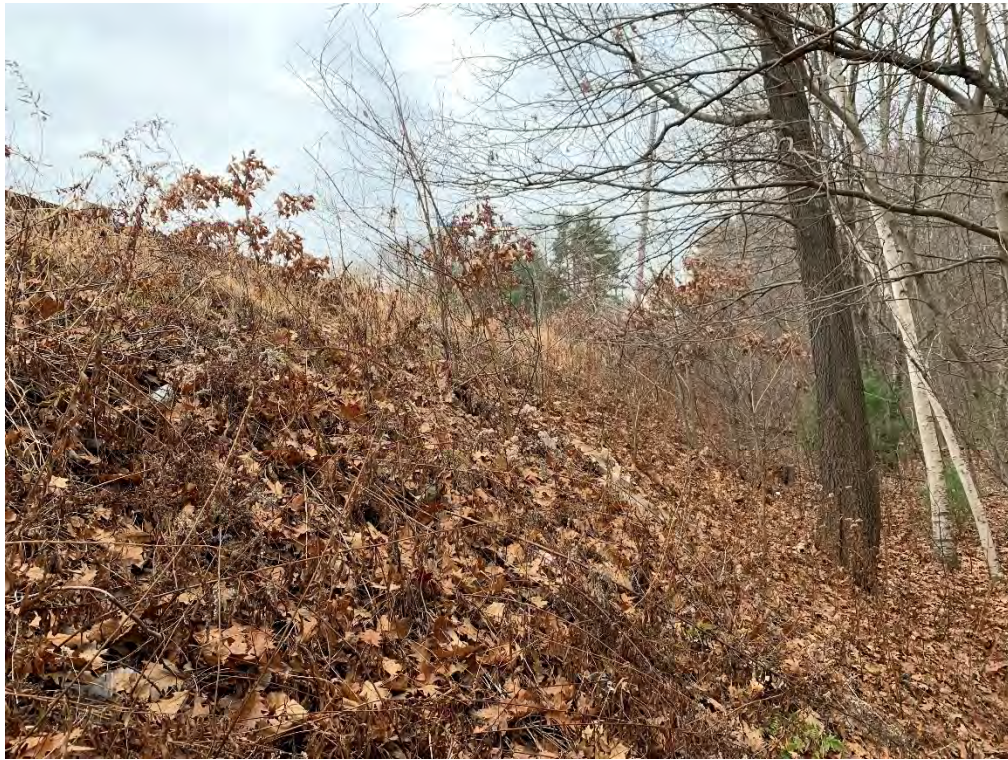
Photo 13 - The downstream slope between the spillway and right abutment. Woody vegetation and a thick cover of leaves and plant debris made inspection difficult and may have obscured deficiencies.

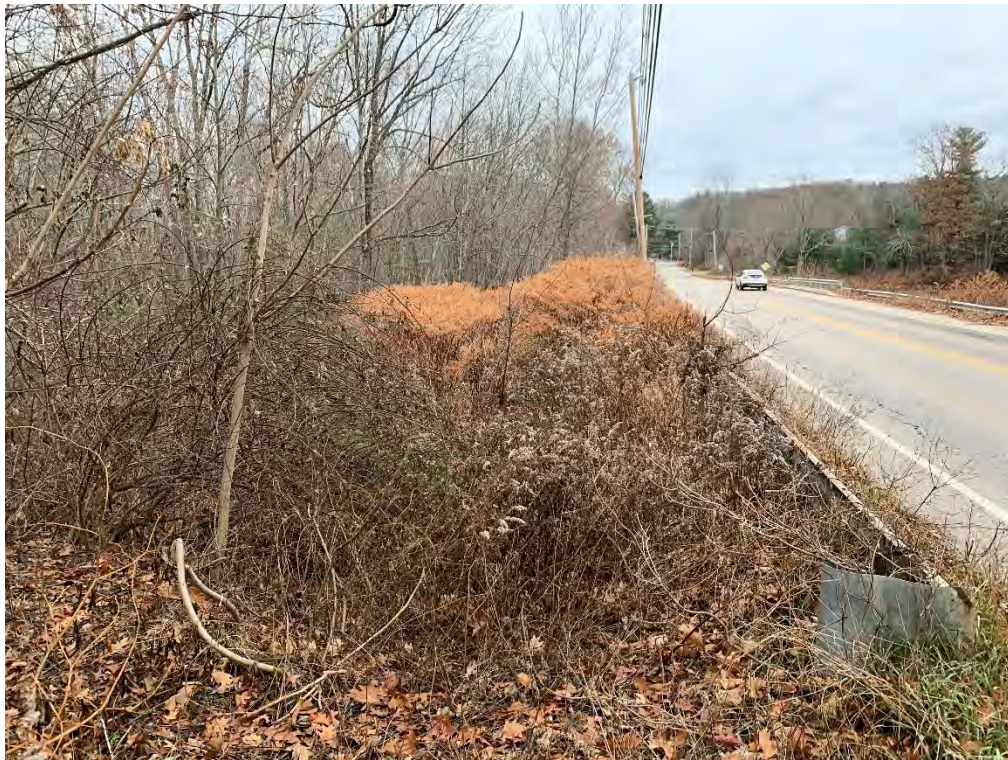
Photo 14 - The downstream slope where it contacts the left abutment (left downstream groin). Thick brush and wetland vegetation is present in this area.

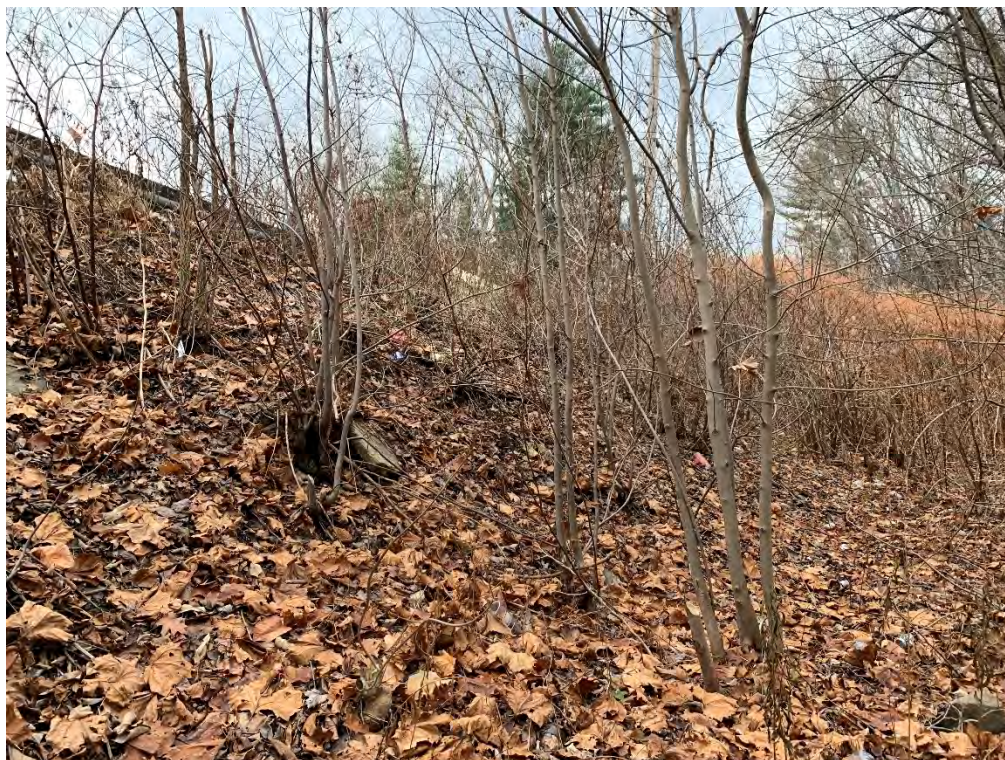
Photo 15 - The downstream slope between the spillway and left abutment. Woody vegetation and a thick cover of leaves and plant debris made inspection difficult and may have obscured deficiencies.

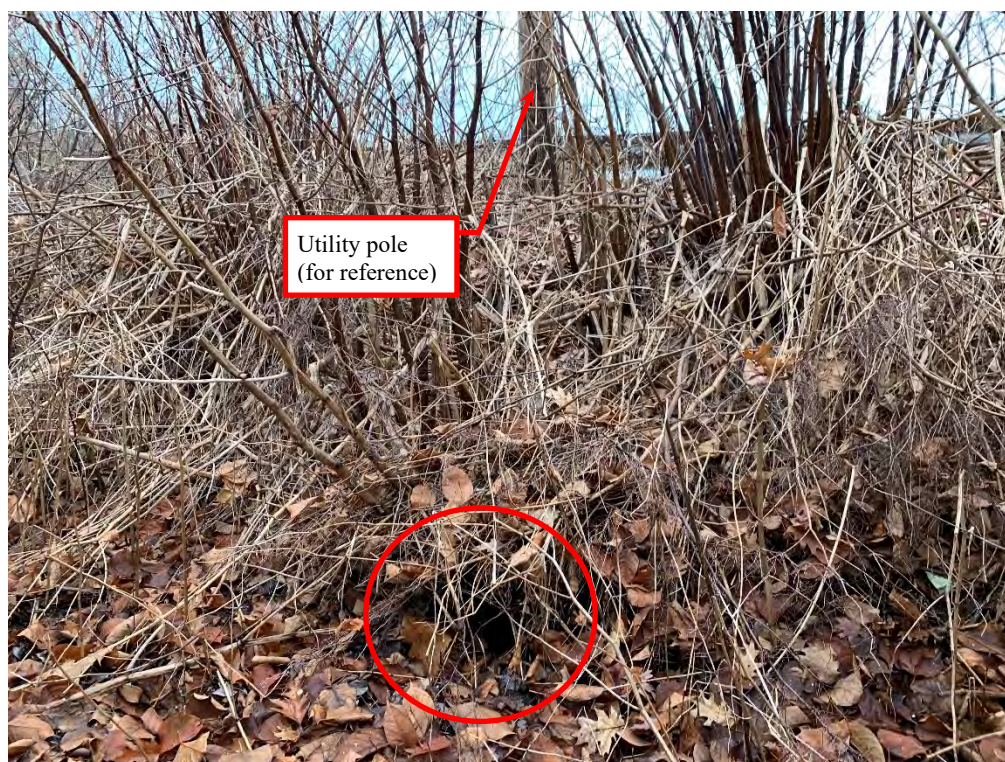
- A catch basin located in the downstream gutter line of Boston Road contains an 18-inch diameter corrugated metal stormwater outfall pipe that daylights through the downstream slope along the toe between the spillway and left abutment. The exposed end of the pipe was partially buried and obscured by vegetation. The pipe was dry at the time of the inspection. No evidence of erosion was observed downstream of the outfall, but as noted above, a thick layer of dead plant debris covering the area could have obscured this condition. See **Photo 16**.

Photo 16 - The partially buried outfall of an 18-inch corrugated metal stormwater drain pipe connected to a catch basin on the dam crest. This outfall is located on the downstream slope between the spillway and left abutment.

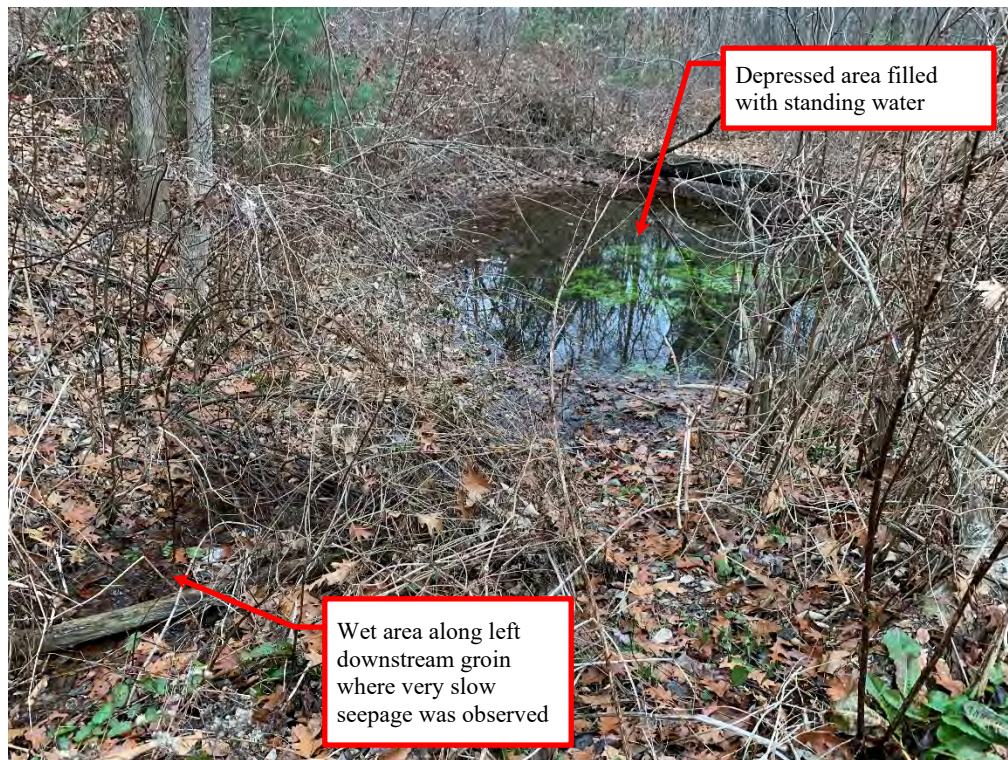
- Slow seepage (less than 0.5 gpm) was observed emerging from the left downstream groin upstream of a small area of ponded water. Slow seepage and standing water in this area have been observed previously. Prior inspections noted a seepage rate between 3 to 5 gpm. The source/origin of the seepage has not been confirmed.

- Slow seepage (less than 0.5 gpm) was observed emerging from the left downstream groin upstream of a small area of ponded water. Reportedly, seepage and standing water have always been an issue near the left abutment on the downstream side of the dam and in the immediate downstream area. Prior inspections (with the impoundment at normal pool elevation) noted a seepage rate between 3 to 5 gpm. See **Photo 17**.

Photo 17 - Ponded water in a depression along the toe of the downstream slope near the left abutment. A wet area with slow seepage was observed upstream of the ponded water along the lower portion of the left downstream groin. Seepage has been observed in this area previously, but the origin/source is unknown.

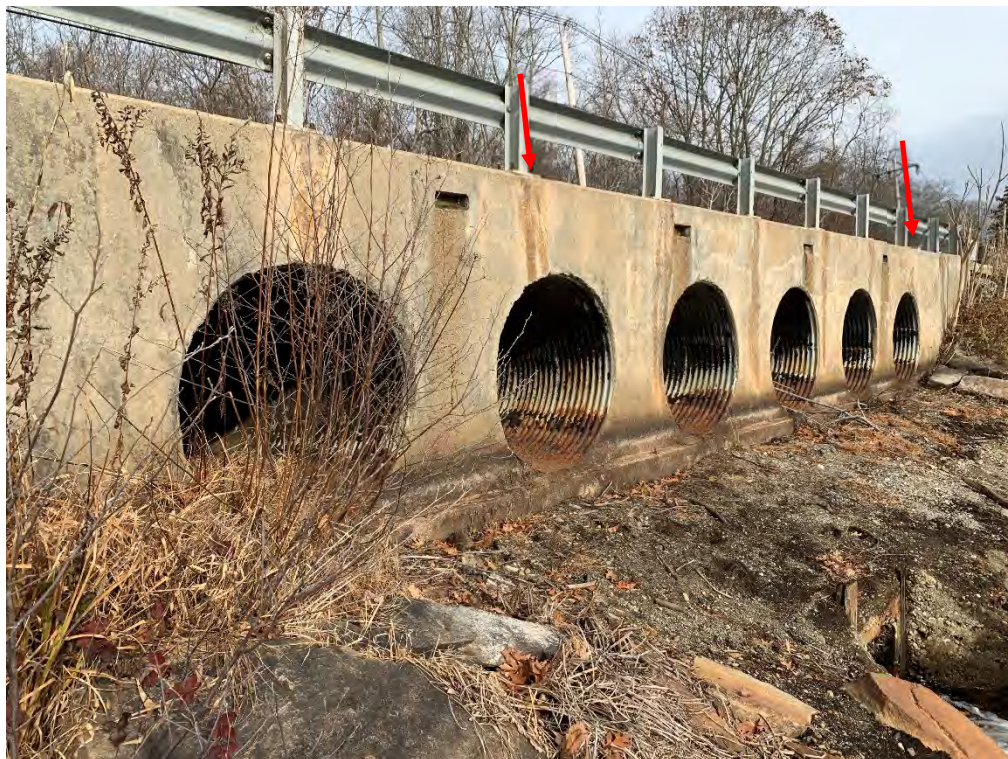
- There are transverse cracks in the reinforced concrete headwall above the second and sixth CMP culverts (from the left) and a longitudinal crack between the third and fourth CMP culvert (from the left). See **Photo 18** and **Photo 19**.
- The protective bituminous coating lining the interior of the CMP culverts is cracked at the top of the pipes and mostly missing along the inverts. The pipe inverts are corroded where the bituminous coating is missing. See **Photo 20**.
- Cracking and general concrete deterioration were observed at the reinforced concrete endwall (downstream side of spillway) along an apparent construction joint between the endwall and bedding slab or footing beneath the CMP culverts. No evidence of wall movement was observed. See **Photo 21** and **Photo 22**.

Photo 18 - Overview of the spillway and reinforced concrete headwall. Transverse cracks were observed above the second and sixth CMPs from the left and a longitudinal crack was observed between the third and fourth CMPs from the left.

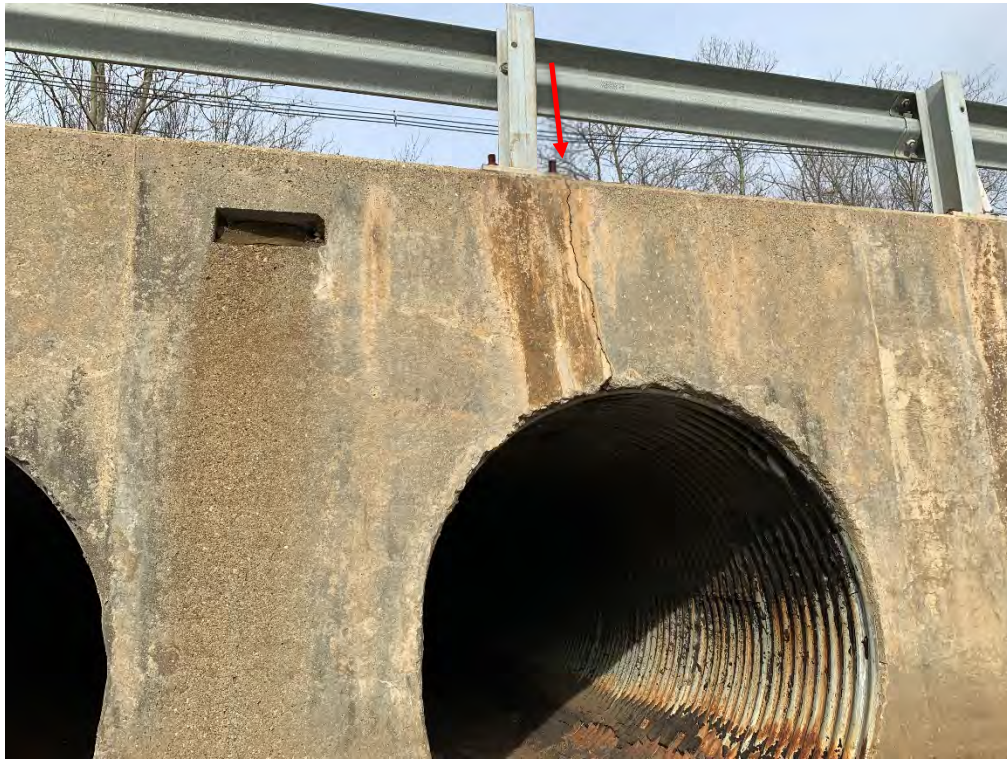
Photo 19 - Close up view of a transverse crack above rightmost CMP.

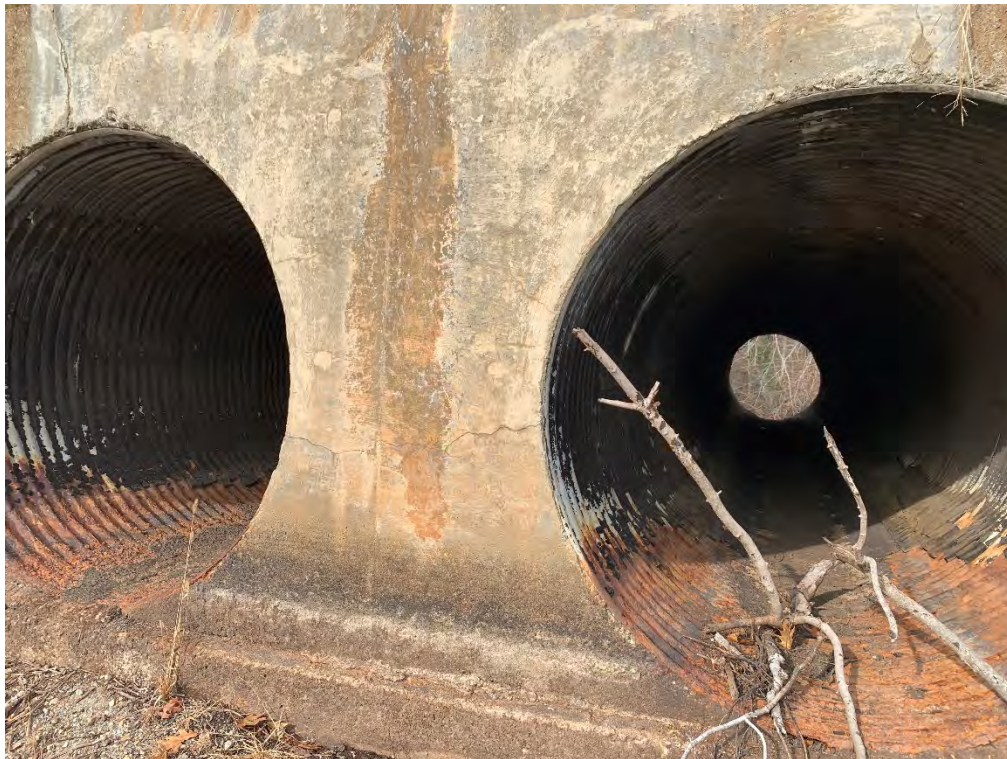
- A bituminous coating lining the interior of the CMP culverts is cracked at the top of the pipes and mostly missing along the inverts. The pipe inverts are corroded where the coating is missing. Continued corrosion and deterioration could result in leakage into the embankment.

Photo 20 - Close up view of two of the CMPs. The protective bituminous coating on the CMPs is cracked at the top of the pipes and is missing along the inverts. The bottom of the CMPs are corroded where the bituminous coating is missing.

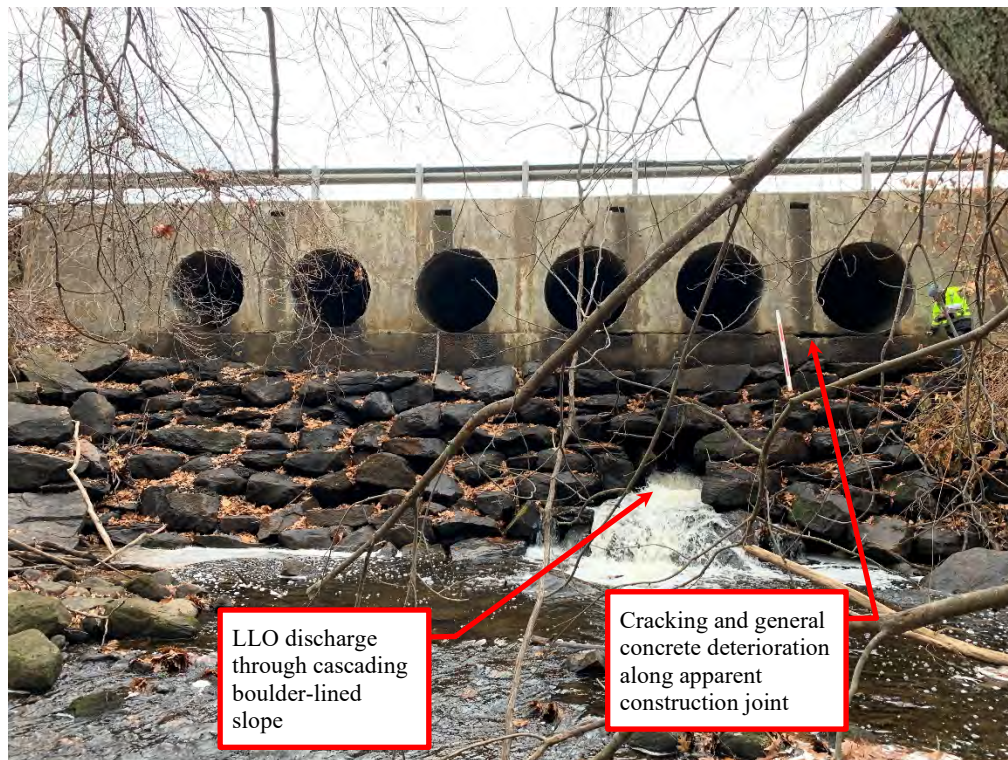
Photo 21 - Overview of the downstream side of the spillway and cascading boulder-lined discharge slope. The spillway's reinforced concrete endwall is cracked and deteriorated in several locations.

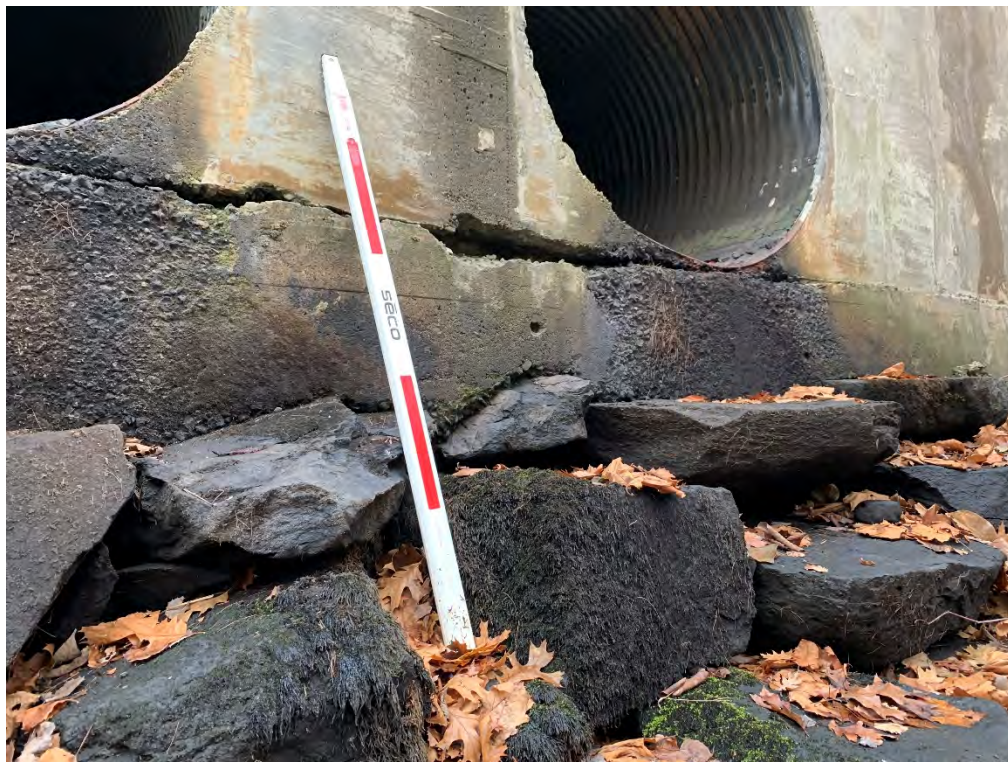
Photo 22 - Close-up view of cracked and deteriorated concrete at the spillway endwall along an apparent construction joint.

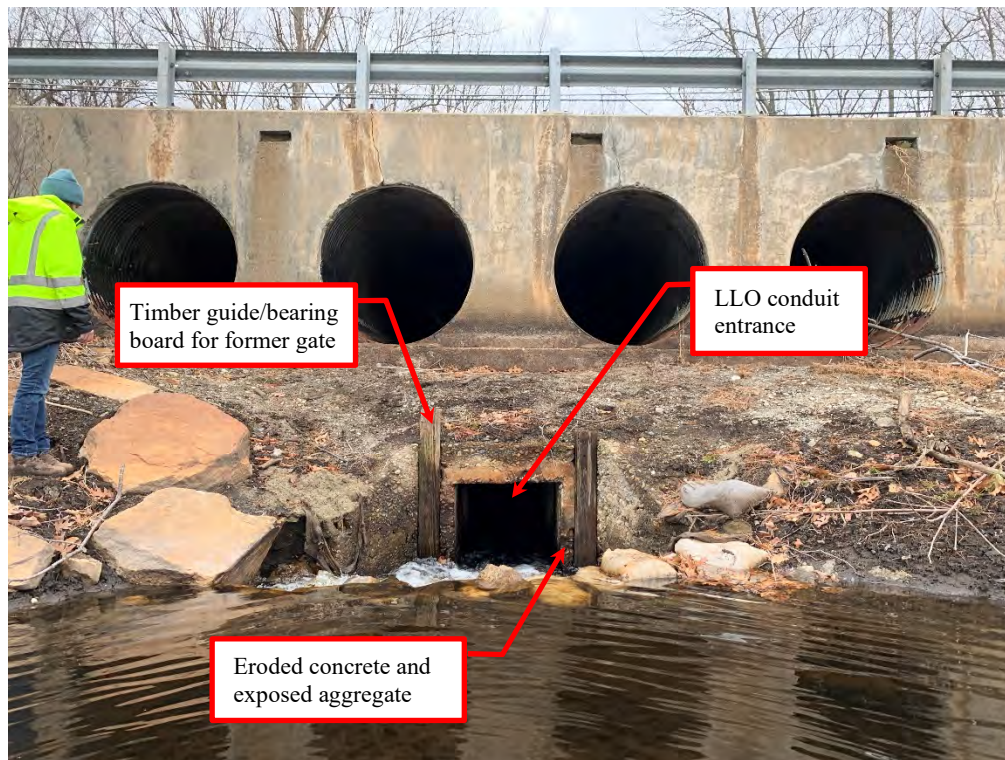
- The stone and sandbag check dam installed by the Town was still in place and functioning as intended. The approach area upstream of the check dam was generally free of pond debris. See **Photo 23**.
- The timber guide/bearing boards mounted to the left and right side of the conduit entrance appeared to be in generally fair condition but the concrete at the conduit entrance (against which the former push gate ‘sealed’) is eroded to the point where individual pieces of aggregate are exposed. See **Photo 23** and **Photo 24**.
- When viewed from the downstream end, the LLO conduit appeared to be in generally fair condition and flowing freely. See **Photo 25**.

Photo 23 - Overview of the LLO approach area. The LLO control mechanism (timber gate) failed and was removed in July 2019. A stone and sandbag check dam is present upstream of the LLO inlet.

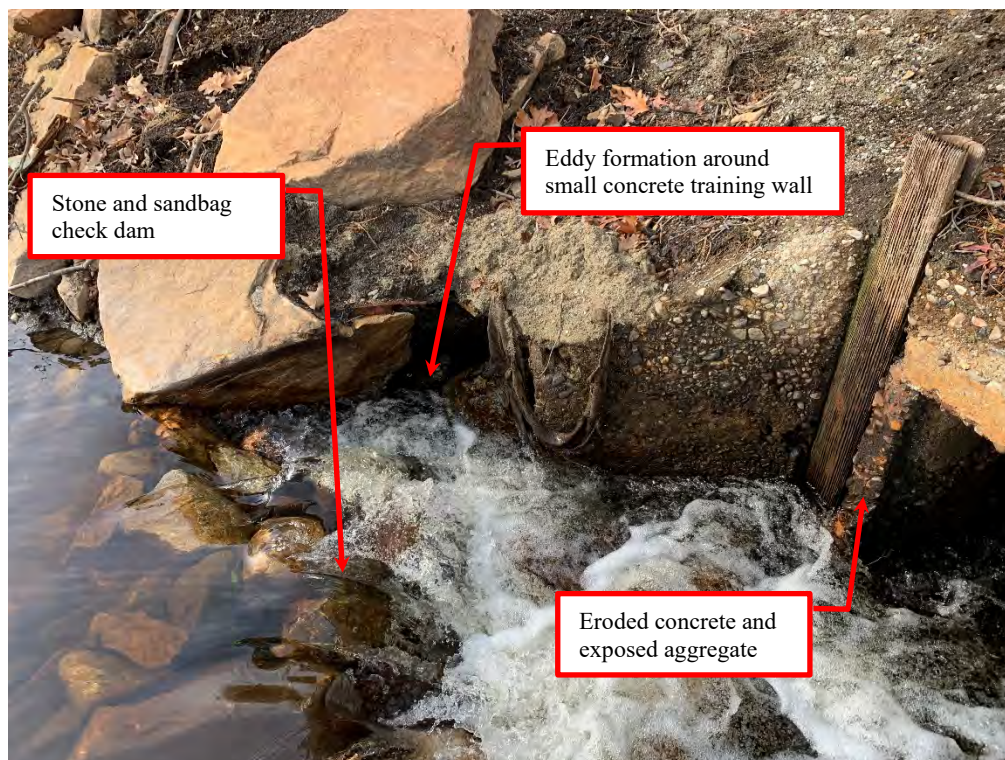
Photo 24 - Close up view of the LLO approach area and eddy at the end of the left LLO training wall. The eddy appears to be eroding a small cavity behind the training wall. Erosion of the concrete at the conduit entrance has resulted in exposed aggregate.

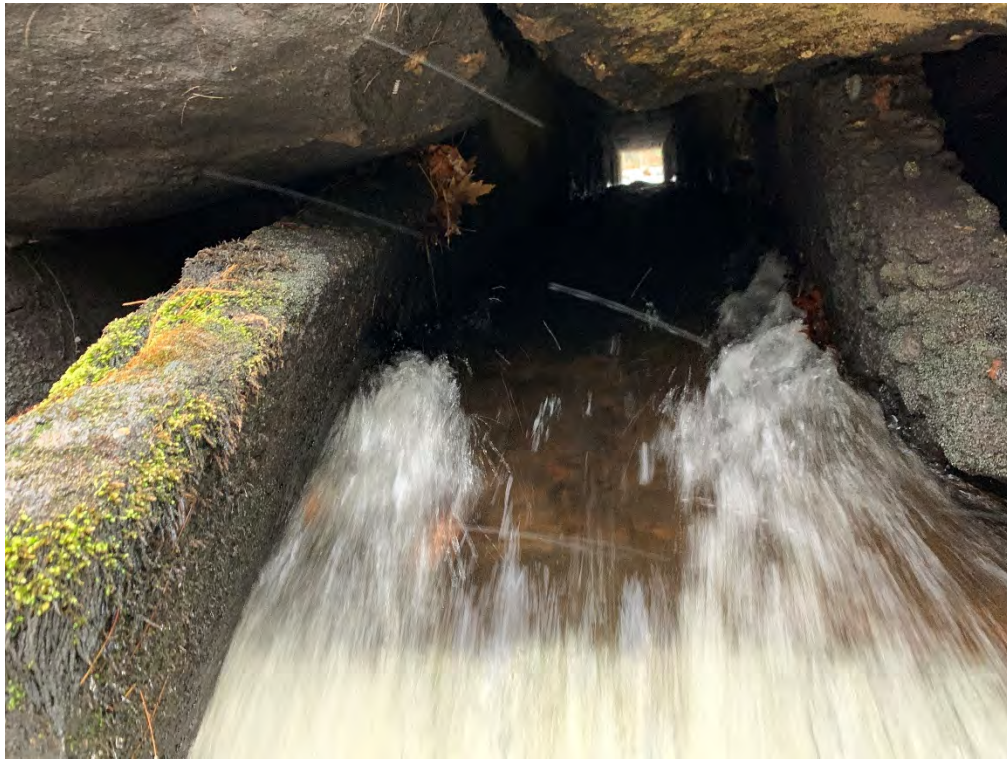
Photo 25 - The LLO conduit viewed looking upstream from the downstream end where the conduit daylights through the cascading boulder-lined slope. The conduit appeared to be flowing freely.

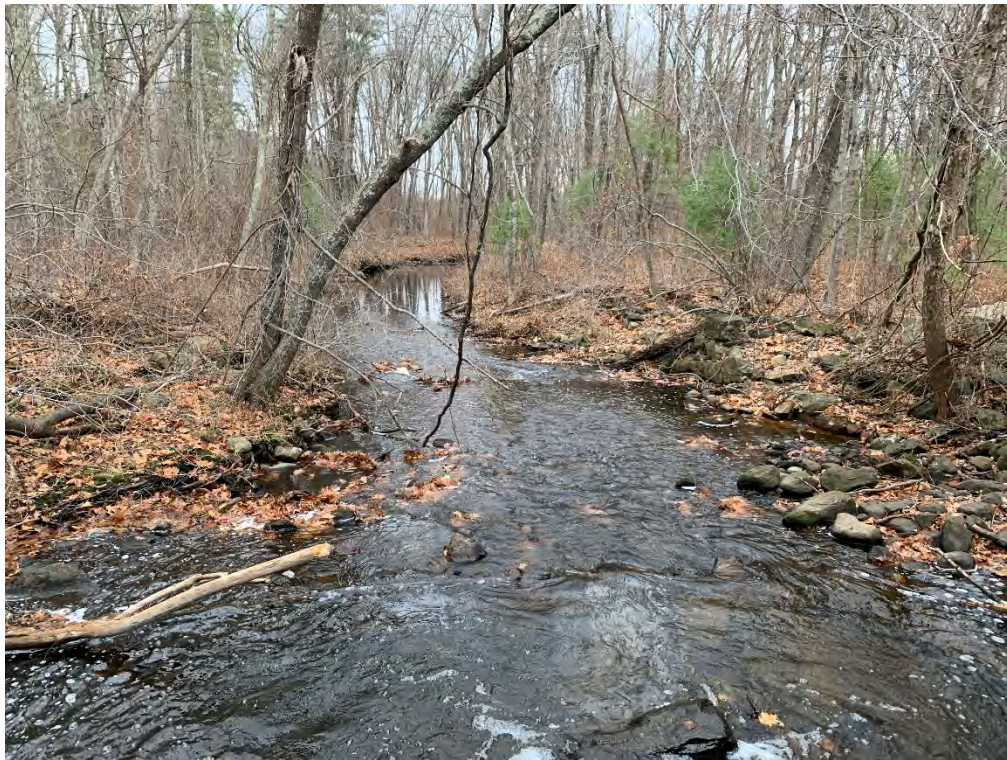
Photo 26 - Overview of the immediate downstream area and banks of the downstream channel (Cold Spring Brook). The immediate downstream area is heavily wooded. Access to the downstream area is possible by foot only. The downstream channel appears to flow freely.
