### Site-specific BMPs

<b>BEALS + THOMAS</b>		<b>SWPPP PHOTOGRAPHIC LOG</b>	
<b>Client Name:</b> Scannell Properties		<b>Photo Location:</b> Blackstone Logistics Center	
<b>Project No:</b> 3077.12			
<b>Photo No:</b> 1	<b>Date:</b> 11/16/2022		
<b>Description:</b> Northern cut slope remains stable and vegetated. Recently completed swale awaiting pre-winter stabilization measures to be implemented. No issues observed.		 	
<b>Client Name:</b> Scannell Properties		<b>Photo Location:</b> Blackstone Logistics Center	
<b>Project No:</b> 3077.12			
<b>Photo No:</b> 2	<b>Date:</b> 11/16/2022		
<b>Description:</b> View of the eastern off-grading areas between emergency access driveway and truck court. No erosion observed. Previously placed hydromulch appears to be keeping soils in place.

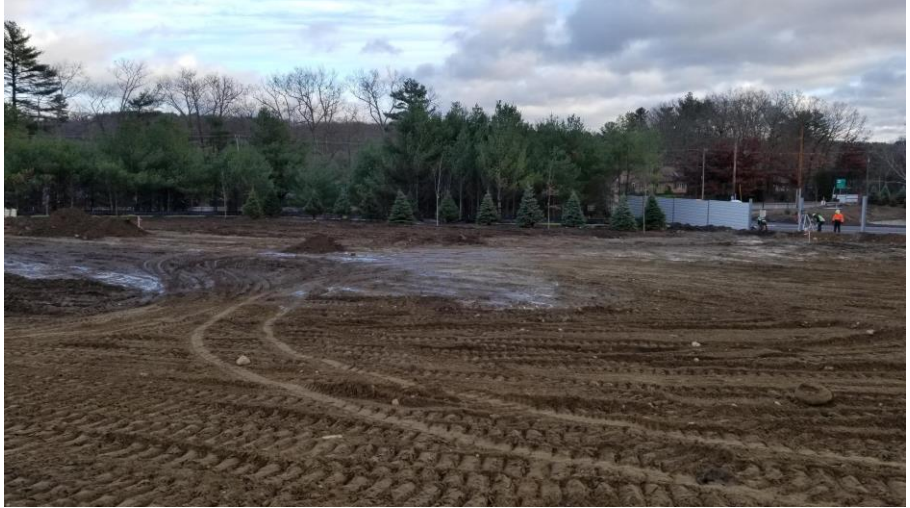
<b>Client Name:</b> Scannell Properties		<b>Photo Location:</b> Blackstone Logistics Center	<b>Project No:</b> 3077.12
<b>Photo No:</b> 3	<b>Date:</b> 11/16/2022

<b>Description:</b> Final cleanup of loam and landscaping stockpile area is in-progress. Finish grading and pre-winter stabilization is pending. No issues observed along limit of work line.			
<b>Client Name:</b> Scannell Properties		<b>Photo Location:</b> Blackstone Logistics Center	<b>Project No:</b> 3077.12
<b>Photo No:</b> 4	<b>Date:</b> 11/16/2022

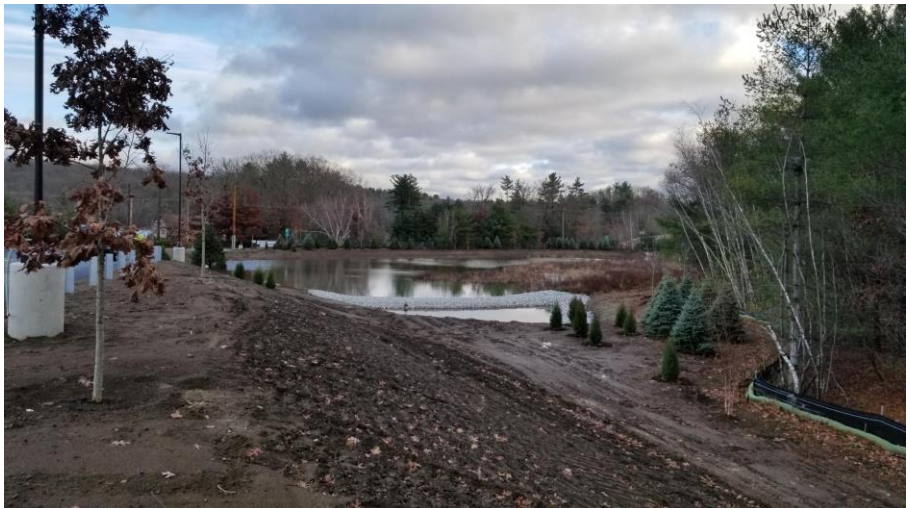
<b>Description:</b> No issues observed along off-grading slopes north of Infiltration Basin-2. Pre-winter stabilization/hydroseeding/hydromulch is pending.

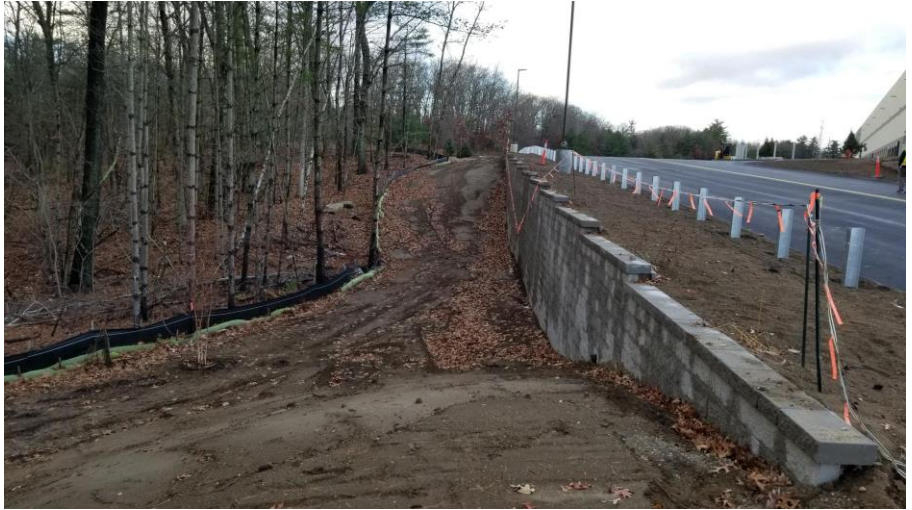
<b>Client Name:</b> Scannell Properties		<b>Photo Location:</b> Blackstone Logistics Center	<b>Project No:</b> 3077.12
<b>Photo No:</b> 5	<b>Date:</b> 11/16/2022

<b>Description:</b> No erosion issues observed along recently loamed area along Wall #10. Pre-winter stabilization measures pending.			
<b>Client Name:</b> Scannell Properties		<b>Photo Location:</b> Blackstone Logistics Center	<b>Project No:</b> 3077.12
<b>Photo No:</b> 6	<b>Date:</b> 11/16/2022

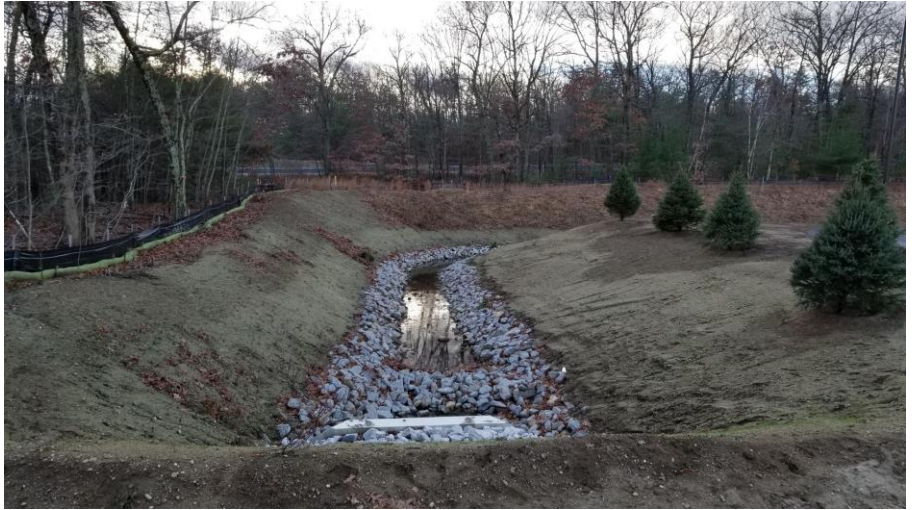
<b>Description:</b> Lower portion of the western drainage swale appeared to be in adequate condition. Final cleanup and rip-rap placement is pending.

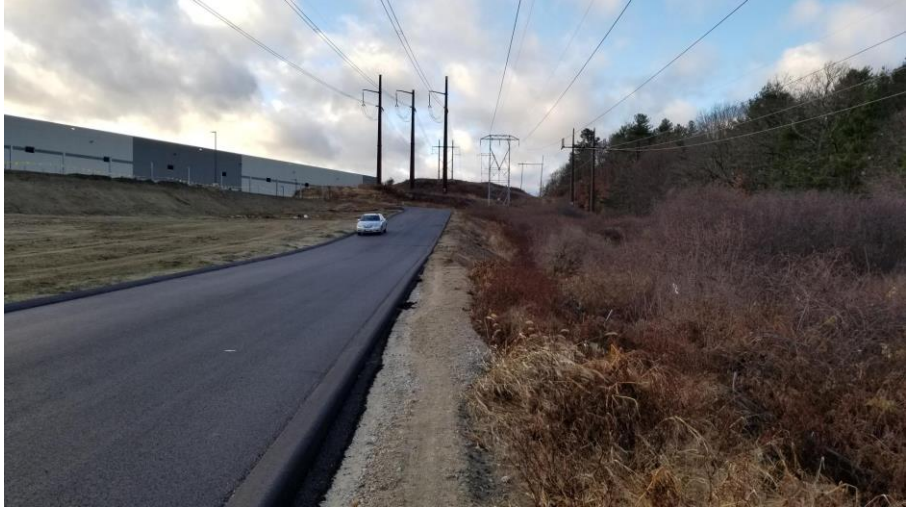
<b>Client Name:</b> Scannell Properties		<b>Photo Location:</b> Blackstone Logistics Center	<b>Project No:</b> 3077.12
<b>Photo No:</b> 7	<b>Date:</b> 11/16/2022

<b>Description:</b> No erosion issues observed along the eastern off-grading slopes. Stormwater from emergency access driveway now being directed into catch basins.			
<b>Client Name:</b> Scannell Properties		<b>Photo Location:</b> Blackstone Logistics Center	<b>Project No:</b> 3077.12
<b>Photo No:</b> 8	<b>Date:</b> 11/16/2022

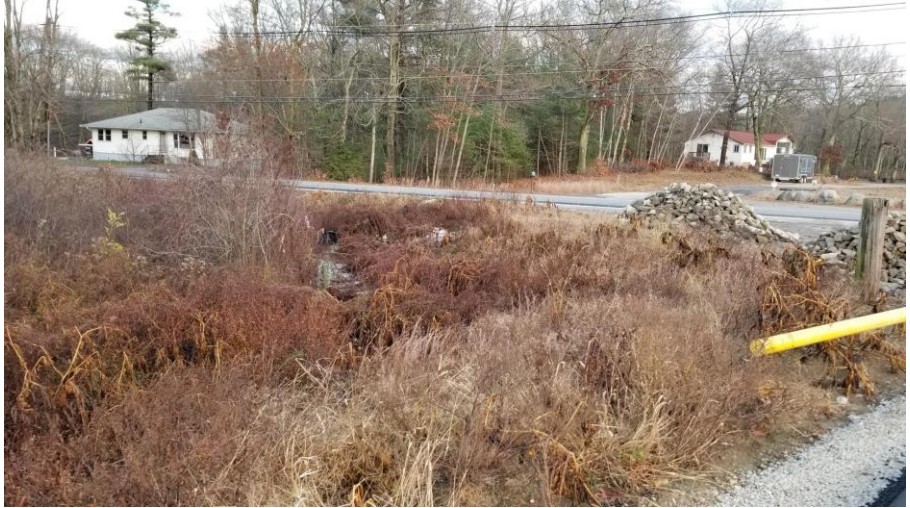
<b>Description:</b> No issues observed along the eastern limit of work adjacent to the emergency access driveway and Lackey Dam Road.

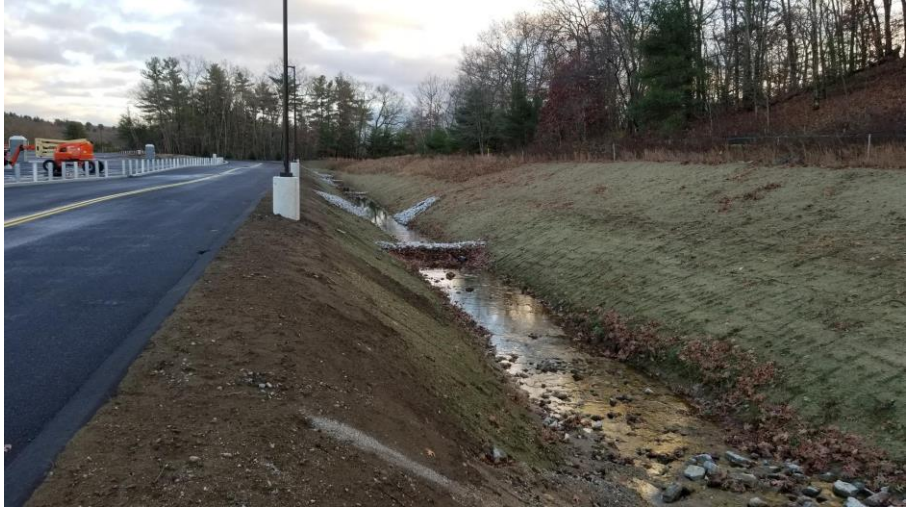
<b>Client Name:</b> Scannell Properties		<b>Photo Location:</b> Blackstone Logistics Center	<b>Project No:</b> 3077.12
<b>Photo No:</b> 9	<b>Date:</b> 11/16/2022

<b>Description:</b> No new erosion was observed along the upper portion of the western swale. Final cleanup/repair of lower slopes and rip-rap placement in the swale bottom is pending.			
<b>Client Name:</b> Scannell Properties		<b>Photo Location:</b> Blackstone Logistics Center	<b>Project No:</b> 3077.12
<b>Photo No:</b> 10	<b>Date:</b> 11/16/2022

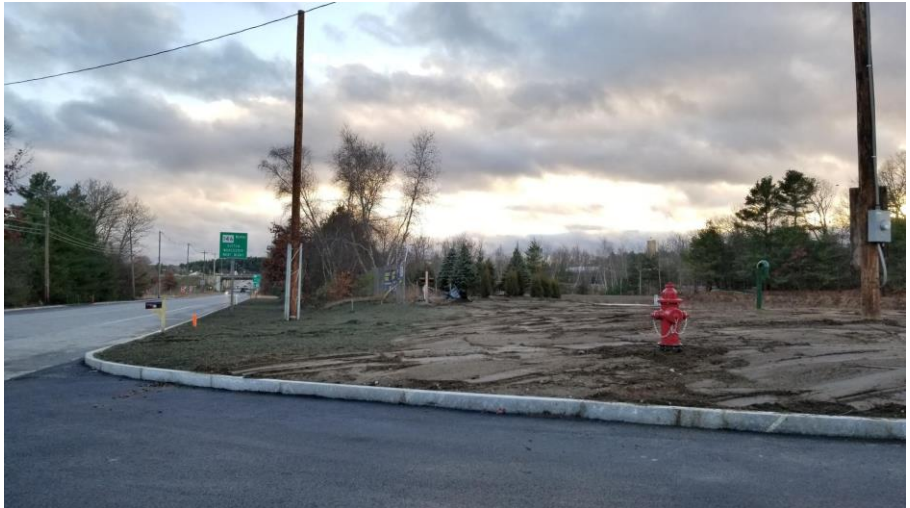
<b>Description:</b> Recently loamed and hydroseeded areas along Lackey Dam Road. Hydroseed application with tackifier is recommended on all exposed topsoil areas prior to winter.
