Stormwater Pollution Prevention Plan: Inspection Checklist

General Information				
Project Name	Blackstone Logistics Center			
NPDES Tracking No.	MAR1003KC	Location	Blackstone Logistics Center	
			E. Douglas, Massachusetts	
Date of Inspection	11/28/2022	Start/End Time	1:00 pm – 3:00 pm	
Inspector's Name(s)	Jeffrey R. Murphy, PE, B	eals and Thomas, Ir	nc.	
Inspector's Title(s)	Civil Engineer			
Inspector's Contact	jmurphy@bealsandthon	nas.com		
Information				
Describe present phase	Finish grading, finish inte	erior building work	, punch list site work items and	
of construction	cleanup.			
Inspection Frequency:				
	y 14 days <i>and</i> within 24 ho	ours of a 0.25" rain		
☐ Every 7 days <i>and</i> within	24 hours of a 0.25" rain			
Type of Inspection:				
☐ Regular ☐ Pre-s	☐ Regular ☐ Pre-storm event ☐ During storm event ☐ Post-storm event			
Weather Information				
Has there been a storm ev	ent since the last inspecti	on? ⊠ Yes □ No)	
If yes, provide:				
Storm Start Date & Time Storm: 11/27/22, 4 pm Duration (hrs.): 8 hr

SWPPP PHOTOGRAPHIC LOG

Photo Location: Blackstone Logistics Center **Project No:** 3077.12

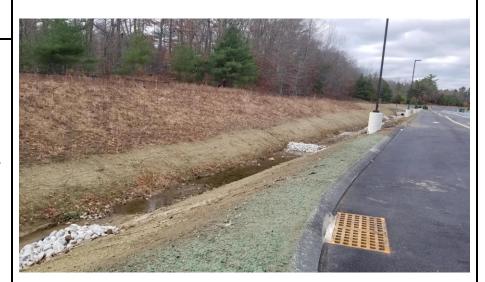
Photo No: 1

No new issues observed within the western drainage swale. Final rip-rap placement along the bottom of the swale is scheduled to occur in the near future.

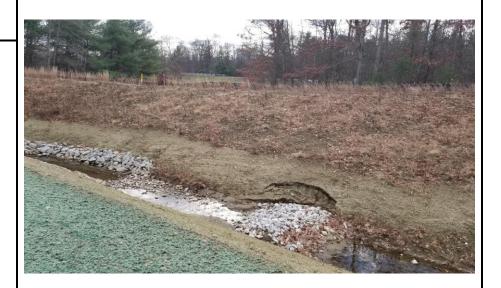
Photo No: 2

Prior area of sloughing which is scheduled to be repaired along with the final rip-rap placement.

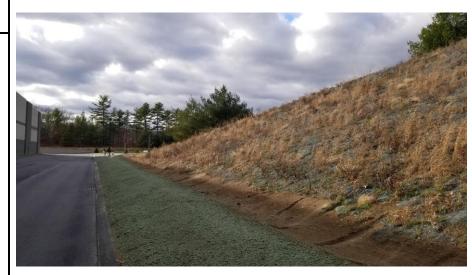
No: 3

No issues observed along the northern cut slope or swale at the toe of slope. Final hydroseeding was inprogress during site visit.

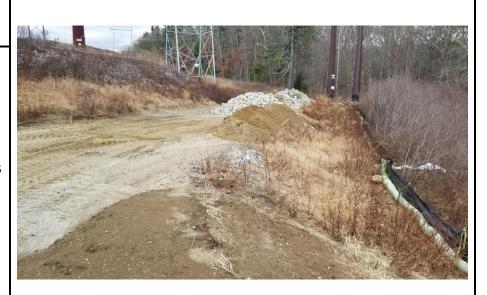
No issues observed along the N-Grid access spur.
Temporary stockpiles of rip-rap and soil should be removed as soon as practical before the next storm event.

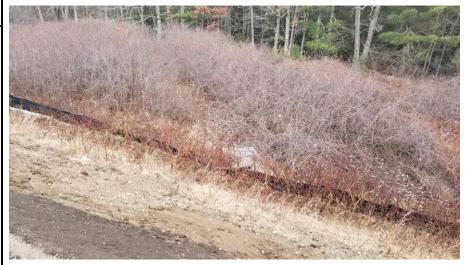
Photo Date:
No: 5 11/28/2022

No issues observed along the eastern limit of work. A piece of rigid foam insulation was observed just beyond the silt fence which should be cleaned up.

Are storm drain inlets properly protected?	⊠ Yes □ No	□ Yes ⊠ No	Silt sacks have been removed from catch basins as final paving is now complete. Sweep pavement in areas where topsoil was tracked for final loaming along entry drive.
Is the construction exit preventing sediment from being tracked into the street?	⊠ Yes □ No	□ Yes ⊠ No	Site has been fully paved. There is no longer a need for a construction entrance/tracking pad. Contractor should sweep/clean up pavement following loam placement for final grading.
Is trash/litter from work areas collected and placed in covered dumpsters?	⊠ Yes □ No	⊠ Yes □ No	Clean up piece of foam insulation off the eastern limit of work.

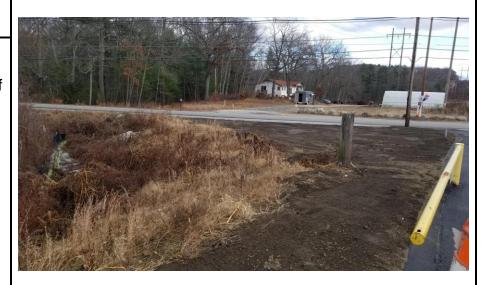
Final loam placement along the shoulders of the emergency access road. Hydroseeding inprogress during the site visit.

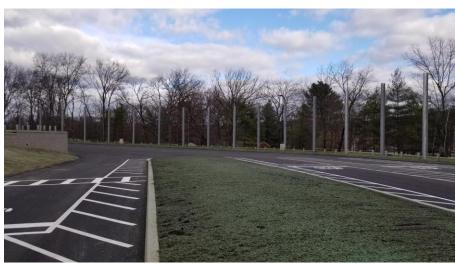
Photo Date: No: 7 11/28/2022

No issues observed in the recently hydroseeded areas along the southern entry drive and island.

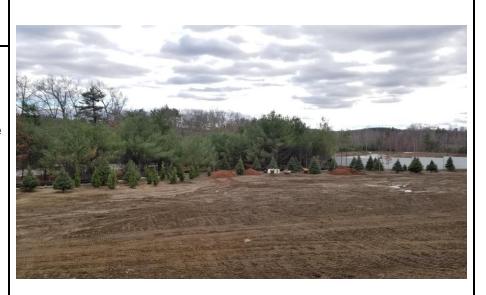
The area to the south of the building previously being used as a material stockpile area is undergoing final grading and cleanup. No issues observed along southern ECB.

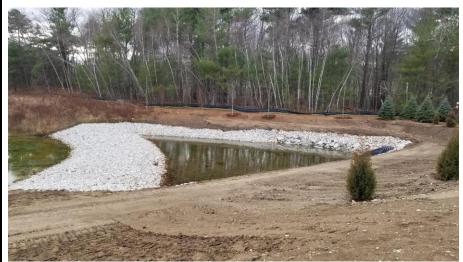
Photo Date: No: 9 11/28/2022

No issues observed along the main entry drive off-grading slopes and at the Sediment Forebay adjacent to Infiltration Basin #2.
Hydroseeding of loamed areas in progress throughout the site.

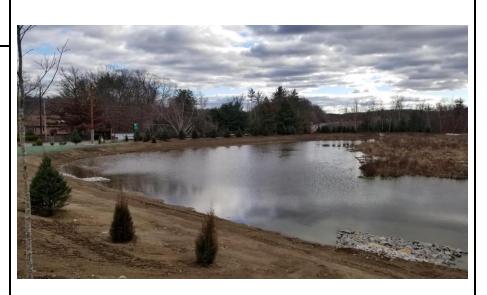
Photo Date: No: 10 11/28/2022

Clear standing water observed in Infiltration Basin #2 after storm event. Hydroseeding of side slope areas is scheduled to occur in the coming days.

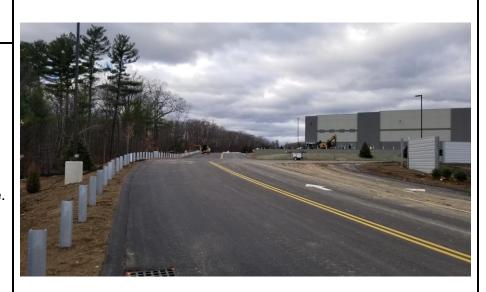
Area of loam tracking on the pavement where vehicles are driving in and out of the plant stockpile area. Sweep pavement after plantings are complete.

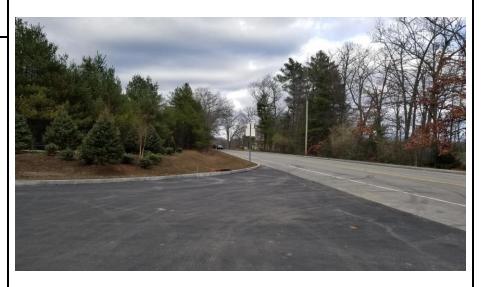
Final grading and pavement at site entrance looking north along Lackey Dam Road. Hydroseeding scheduled in coming days.

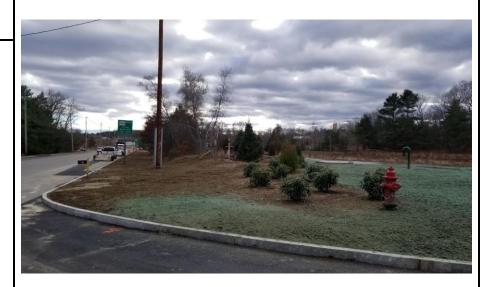
Description:
Final grading along southern apron at site entrance. Final hydroseeding scheduled in coming

days.

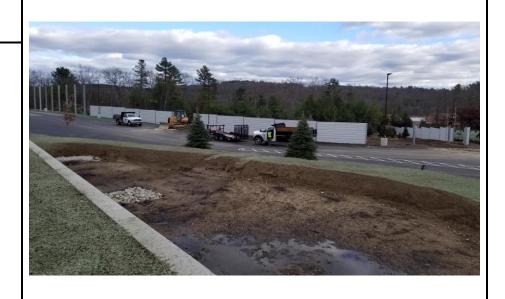
Description:
No issues were observed at the bioretention area.
Final seeding of the area is pending.
