Stormwater Pollution Prevention Plan: Inspection Checklist

General Information			
Project Name	Blackstone Logistics Center		
NPDES Tracking No.	MAR1003KC	Location	Blackstone Logistics Center E. Douglas, Massachusetts
Date of Inspection	3/15/2023	Start/End Time	4:15 pm – 4:45 pm
Inspector's Name(s)	Jeffery R. Murphy, PE, Beals and Thomas, Inc.		
Inspector's Title(s)	Civil Engineer		
Inspector's Contact Information	jmurphy@bealsandthomas.com		
Describe present phase of construction	Finish interior building work, signage installation, site cleanup.		
Inspection Frequency: <input type="checkbox"/> Every 7 days <input checked="" type="checkbox"/> Every 14 days <i>and</i> within 24 hours of a 0.25" rain <input type="checkbox"/> Every 7 days <i>and</i> within 24 hours of a 0.25" rain			
Type of Inspection: <input type="checkbox"/> Regular <input type="checkbox"/> Pre-storm event <input type="checkbox"/> During storm event <input checked="" type="checkbox"/> Post-storm event

BEALS + THOMAS		SWPPP PHOTOGRAPHIC LOG	
Client Name: Scannell Properties		Photo Location: Blackstone Logistics Center	
Project No: 3077.12			
Photo No: 1	Date: 3/15/2023

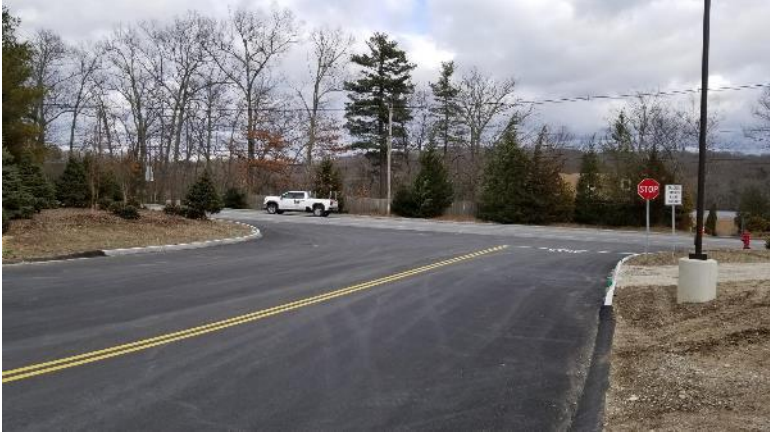
Description: No issues observed at the site entrance off Lackey Dam Road.			
Client Name: Scannell Properties		Photo Location: Blackstone Logistics Center	
Project No: 3077.12			
Photo No: 2	Date: 3/15/2023

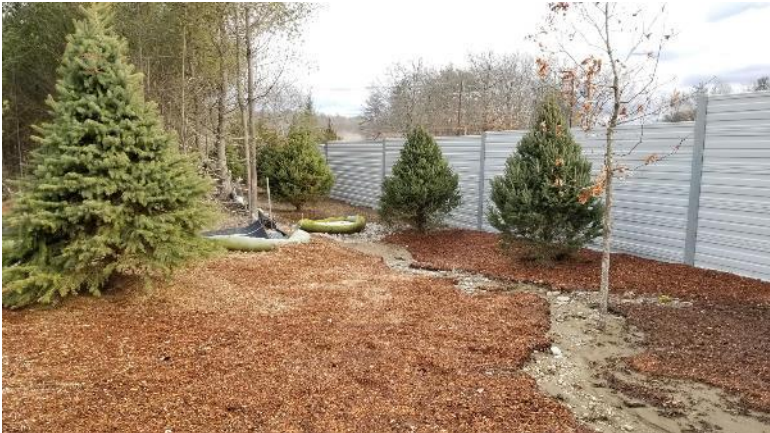
Description: In the area adjacent to the main entry driveway located south of the sound wall, prior rills and erosion do not appear to have worsened since the last SWPPP inspection. B+T observed that the Contractor had placed some crushed stone around the drop inlet, in addition to the filter sock that was previously installed around the inlet. This area will continue to be monitored in the coming weeks.

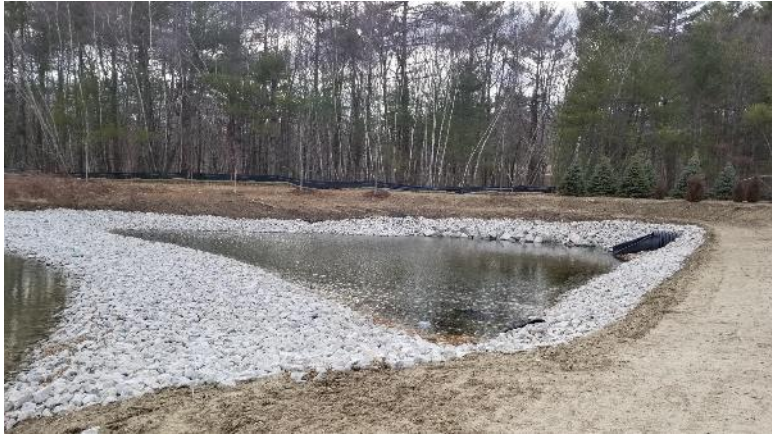
Client Name: Scannell Properties		Photo Location: Blackstone Logistics Center	Project No: 3077.12
Photo No: 3	Date: 3/15/2023

Description: View of the Sediment Forebay of Infiltration Basin-2. No issues were observed.			
Client Name: Scannell Properties		Photo Location: Blackstone Logistics Center	Project No: 3077.12
Photo No: 4	Date: 3/15/2023

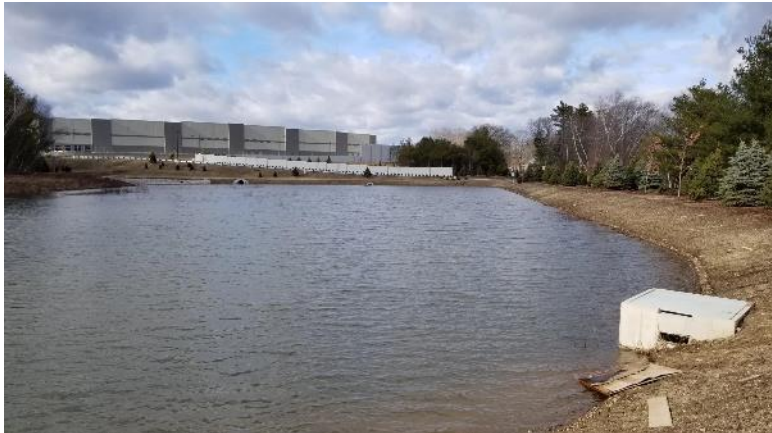
Description: View of Infiltration Basin-2. No issues were observed.

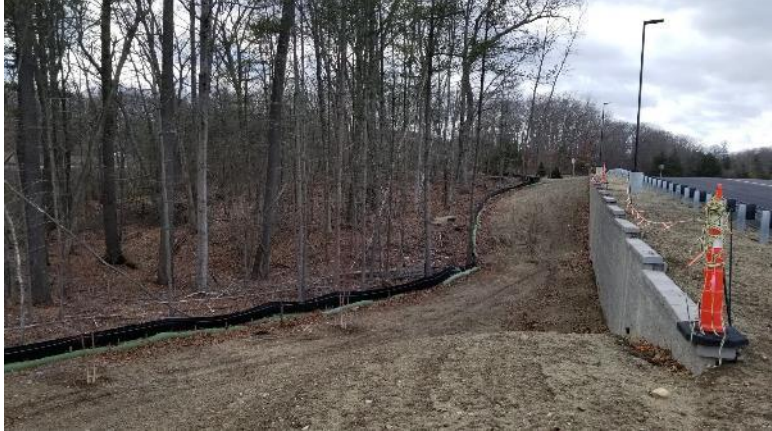
Client Name: Scannell Properties		Photo Location: Blackstone Logistics Center	Project No: 3077.12
Photo No: 5	Date: 3/15/2023

Description: View of the western limit of work adjacent to Wall #10. No erosion issues observed.			
Client Name: Scannell Properties		Photo Location: Blackstone Logistics Center	Project No: 3077.12
Photo No: 6	Date: 3/15/2023

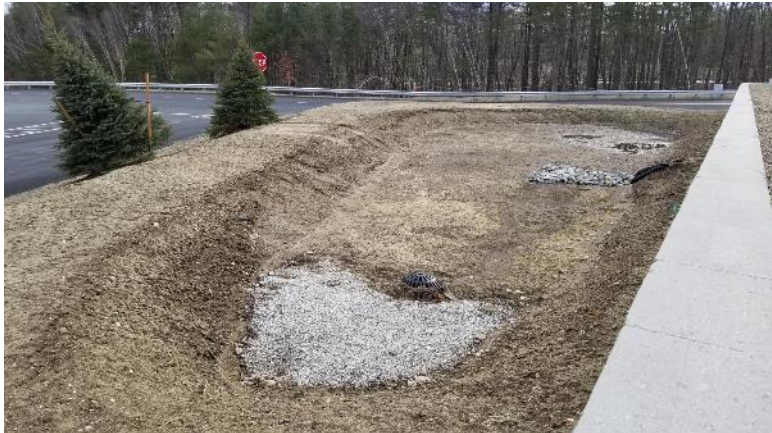
Description: Bioretention Area located south of the employee parking lot. No issues were observed.

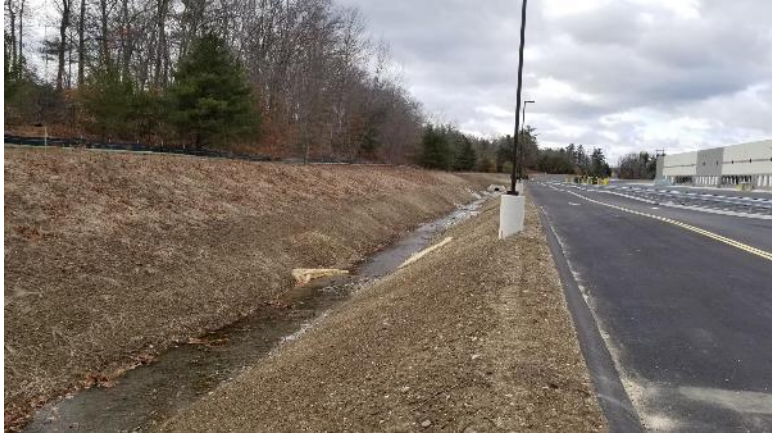
Client Name: Scannell Properties		Photo Location: Blackstone Logistics Center	Project No: 3077.12
Photo No: 7	Date: 3/15/2023

Western Swale	<input checked="" type="checkbox"/> Yes <input type="checkbox"/> No	<input type="checkbox"/> Yes <input checked="" type="checkbox"/> No	Swale repairs have been completed.
	<input type="checkbox"/> Yes <input type="checkbox"/> No	<input type="checkbox"/> Yes <input type="checkbox"/> No	
	<input type="checkbox"/> Yes <input type="checkbox"/> No	<input type="checkbox"/> Yes <input type="checkbox"/> No	
	<input type="checkbox"/> Yes <input type="checkbox"/> No	<input type="checkbox"/> Yes <input type="checkbox"/> No	
	<input type="checkbox"/> Yes <input type="checkbox"/> No	<input type="checkbox"/> Yes <input type="checkbox"/> No

Description: Western swale viewed to the north. Prior side washouts caused by erosion have since been repaired. This area will continue to be monitored in the coming weeks.			
Client Name: Scannell Properties		Photo Location: Blackstone Logistics Center	Project No: 3077.12
Photo No: 8	Date: 3/15/2023

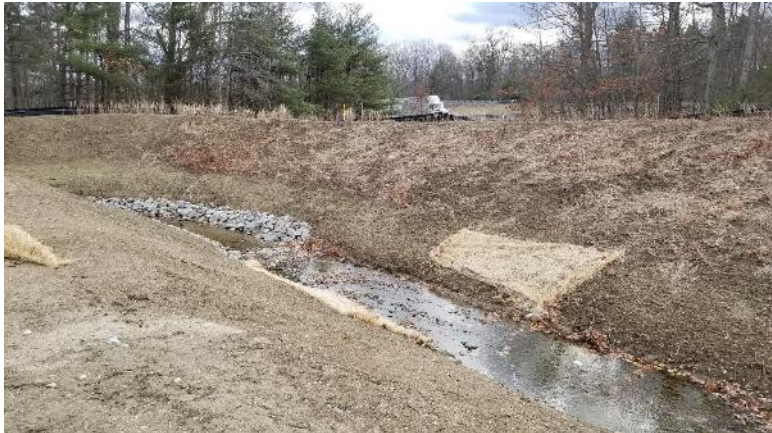
Description: View of jute matting used to help stabilize the repaired side slopes of the western swale. B+T observed that the jute matting had become slightly loose in certain locations. B+T recommends the Contractor continue to monitor the side slopes and rebolster the jute matting as needed.

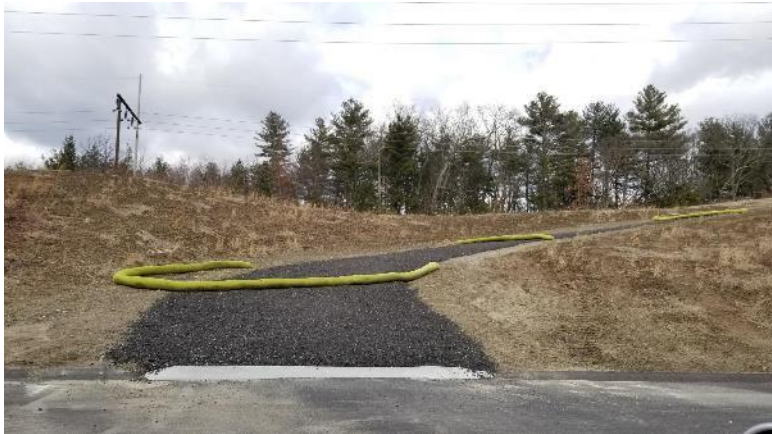
Description: View of the N-Grid transmission tower access driveway. The Contractor had placed and compacted pavement millings throughout the driveway to help stabilize the area and minimize further erosion. No issues were observed. This area will continue to be monitored in the coming weeks.

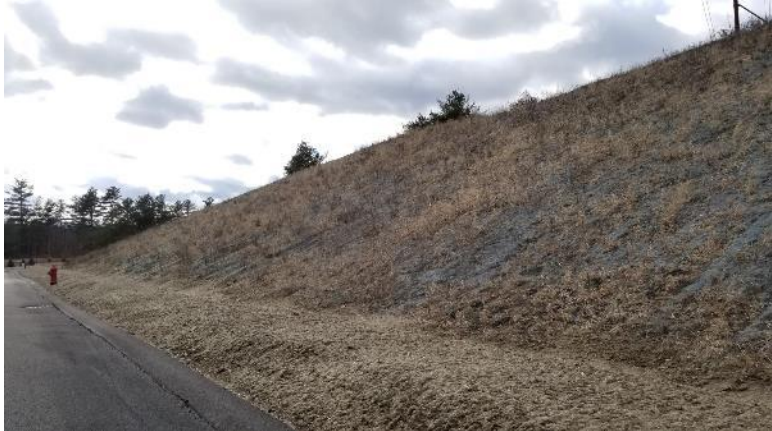
Client Name: Scannell Properties		Photo Location: Blackstone Logistics Center	Project No: 3077.12
Photo No: 11	Date: 3/15/2023

Description: No issues were observed along the northern cut-slope or swale at the base of the hill.			
Client Name: Scannell Properties		Photo Location: Blackstone Logistics Center	Project No: 3077.12
Photo No: 12	Date: 3/15/2023

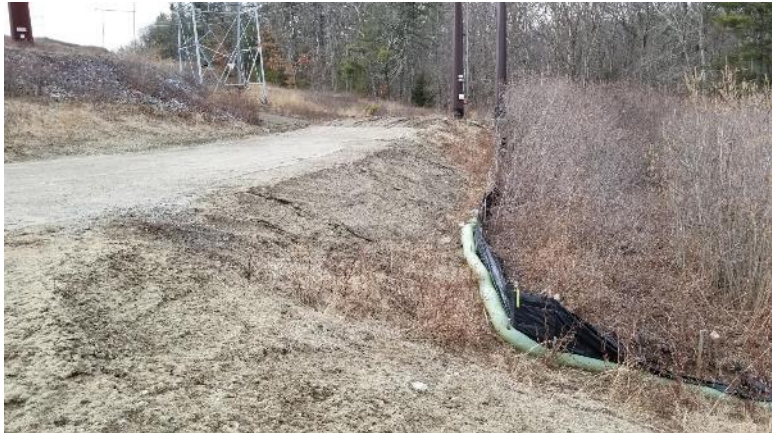
Description: View of the eastern N-Grid spur road adjacent to the emergency access driveway. Minor rills were observed along the off-grading slopes, but otherwise the area appears to have remained stable.

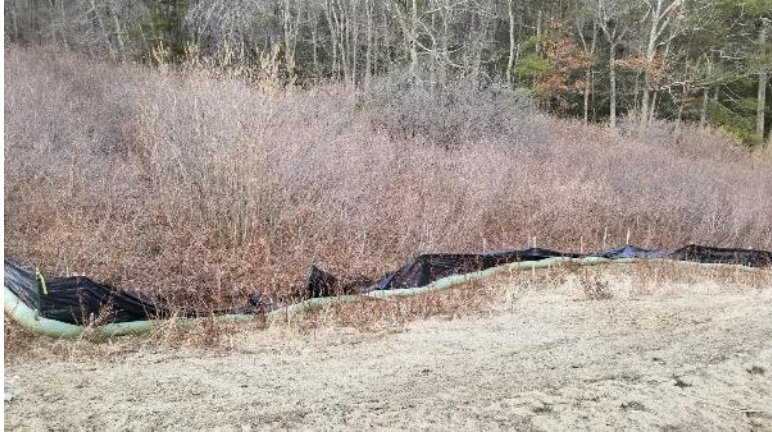
Client Name: Scannell Properties		Photo Location: Blackstone Logistics Center	Project No: 3077.12
Photo No: 13	Date: 3/15/2023

Are perimeter controls and sediment barriers adequately installed (keyed into substrate) and maintained?	<input checked="" type="checkbox"/> Yes <input type="checkbox"/> No	<input type="checkbox"/> Yes <input checked="" type="checkbox"/> No	A section of the silt fence along the eastern off-grading slopes, just east of the N-Grid spur road, has become loose. Contractor should bolster the silt fence as needed.
Are discharge points and receiving waters free of any sediment deposits?	<input checked="" type="checkbox"/> Yes <input type="checkbox"/> No	<input type="checkbox"/> Yes <input checked="" type="checkbox"/> No	No issues observed at any outlet points.
Are storm drain inlets properly protected?	<input checked="" type="checkbox"/> Yes <input type="checkbox"/> No	<input type="checkbox"/> Yes <input checked="" type="checkbox"/> No	Silt sacks on-site have been removed from catch basins as final paving is now complete. Silt sacks remain in place on CBs in Lackey Dam Rd.

Description: A section of the silt fence along the eastern off-grading slopes, just east of the N-Grid spur road, has become loose. No sediment appeared to have bypassed the filter sock or silt fence. B+T recommends the Contractor re-staple the silt fence as needed.			
Client Name: Scannell Properties		Photo Location: Blackstone Logistics Center	Project No: 3077.12
Photo No: 14	Date: 3/15/2023

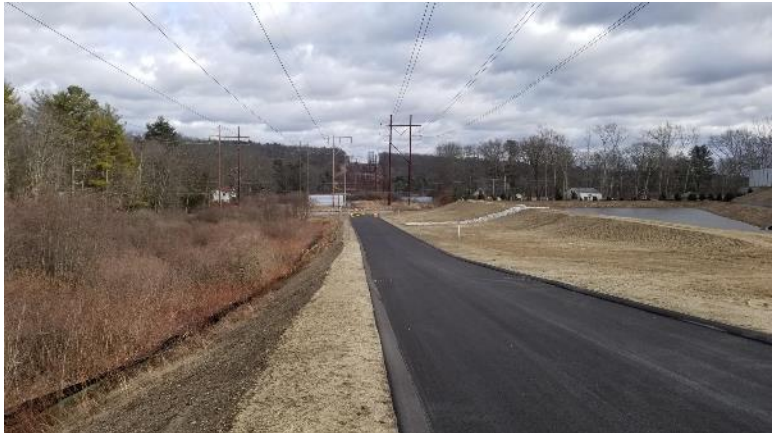
Description: No issues were observed along the emergency access driveway, the eastern off-grading slopes, and the off-grading slopes adjacent to Infiltration Basin-1.
