Site-specific BMPs

BEALS + THOMAS		SWPPP PHOTOGRAPHIC LOG	
Client Name: Scannell Properties		Photo Location: Blackstone Logistics Center	Project No: 3077.13
Photo No: 1	Date: 5/3/2023

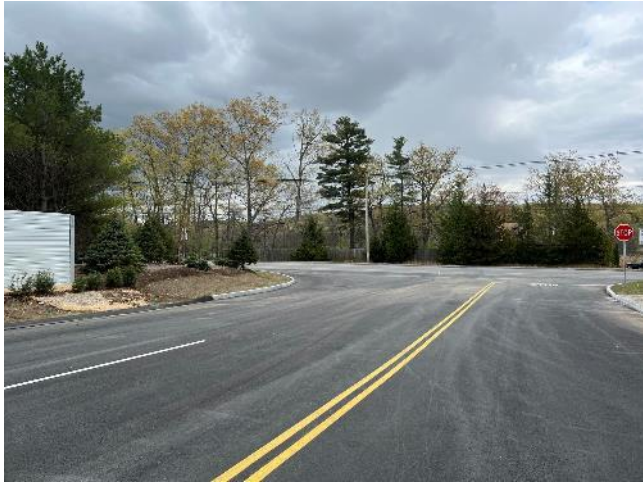
Description: Some sediment was observed being tracked onto Lackey Dam Road at the site entrance. B+T recommends the Contractor sweep the site entrance as needed. No other issues, particularly regarding the prior washout area, were observed.			
Client Name: Scannell Properties		Photo Location: Blackstone Logistics Center	Project No: 3077.13
Photo No: 2	Date: 5/3/2023

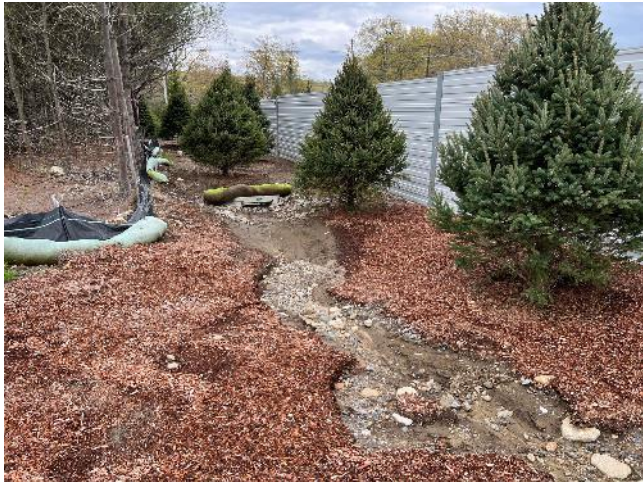
Description: In the area located behind the sound wall, adjacent to the main entry driveway, prior rills and erosion do not appear to have worsened much since the last SWPPP inspection. B+T recommends the Contactor place additional crushed stone around the drop inlet and upstream of the structure where the more critical erosion is occurring. This area will continue to be monitored in the coming weeks.

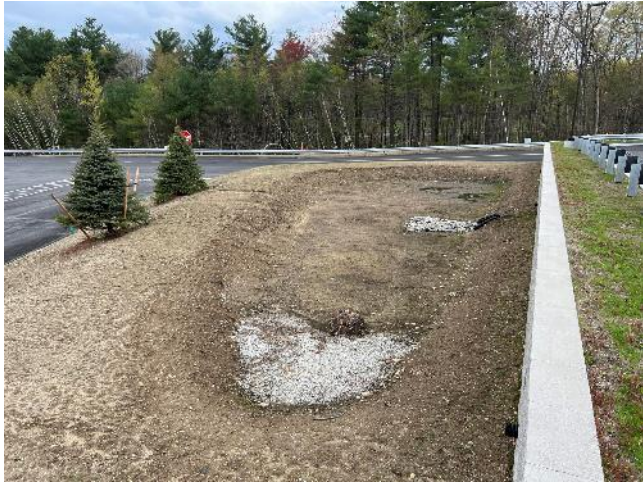
Description: View of the Bioretention Area located south of the employee parking lot. Leaves and other debris were observed to be blocking the grate of the outlet control structure and shall be removed. Otherwise, no issues were observed.			
Client Name: Scannell Properties		Photo Location: Blackstone Logistics Center	Project No: 3077.13
Photo No: 4	Date: 5/3/2023

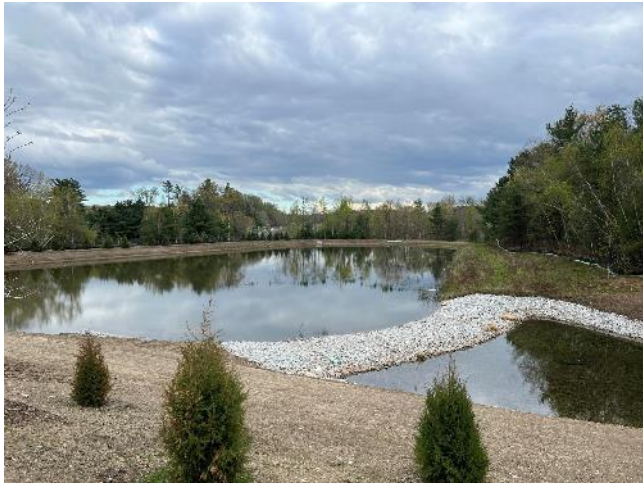
Description: View of the Sediment Forebay and Infiltration Basin-2. No issues were observed.

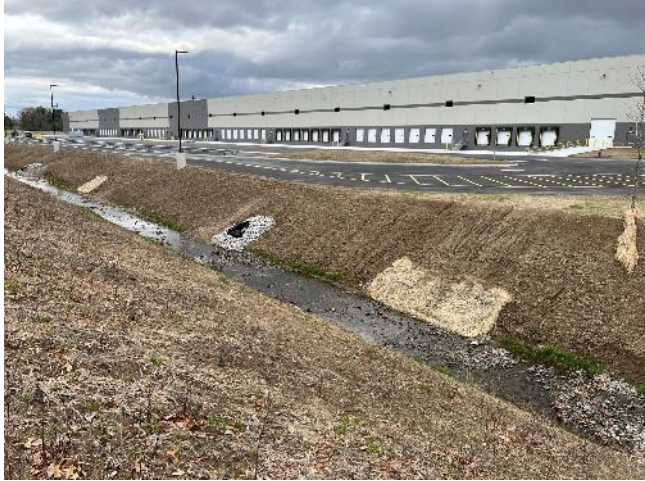
Description: View of jute matting used to help stabilize the repaired side slopes of the western swale. Minor rills were observed along the side slopes. These areas should be reseeded to establish vegetative cover, and will continue to be monitored in the coming weeks.			
Client Name: Scannell Properties		Photo Location: Blackstone Logistics Center	Project No: 3077.13
Photo No: 6	Date: 5/3/2023

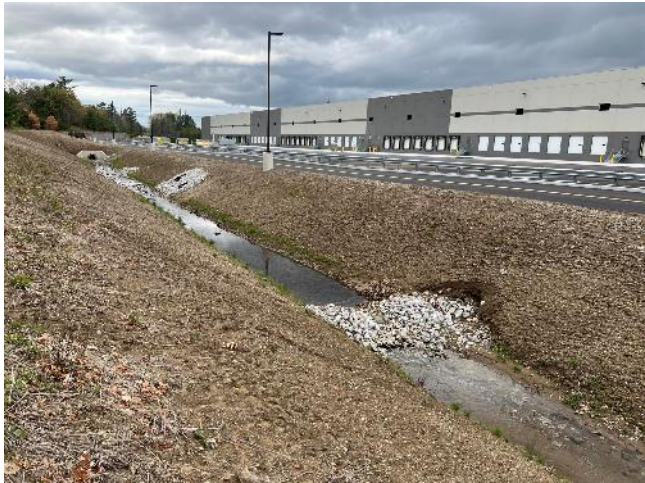
Description: Western swale viewed to the north. Some erosion was observed at one of the upstream check dams, causing some sediment to be washed out in the swale. This area will continue to be monitored in the coming weeks.

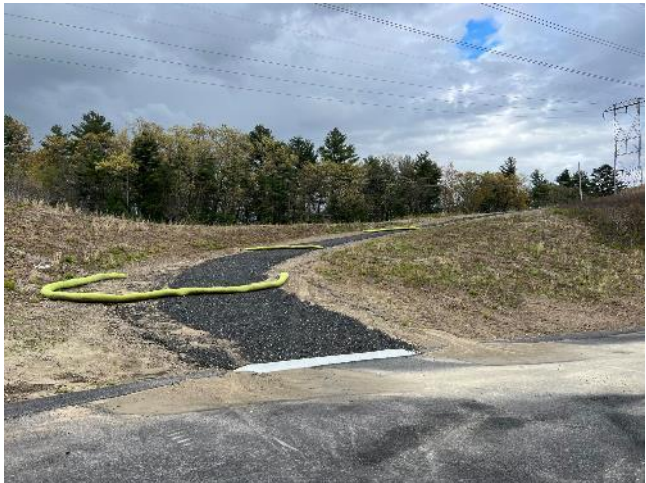
Description: View of the N-Grid transmission tower access driveway. Sediment has collected on the pavement at the bottom of the driveway, as well as behind the lowermost compost filter sock, due to erosion occurring along the shoulders of the compacted pavement millings. The Contractor shall remove the collected sediment on the pavement and behind the filter sock. This area will continue to be monitored in the coming weeks.			
Client Name: Scannell Properties		Photo Location: Blackstone Logistics Center	Project No: 3077.13
Photo No: 8	Date: 5/3/2023

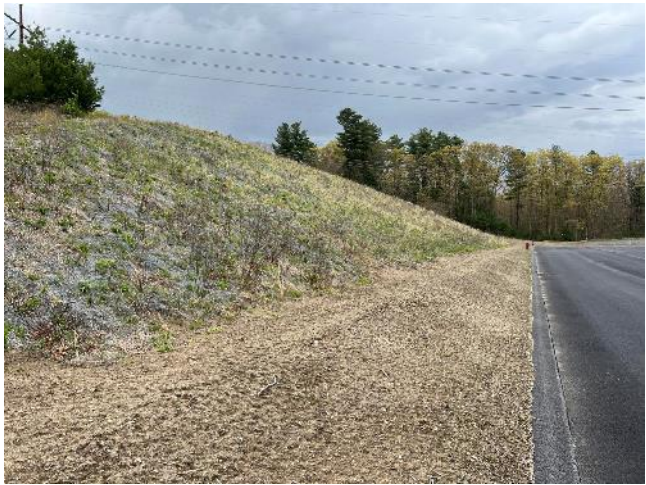
Description: No issues were observed along the northern cut-slope or swale at the base of the hill.

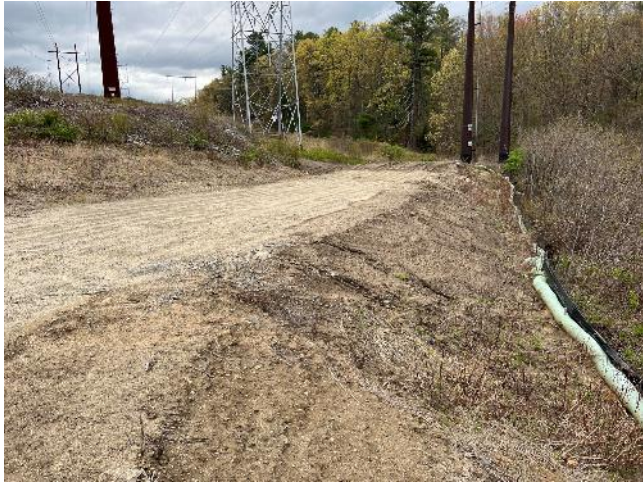
Description: View of the eastern N-Grid spur road adjacent to the emergency access driveway. Some rills were observed along the off-grading slopes, but otherwise the area appears to have remained stable. Unstabilized areas should be reseeded.			
Client Name: Scannell Properties		Photo Location: Blackstone Logistics Center	Project No: 3077.13
Photo No: 10	Date: 5/3/2023

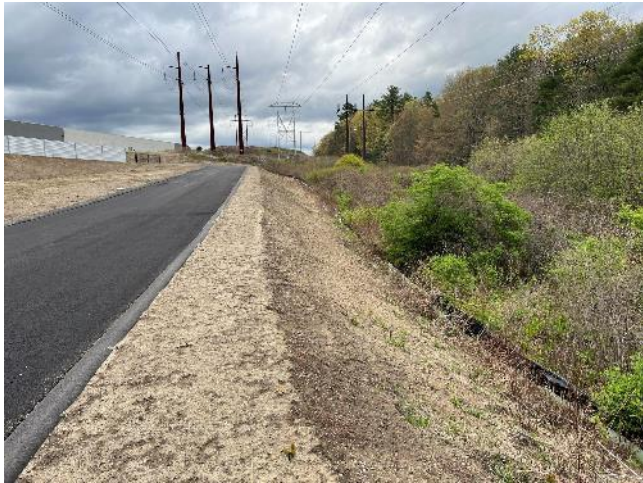
Description: No issues were observed along the emergency access driveway and the eastern off-grading slopes.

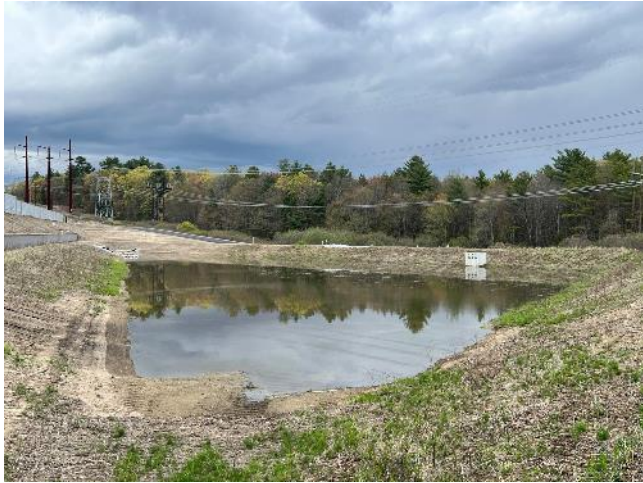
Description: View of Infiltration Basin- 1. No issues were observed.			
Client Name: Scannell Properties		Photo Location: Blackstone Logistics Center	Project No: 3077.13
Photo No: 12	Date: 5/3/2023

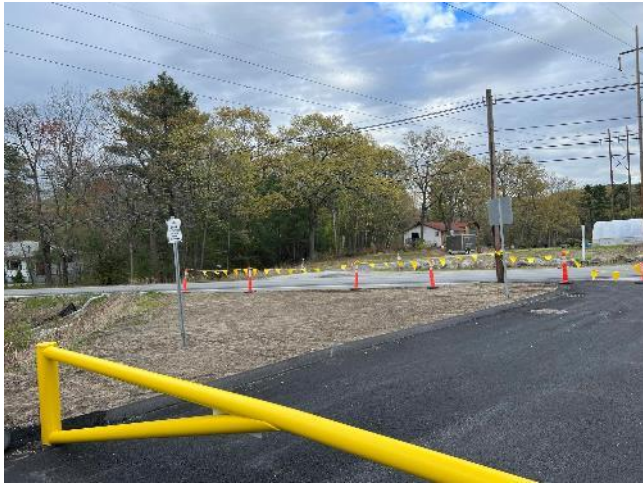
Description: No issues were observed in the area adjacent to the emergency access driveway along Lackey Dam Road.
