## SWPPP PHOTOGRAPHIC LOG

Scannell Properties

**Photo Location:** Blackstone  
Logistics Center

**Project No:** 3077.12

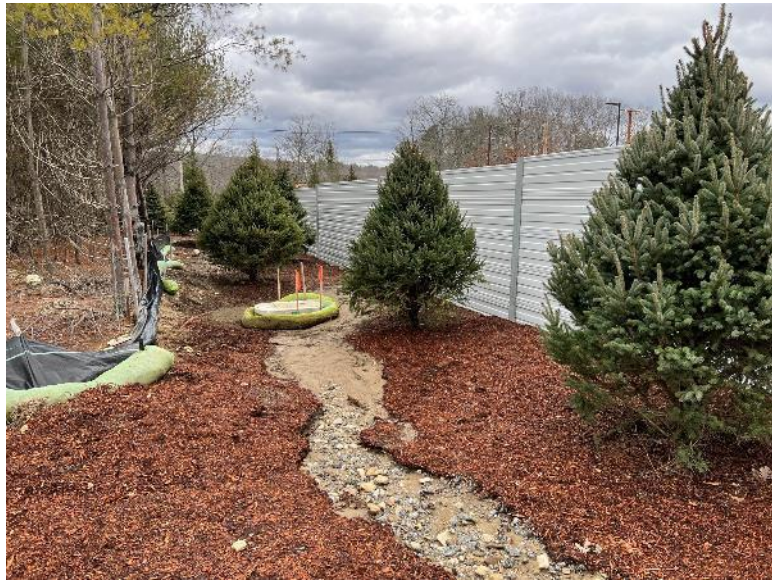
**Photo  
No:** 1

In the area south of the main entry driveway located south of the sound wall, prior rills and erosion do not appear to have worsened since the last SWPPP inspection. As suggested, the silt fence around the drop inlet had been removed and replaced with a filter sock. Corrective actions are pending.

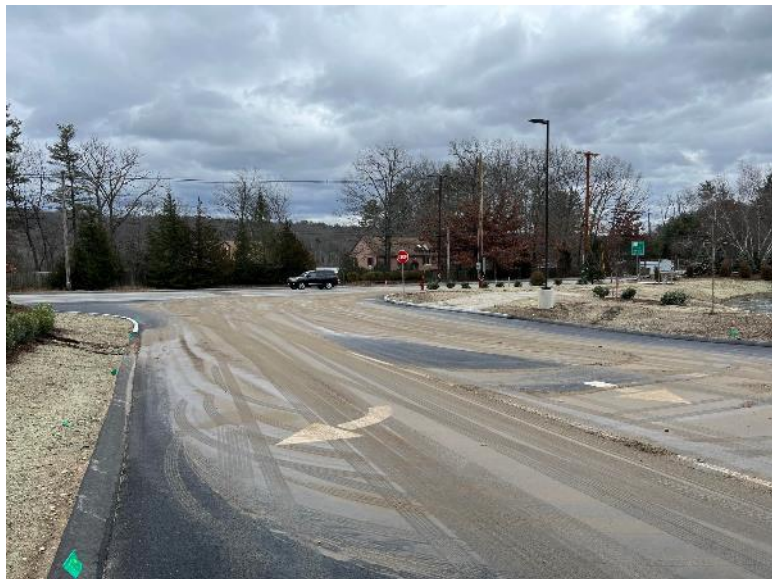
**Photo  
No:** 2

View of the sediment washout along the main entry driveway caused by the diverted flows at the drop inlet. The large deposits of sediment that had previously collected on the pavement have been removed, however significant sediment track-out remains. Corrective actions are pending.

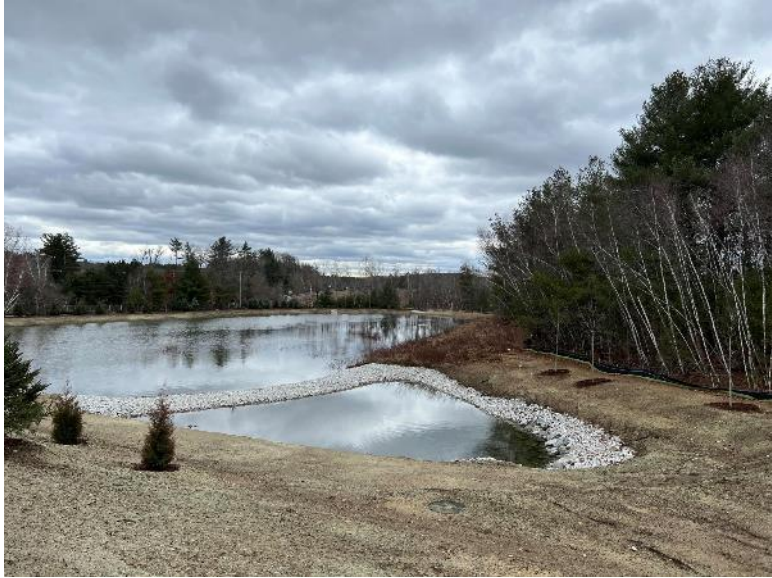
<b>Client Name:</b> Scannell Properties		<b>Photo Location:</b> Blackstone Logistics Center	<b>Project No:</b> 3077.12
<b>Photo No:</b> 3	<b>Date:</b> 1/26/2023

<b>Description:</b> View of the Sediment Forebay and Infiltration Basin-2. No further erosion of upgradient slopes was observed.			
<b>Client Name:</b> Scannell Properties		<b>Photo Location:</b> Blackstone Logistics Center	<b>Project No:</b> 3077.12
<b>Photo No:</b> 4	<b>Date:</b> 1/26/2023

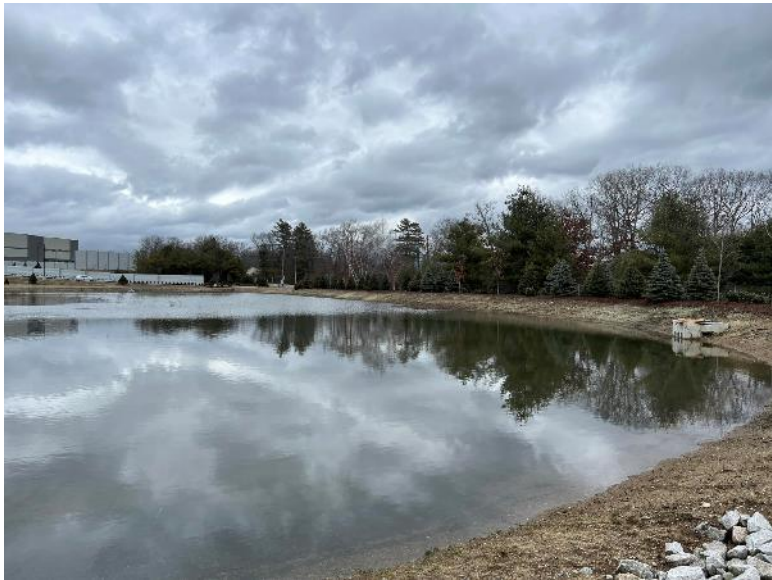
<b>Description:</b> View of Infiltration Basin-2. No issues were observed along the basin side slopes.

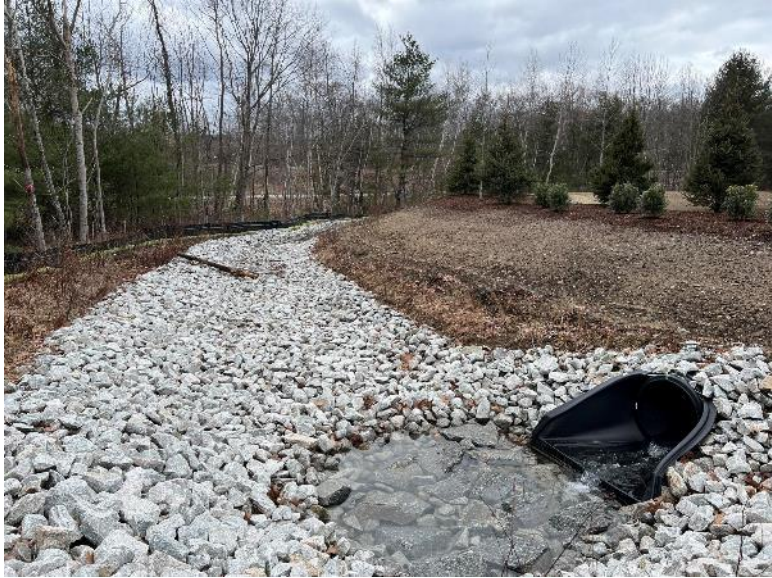
<b>Client Name:</b> Scannell Properties		<b>Photo Location:</b> Blackstone Logistics Center	<b>Project No:</b> 3077.12
<b>Photo No:</b> 5	<b>Date:</b> 1/26/2023

<b>Description:</b> View of stormwater discharge at FE-15 of Basin-2. No issues were observed along the rip-rap lined outlet swale.			
<b>Client Name:</b> Scannell Properties		<b>Photo Location:</b> Blackstone Logistics Center	<b>Project No:</b> 3077.12
<b>Photo No:</b> 6	<b>Date:</b> 1/26/2023

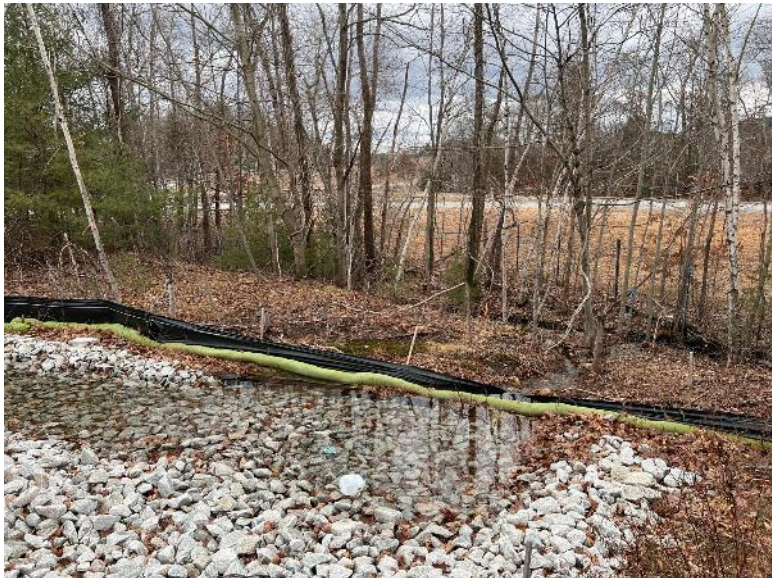
<b>Description:</b> View of stormwater discharge at the outlet swale of Basin-2. The discharging stormwater appeared to be clear and free of any sediment. Minor trash was observed in the outlet swale and shall be removed.

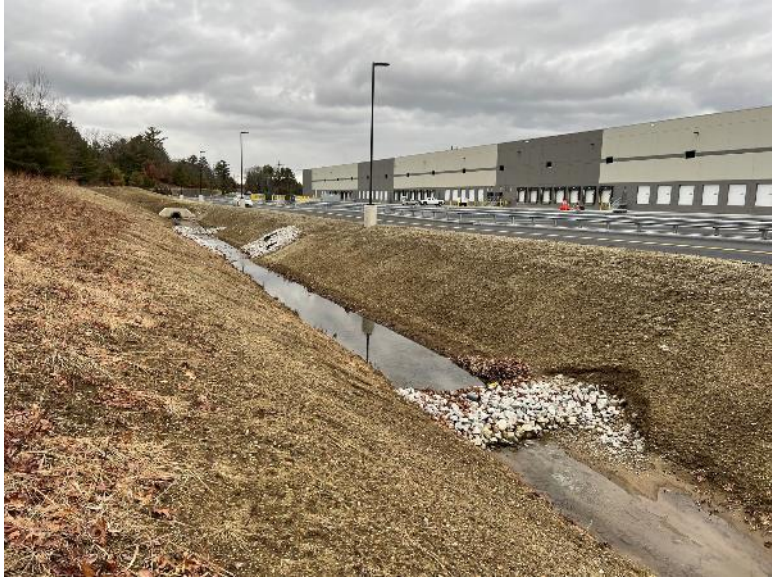
<b>Client Name:</b> Scannell Properties		<b>Photo Location:</b> Blackstone Logistics Center	<b>Project No:</b> 3077.12
<b>Photo No:</b> 7	<b>Date:</b> 1/26/2023

<b>Description:</b> Western swale viewed to the north. Prior erosion does not appear to have worsened. Swale repairs are pending.			
<b>Client Name:</b> Scannell Properties		<b>Photo Location:</b> Blackstone Logistics Center	<b>Project No:</b> 3077.12
<b>Photo No:</b> 8	<b>Date:</b> 1/26/2023

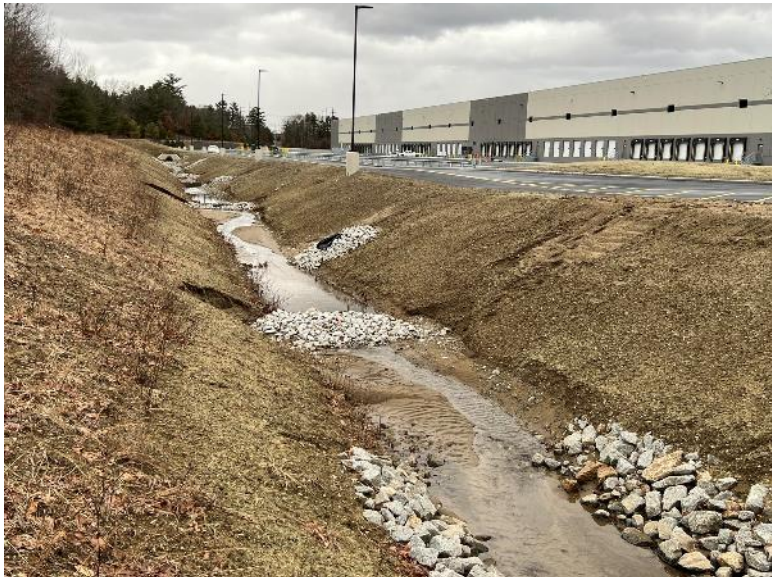
<b>Description:</b> View of western swale side washouts. Prior erosion does not appear to have worsened. Swale repairs are pending. Please note western swale erosion is not causing any off-site issues.

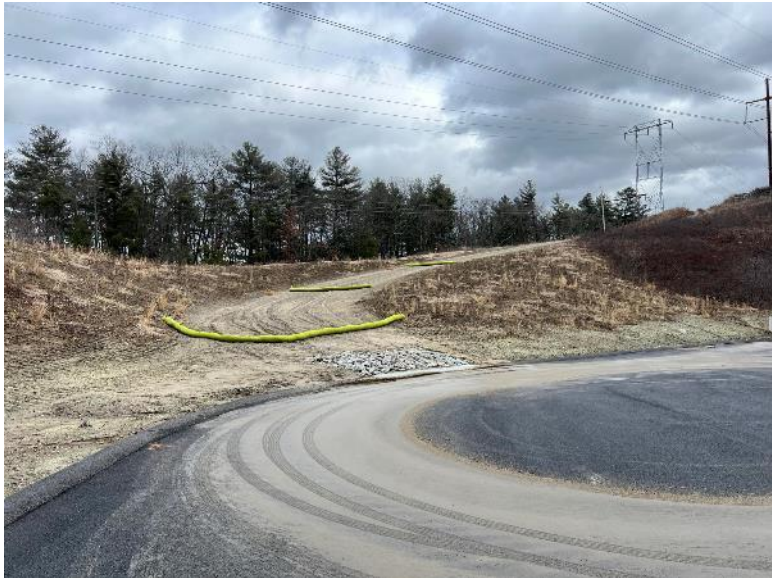
<b>Client Name:</b> Scannell Properties		<b>Photo Location:</b> Blackstone Logistics Center	<b>Project No:</b> 3077.12
<b>Photo No:</b> 11	<b>Date:</b> 1/26/2023

<b>Description:</b> View of the N-Grid transmission tower access driveway. The large deposits of sediment that had previously collected on the pavement have been removed. This area will continue to be monitored in the coming weeks. B+T will discuss a long-term solution with the Contractor to minimize future erosion.			
<b>Client Name:</b> Scannell Properties		<b>Photo Location:</b> Blackstone Logistics Center	<b>Project No:</b> 3077.12
<b>Photo No:</b> 12	<b>Date:</b> 1/26/2023

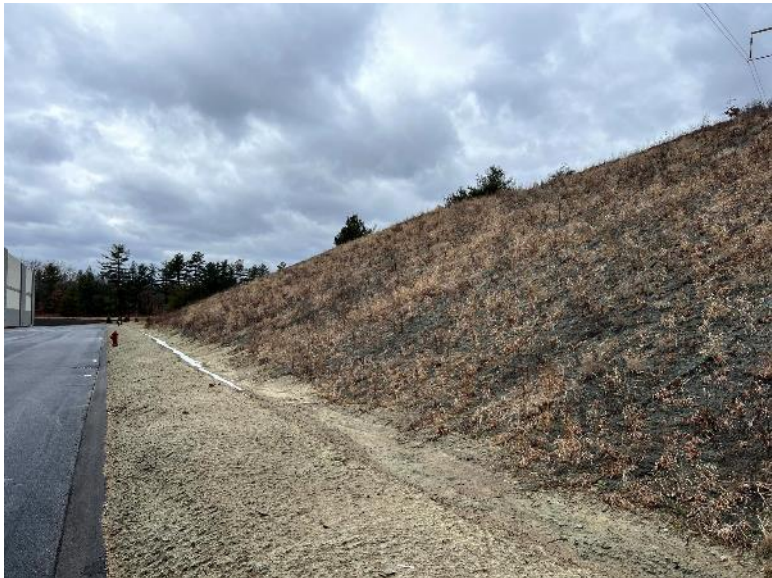
<b>Description:</b> No issues were observed along the northern cut-slope or swale at the base of the hill.

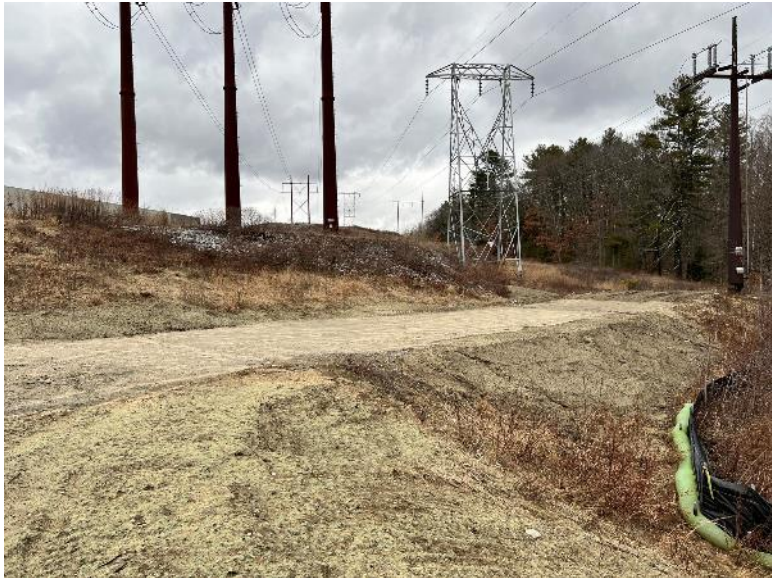
<b>Client Name:</b> Scannell Properties		<b>Photo Location:</b> Blackstone Logistics Center	<b>Project No:</b> 3077.12
<b>Photo No:</b> 13	<b>Date:</b> 1/26/2023

<b>Description:</b> View of the eastern N-Grid spur road adjacent to the emergency access driveway. Minor rills were observed along the off-grading slopes, but otherwise the area appears to have remained stable.			
<b>Client Name:</b> Scannell Properties		<b>Photo Location:</b> Blackstone Logistics Center	<b>Project No:</b> 3077.12
<b>Photo No:</b> 14	<b>Date:</b> 1/26/2023

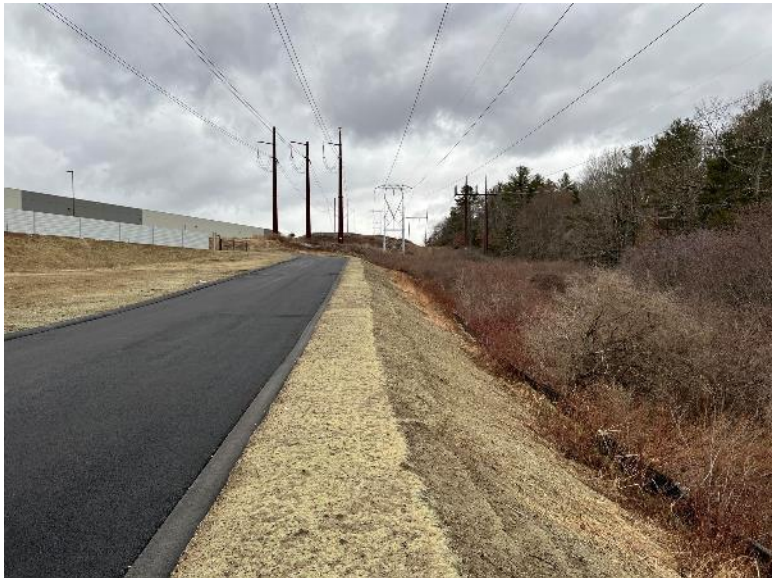
<b>Description:</b> No issues were observed along the emergency access driveway and the eastern off-grading slopes.

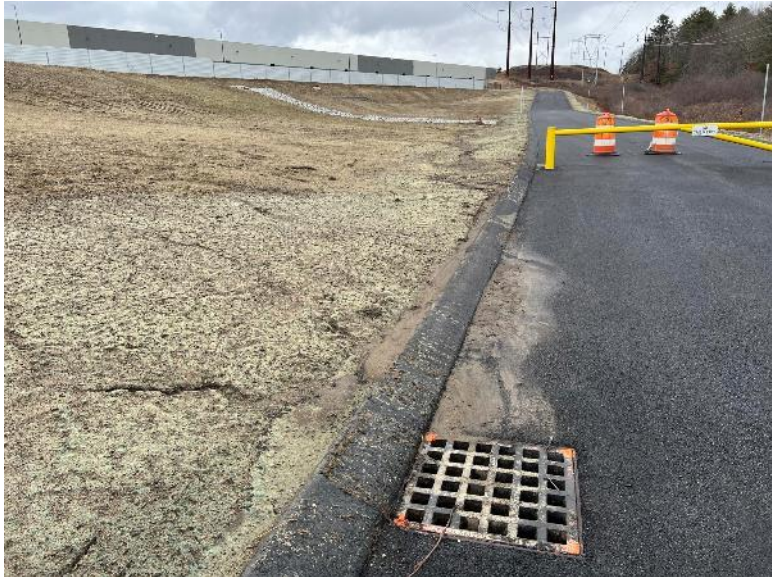
<b>Client Name:</b> Scannell Properties		<b>Photo Location:</b> Blackstone Logistics Center	<b>Project No:</b> 3077.12
<b>Photo No:</b> 15	<b>Date:</b> 1/26/2023

<b>Description:</b> Prior rills observed throughout the off-grading slopes of Infiltration Basin-1 along the emergency access driveway do not appear to have worsened. Contractor shall remove the sediment collected on the pavement. We suggest installing a filter bag in CB-39 until this area reaches proper stabilization.			
<b>Client Name:</b> Scannell Properties		<b>Photo Location:</b> Blackstone Logistics Center	<b>Project No:</b> 3077.12
<b>Photo No:</b> 16	<b>Date:</b> 1/26/2023

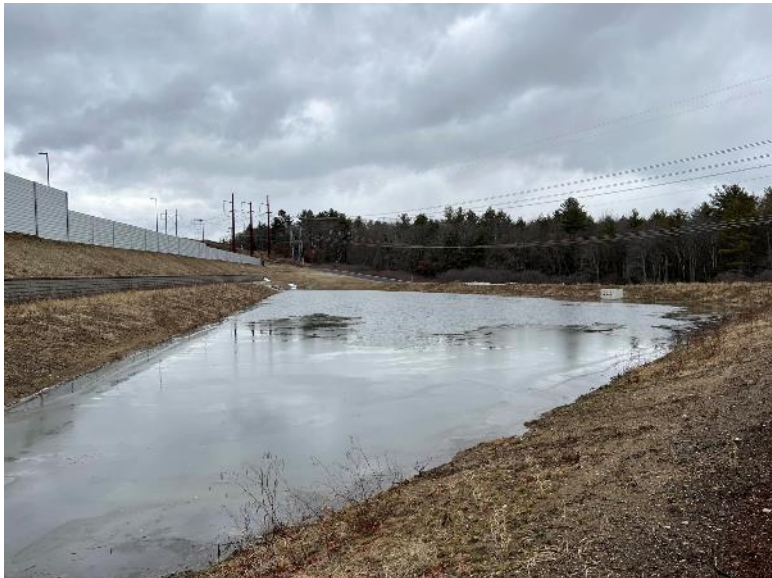
<b>Description:</b> View of Infiltration Basin-1. No issues were observed.

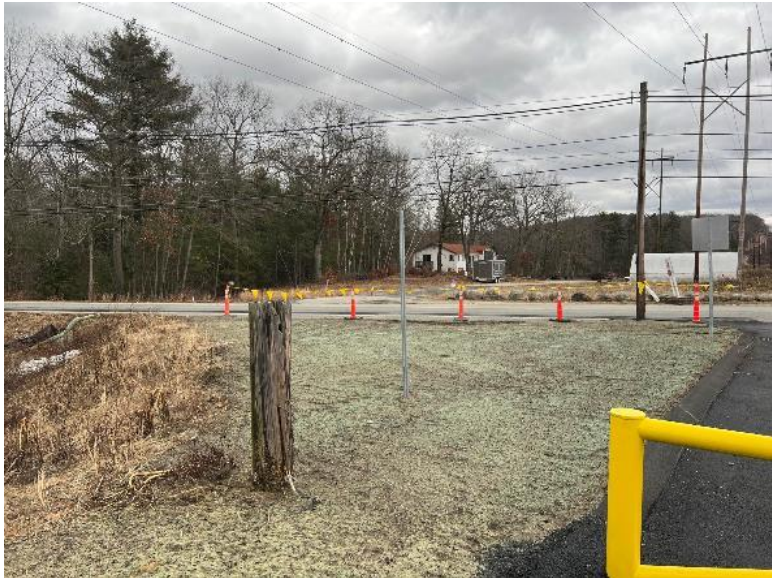
<b>Client Name:</b> Scannell Properties		<b>Photo Location:</b> Blackstone Logistics Center	<b>Project No:</b> 3077.12
<b>Photo No:</b> 17	<b>Date:</b> 1/26/2023

<b>Description:</b> No issues were observed in the area adjacent to the emergency access driveway along Lackey Dam Road.
