#### Site-specific BMPs

<b>BEALS + THOMAS</b>		<b>SWPPP PHOTOGRAPHIC LOG</b>	
<b>Client Name:</b> Scannell Properties		<b>Photo Location:</b> Blackstone Logistics Center	
<b>Project No:</b> 3077.12			
<b>Photo No:</b> 1	<b>Date:</b> 1/4/2023		
<b>Description:</b> View west of Infiltration Basin-2. No issues were observed along basin side slopes.

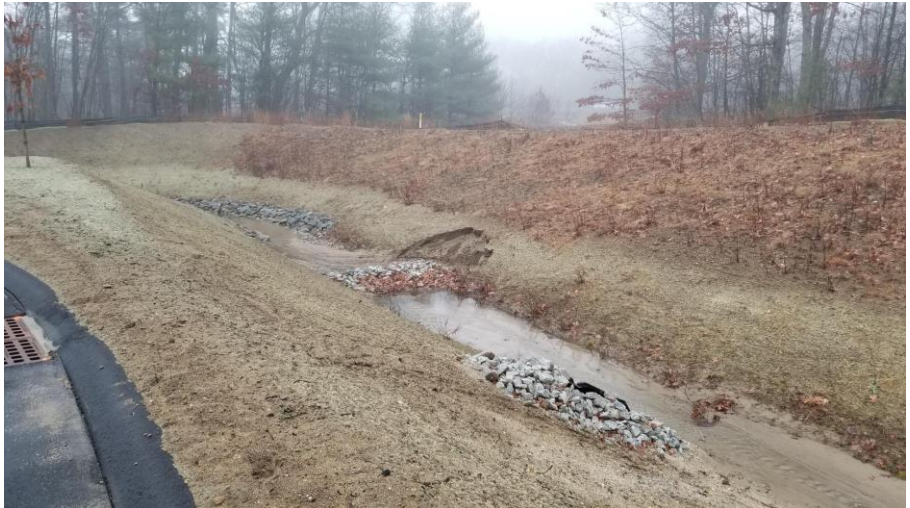
<b>Client Name:</b> Scannell Properties		<b>Photo Location:</b> Blackstone Logistics Center	
<b>Project No:</b> 3077.12			
<b>Photo No:</b> 2	<b>Date:</b> 1/4/2023		
<b>Description:</b> View of western swale lower check dam. Prior erosion does not appear to have worsened. Repairs are scheduled for next week.

Western Swale	<input checked="" type="checkbox"/> Yes <input type="checkbox"/> No	<input checked="" type="checkbox"/> Yes <input type="checkbox"/> No	Final swale repairs pending. Please note this is not causing any off-site issues.
	<input type="checkbox"/> Yes <input type="checkbox"/> No	<input type="checkbox"/> Yes <input type="checkbox"/> No	
	<input type="checkbox"/> Yes <input type="checkbox"/> No	<input type="checkbox"/> Yes <input type="checkbox"/> No	
	<input type="checkbox"/> Yes <input type="checkbox"/> No	<input type="checkbox"/> Yes <input type="checkbox"/> No	
	<input type="checkbox"/> Yes <input type="checkbox"/> No	<input type="checkbox"/> Yes <input type="checkbox"/> No

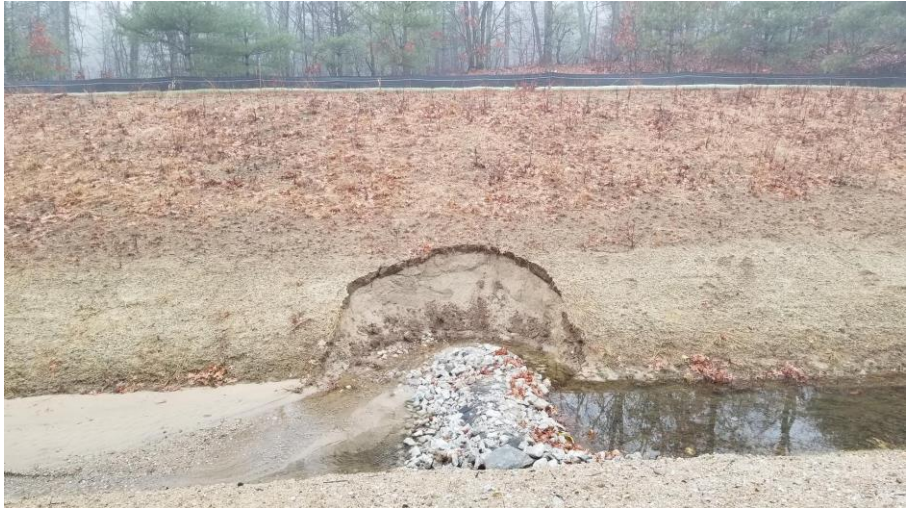
<b>Client Name:</b> Scannell Properties		<b>Photo Location:</b> Blackstone Logistics Center	<b>Project No:</b> 3077.12
<b>Photo No:</b> 3	<b>Date:</b> 1/4/2023

<b>Description:</b> View of western swale side washout. Prior erosion does not appear to have worsened. Repairs are scheduled for next week.			
<b>Client Name:</b> Scannell Properties		<b>Photo Location:</b> Blackstone Logistics Center	<b>Project No:</b> 3077.12
<b>Photo No:</b> 4	<b>Date:</b> 1/4/2023

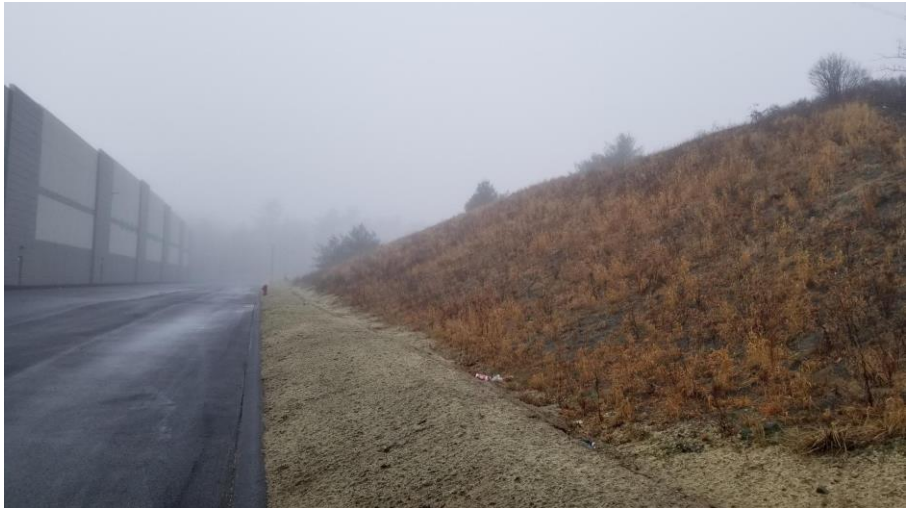
<b>Description:</b> No issues observed along the northern cut slope or along the swale at the toe of slope.

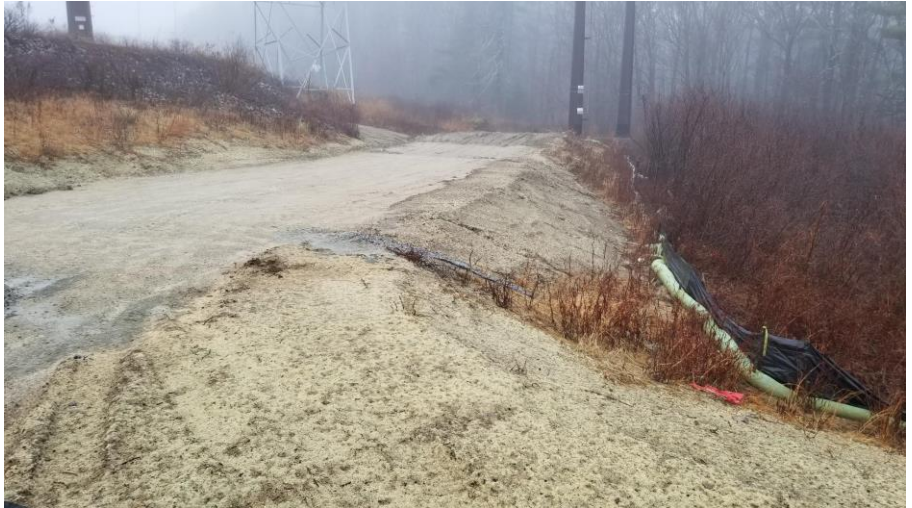
<b>Client Name:</b> Scannell Properties		<b>Photo Location:</b> Blackstone Logistics Center	<b>Project No:</b> 3077.12
<b>Photo No:</b> 5	<b>Date:</b> 1/4/2023

<b>Description:</b> No issues observed along the eastern off-grading slopes. This area will continue to be monitored through the winter months.			
<b>Client Name:</b> Scannell Properties		<b>Photo Location:</b> Blackstone Logistics Center	<b>Project No:</b> 3077.12
<b>Photo No:</b> 6	<b>Date:</b> 1/4/2023

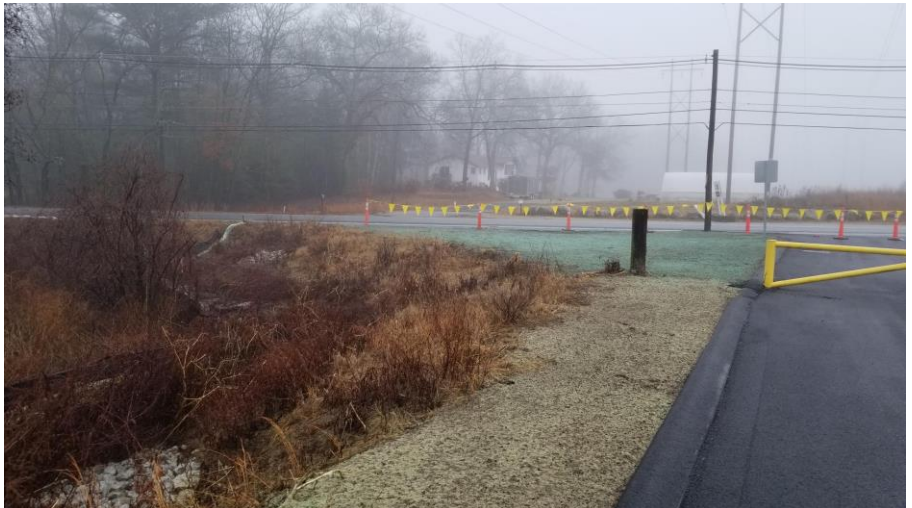
<b>Description:</b> No issues observed along the eastern off-grading slopes and area adjacent to the emergency access driveway along Lackey Dam Road. This area will continue to be monitored through the winter months.

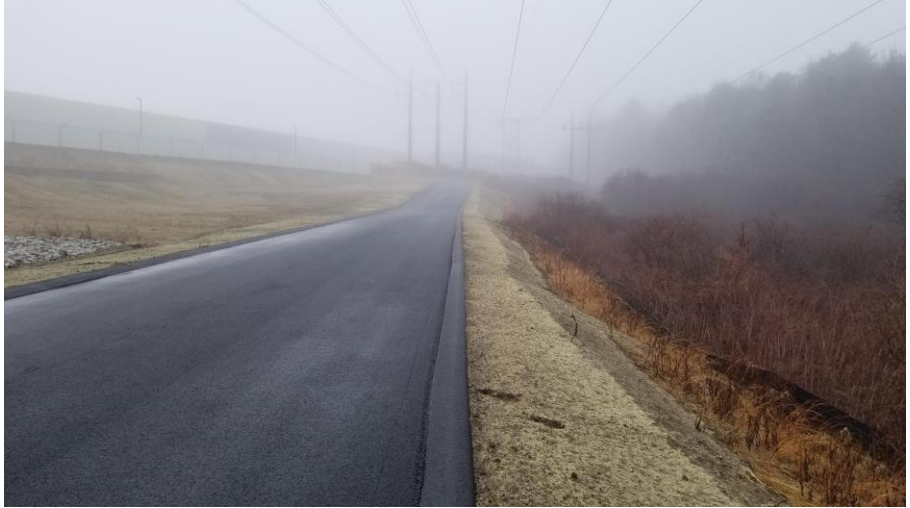
<b>Client Name:</b> Scannell Properties		<b>Photo Location:</b> Blackstone Logistics Center	<b>Project No:</b> 3077.12
<b>Photo No:</b> 7	<b>Date:</b> 1/4/2023

<b>Description:</b> No issues were observed along the eastern off-grading slopes.			
<b>Client Name:</b> Scannell Properties		<b>Photo Location:</b> Blackstone Logistics Center	<b>Project No:</b> 3077.12
<b>Photo No:</b> 8	<b>Date:</b> 1/4/2023

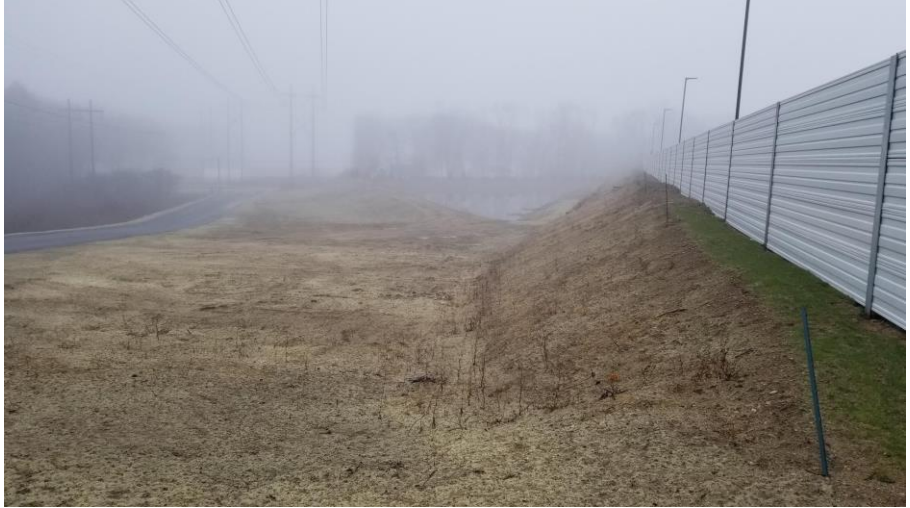
<b>Description:</b> Off-grading slopes between the eastern truck court and emergency access driveway appear to have remained stable.
