Stormwater Pollution Prevention Plan: Inspection Checklist

General Information			
Project Name	Blackstone Logistics Center		
NPDES Tracking No.	MAR1003KC	Location	Blackstone Logistics Center
			E. Douglas, Massachusetts
Date of Inspection	09/20/2022	Start/End Time	8:45 am – 9:30 am
Inspector's Name(s)	Jeffrey R. Murphy, PE, B	eals and Thomas, Ir	nc.
Inspector's Title(s)	Civil Engineer		
Inspector's Contact	jmurphy@bealsandthon	nas.com	
Information			
Describe present phase	•	•	ubgrade preparation and
of construction	commencement of pavir	ng.	
Inspection Frequency:			
	y 14 days <i>and</i> within 24 ho	ours of a 0.25" rain	
☐ Every 7 days <i>and</i> within	24 hours of a 0.25" rain		
Type of Inspection:			
☐ Regular ☐ Pre-s	torm event 🔲 During	storm event	□ Post-storm event
	Weather Inf		
Has there been a storm ev	ent since the last inspecti	on? ⊠ Yes □ No)
If yes, provide:			
Storm Start Date & Time Storm: 9/19/22, 8:30 PM Duration (hrs.): 1.5 hr			
Approx. Amount of Precipitation (in): 0.38 in

SWPPP PHOTOGRAPHIC LOG

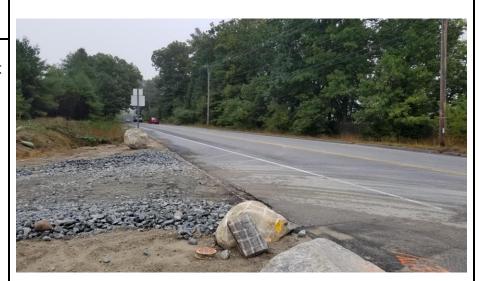
Photo No: 1

No issues observed at the site entrance. Continue to sweep pavement daily.

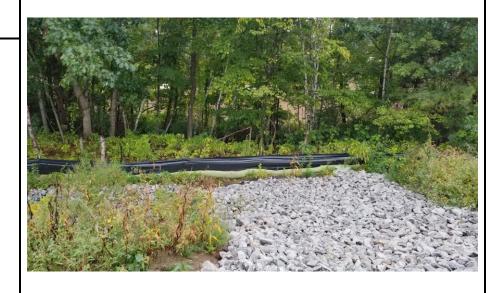
Photo No: 2

No issues were observed at the Infiltration Basin-2 outfall area.
