Site-specific BMPs

BEALS + THOMAS		SWPPP PHOTOGRAPHIC LOG	
Client Name: Scannell Properties		Photo Location: Blackstone Logistics Center	Project No: 3077.12
Photo No: 1	Date: 12/16/2022

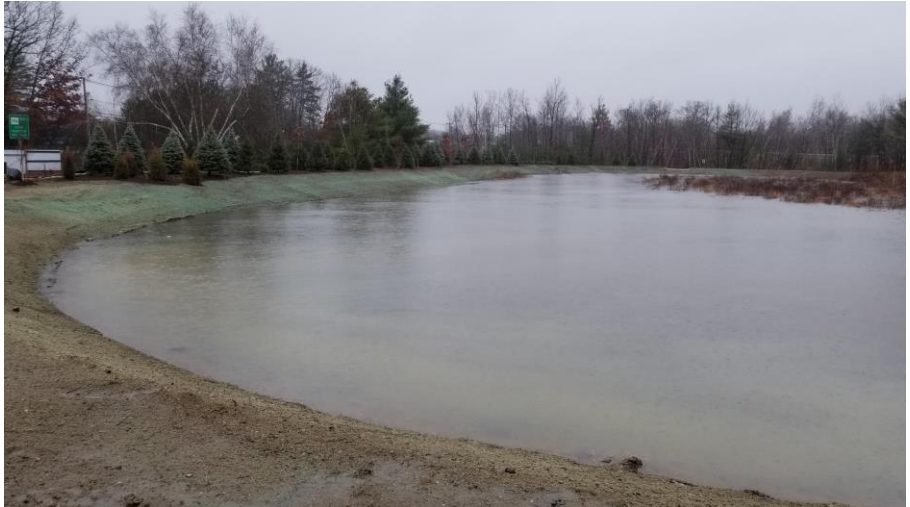
Description: View west of Infiltration Basin-2. No issues were observed along basin side slopes.			
Client Name: Scannell Properties		Photo Location: Blackstone Logistics Center	Project No: 3077.12
Photo No: 2	Date: 12/16/2022

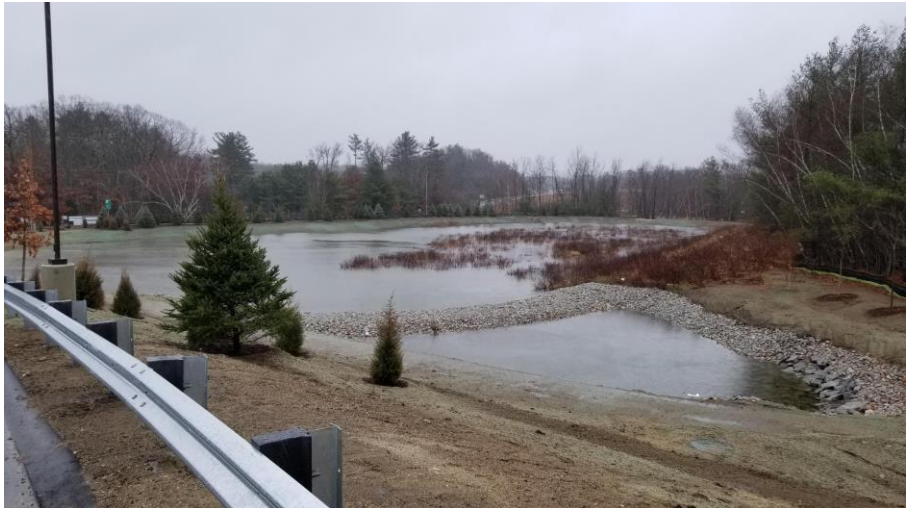
Description: View of the Sediment Forebay and Infiltration Basin-2. No further erosion of upgradient slopes was observed.

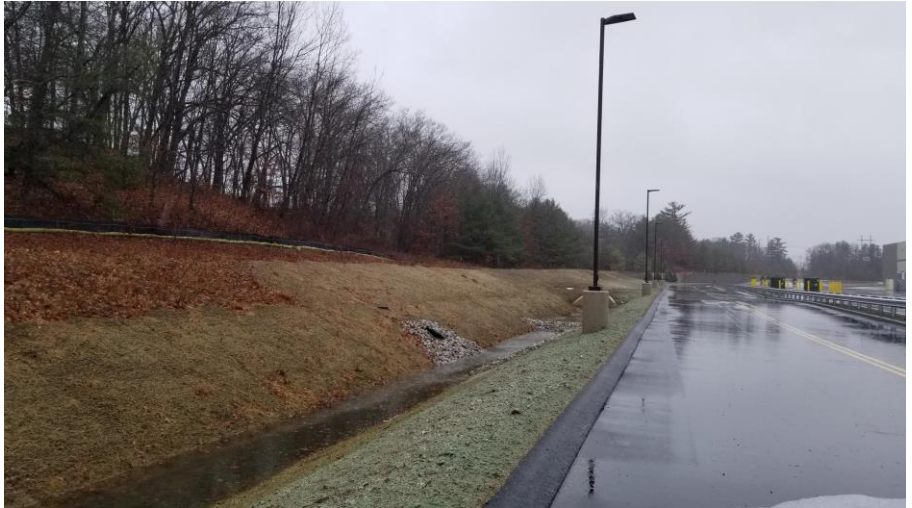
Client Name: Scannell Properties		Photo Location: Blackstone Logistics Center	Project No: 3077.12
Photo No: 5	Date: 12/16/2022

Description: View of the western drainage swale. No new erosion was observed in the upstream portion of the swale beyond the previously identified areas. Please note western swale erosion is not causing any off-site issues.			
Client Name: Scannell Properties		Photo Location: Blackstone Logistics Center	Project No: 3077.12
Photo No: 6	Date: 12/16/2022

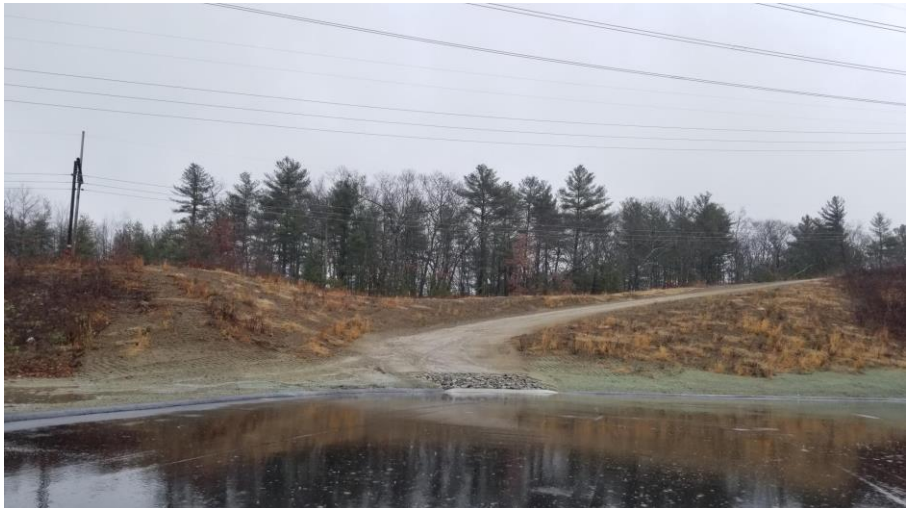
Description: View of new N-Grid transmission tower access driveway. The lower portions of the slope have been hydroseeded. Evidence of minor surficial erosion was observed but not causing any significant rills.

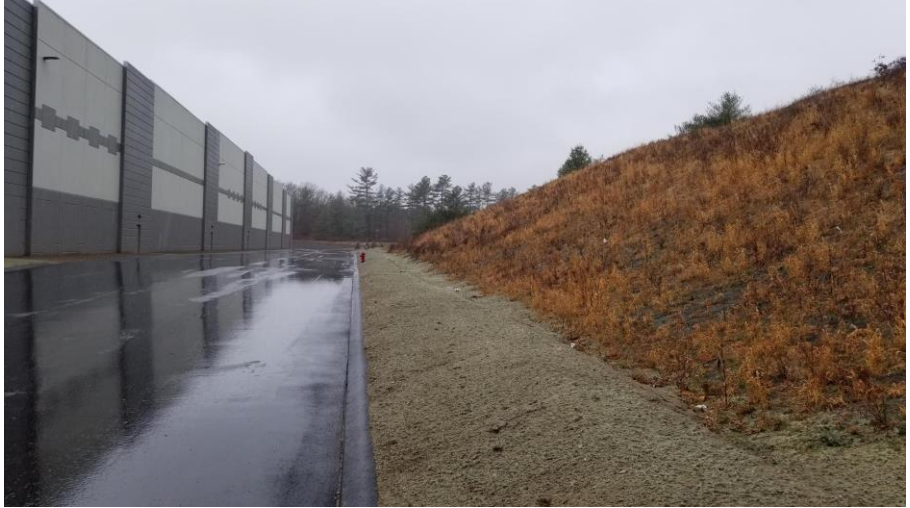
Client Name: Scannell Properties		Photo Location: Blackstone Logistics Center	Project No: 3077.12
Photo No: 7	Date: 12/16/2022

Description: No issues were observed along the northern cut-slope or swale at the base of the hill.			
Client Name: Scannell Properties		Photo Location: Blackstone Logistics Center	Project No: 3077.12
Photo No: 8	Date: 12/16/2022

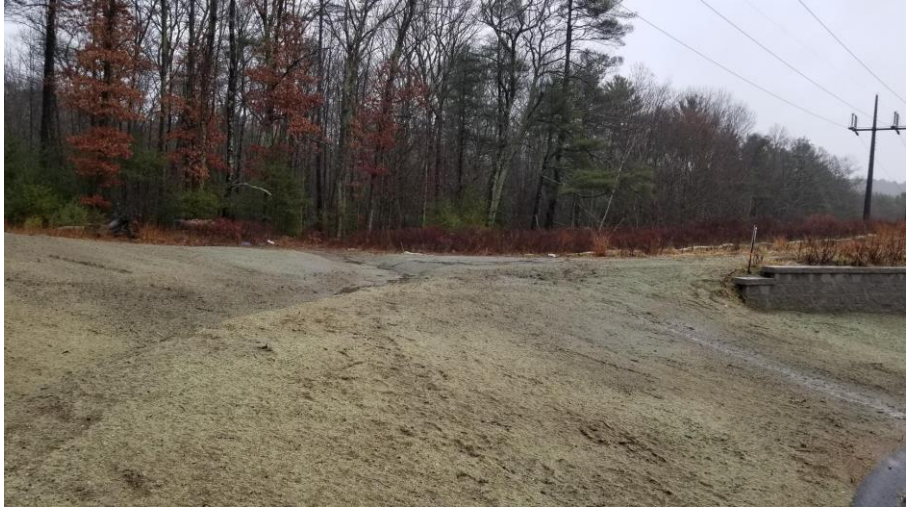
Description: Recently hydroseeded drainage swale within the N-Grid easement appeared to have remained stable.

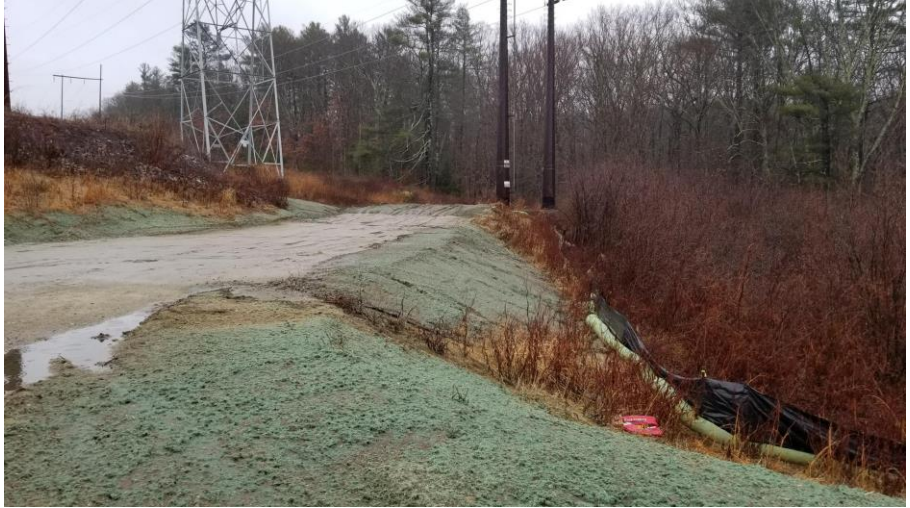
Client Name: Scannell Properties		Photo Location: Blackstone Logistics Center	Project No: 3077.12
Photo No: 9	Date: 12/16/2022

Description: No-issues observed along recently hydroseeded eastern off-grading slopes. This area will be monitored closely throughout the winter months.			
Client Name: Scannell Properties		Photo Location: Blackstone Logistics Center	Project No: 3077.12
Photo No: 10	Date: 12/16/2022

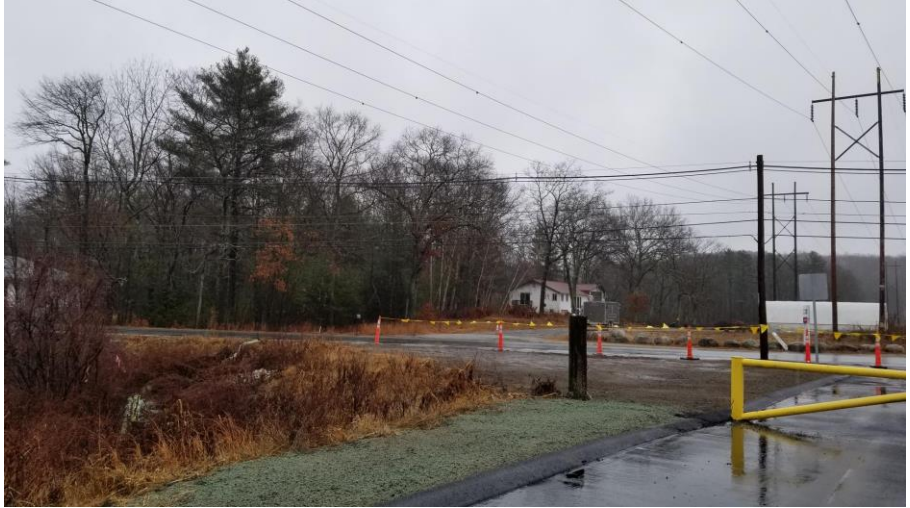
Description: No issues observed at the bottom of the emergency access driveway. Recently loamed areas should be hydroseeded for temporary winter stabilization.

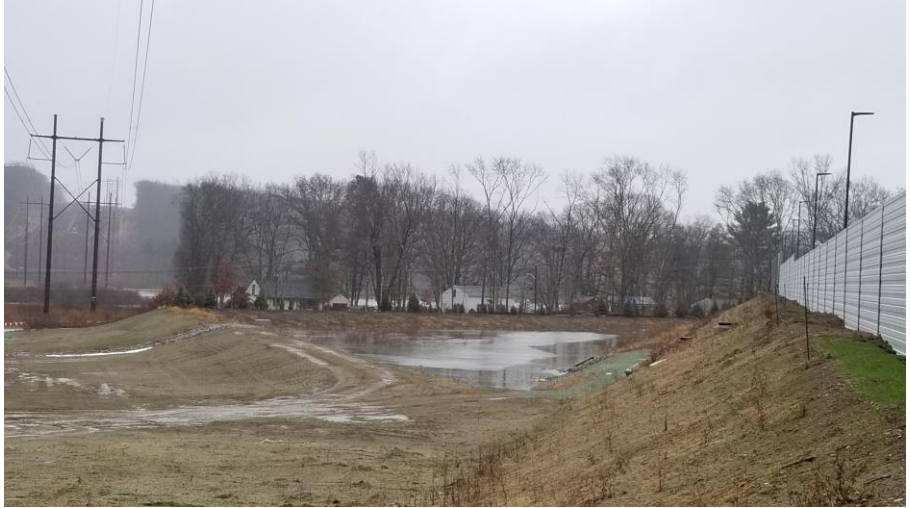
Client Name: Scannell Properties		Photo Location: Blackstone Logistics Center	Project No: 3077.12
Photo No: 11	Date: 12/16/2022

Description: View of Infiltration Basin-1 and off-grading areas. Areas of sheet flow runoff were observed but did not appear to be causing any erosion issues.			
Client Name: Scannell Properties		Photo Location: Blackstone Logistics Center	Project No: 3077.12
Photo No: 12	Date: 12/16/2022

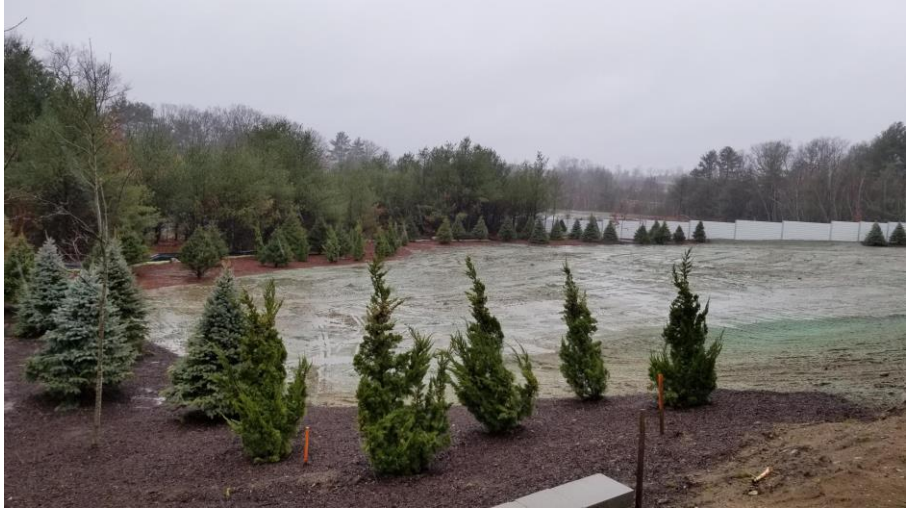
Description: Recently hydroseeded area south of the main entry driveway located south of the sound wall. Landscape plantings have been completed in this area.
