#### Site-specific BMPs

<b>BEALS + THOMAS</b>		<b>SWPPP PHOTOGRAPHIC LOG</b>	
<b>Client Name:</b> Scannell Properties		<b>Photo Location:</b> Blackstone Logistics Center	
<b>Project No:</b> 3077.12			
<b>Photo No:</b> 1	<b>Date:</b> 12/23/2022

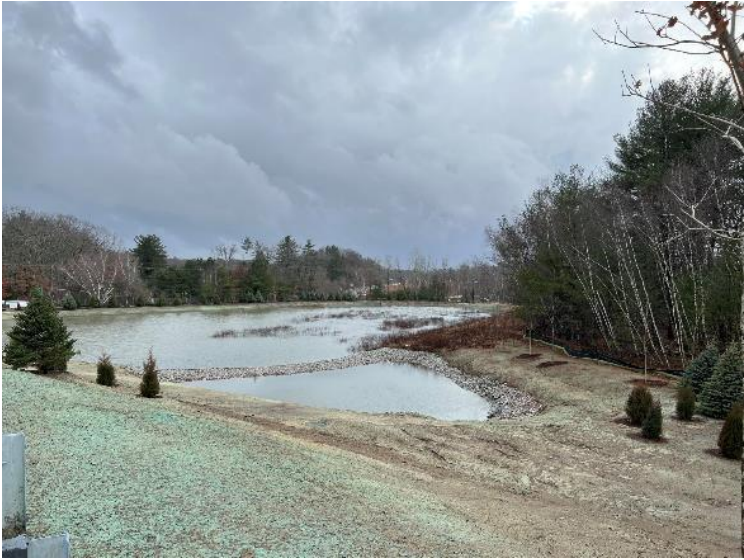
<b>Description:</b> View of the Sediment Forebay and Infiltration Basin-2. No further erosion of upgradient slopes was observed.			
<b>Client Name:</b> Scannell Properties		<b>Photo Location:</b> Blackstone Logistics Center	
<b>Project No:</b> 3077.12			
<b>Photo No:</b> 2	<b>Date:</b> 12/23/2022

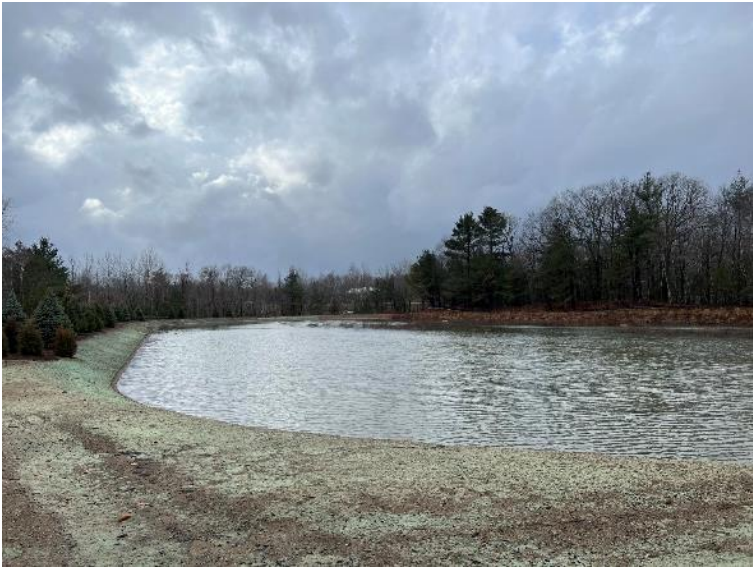
<b>Description:</b> View of Infiltration Basin-2. No issues were observed along basin side slopes.

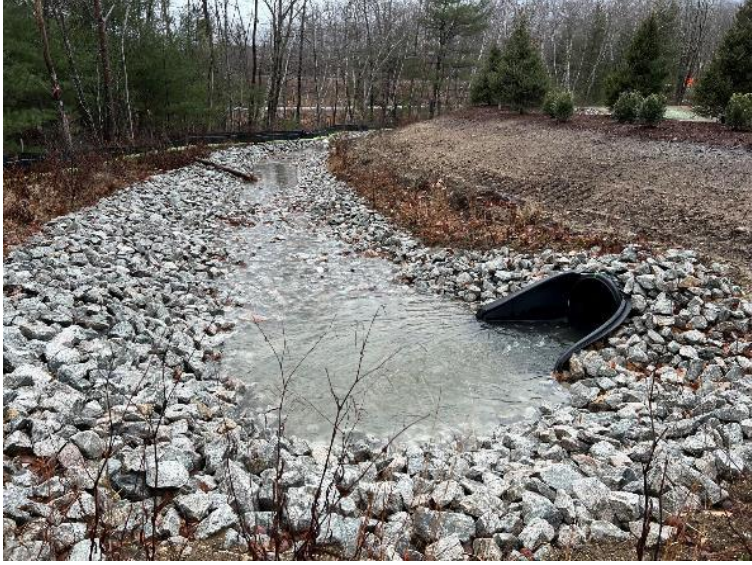
<b>Client Name:</b> Scannell Properties		<b>Photo Location:</b> Blackstone Logistics Center	<b>Project No:</b> 3077.12
<b>Photo No:</b> 3	<b>Date:</b> 12/23/2022

<b>Description:</b> View of stormwater discharge at FE-15 of Basin-2. No issues were observed along the rip-rap lined outlet swale.			
<b>Client Name:</b> Scannell Properties		<b>Photo Location:</b> Blackstone Logistics Center	<b>Project No:</b> 3077.12
<b>Photo No:</b> 4	<b>Date:</b> 12/23/2022

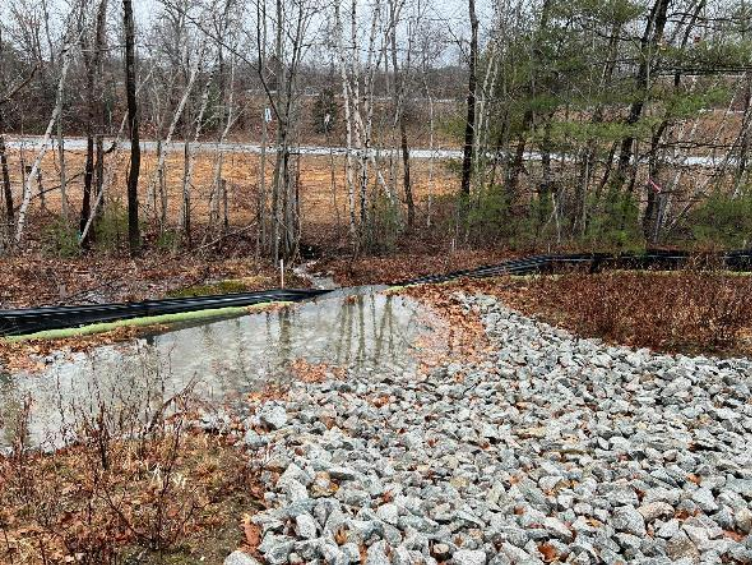
<b>Description:</b> View of stormwater discharge at the outlet swale of Basin-2. The discharging stormwater appeared to be clear and free of any sediment.

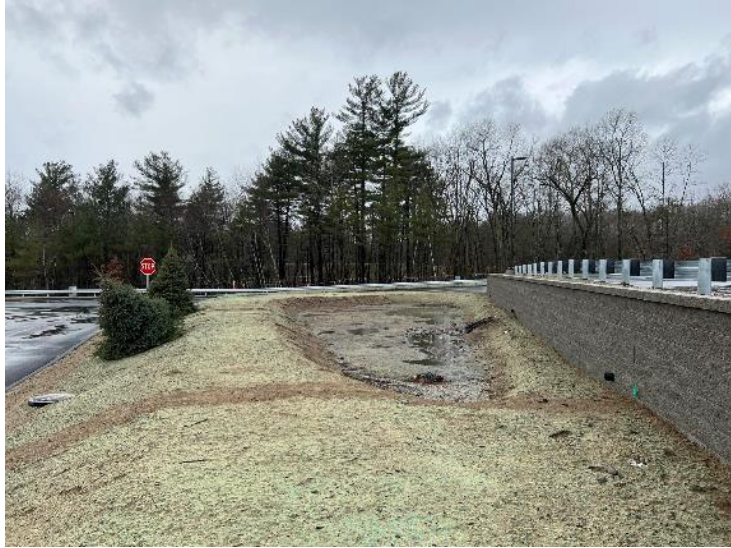
<b>Client Name:</b> Scannell Properties		<b>Photo Location:</b> Blackstone Logistics Center	<b>Project No:</b> 3077.12
<b>Photo No:</b> 5	<b>Date:</b> 12/23/2022

<b>Description:</b> No issues observed in the Bioretention Area adjacent to the employee parking lot.			
<b>Client Name:</b> Scannell Properties		<b>Photo Location:</b> Blackstone Logistics Center	<b>Project No:</b> 3077.12
<b>Photo No:</b> 6	<b>Date:</b> 12/23/2022

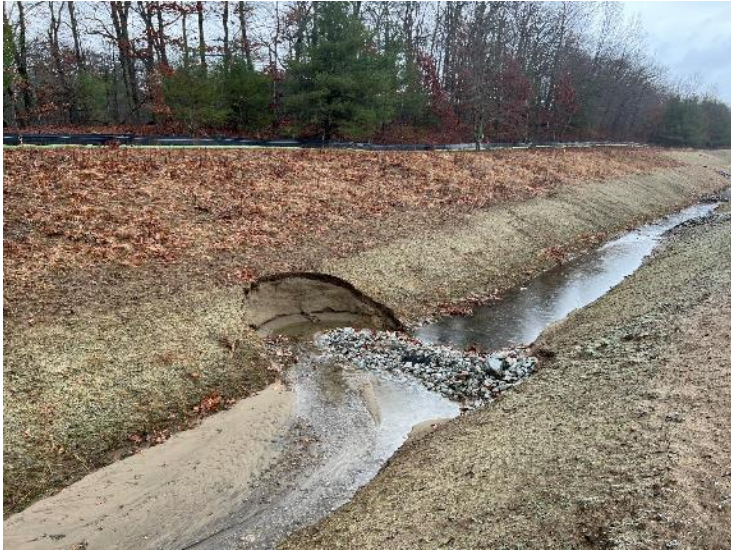
Western Swale	<input checked="" type="checkbox"/> Yes <input type="checkbox"/> No	<input checked="" type="checkbox"/> Yes <input type="checkbox"/> No	Short term check dam modification and slope repairs are needed. Final swale rehabilitation is pending and would be best conducted in the spring. Please note that the western swale issues are not causing any off-site issues, but short term repairs should be addressed as soon as possible to prevent more costly repairs.
	<input type="checkbox"/> Yes <input type="checkbox"/> No	<input type="checkbox"/> Yes <input type="checkbox"/> No	
	<input type="checkbox"/> Yes <input type="checkbox"/> No	<input type="checkbox"/> Yes <input type="checkbox"/> No	
	<input type="checkbox"/> Yes <input type="checkbox"/> No	<input type="checkbox"/> Yes <input type="checkbox"/> No	
	<input type="checkbox"/> Yes <input type="checkbox"/> No	<input type="checkbox"/> Yes <input type="checkbox"/> No

<b>Description:</b> The previous washout areas in the western swale appeared to be more significant since the last site visit. Modification to the check dam and repair of the eroded slope should be prioritized in the short term.

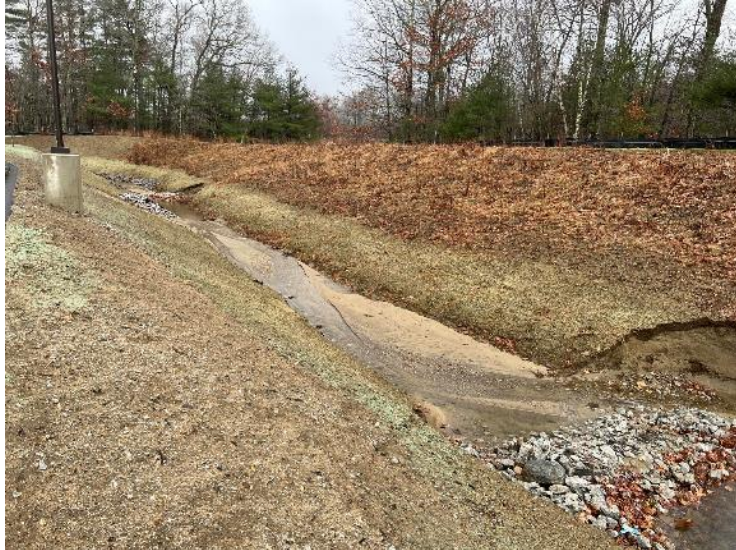
<b>Client Name:</b> Scannell Properties		<b>Photo Location:</b> Blackstone Logistics Center	<b>Project No:</b> 3077.12
<b>Photo No:</b> 7	<b>Date:</b> 12/23/2022

<b>Description:</b> Observed sediment within the western swale caused by the washout areas. Repairs are needed in the short term to prevent further washout.			
<b>Client Name:</b> Scannell Properties		<b>Photo Location:</b> Blackstone Logistics Center	<b>Project No:</b> 3077.12
<b>Photo No:</b> 8	<b>Date:</b> 12/23/2022

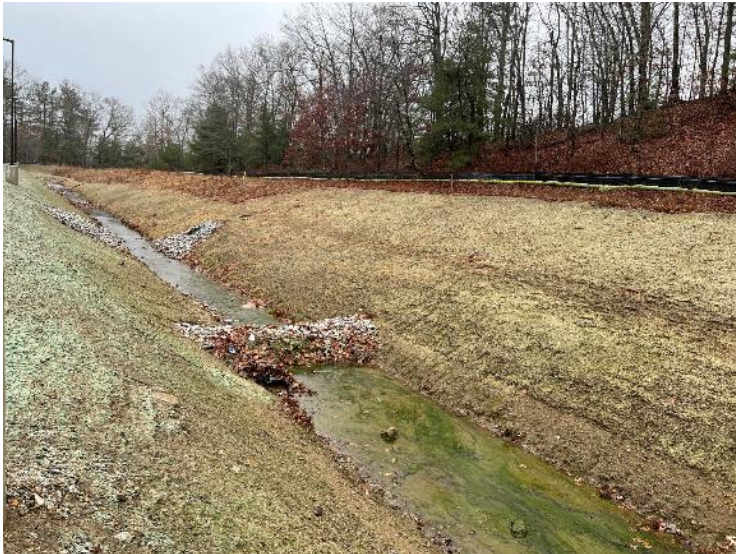
<b>Description:</b> View of the western drainage swale. No new erosion was observed in the upstream portion of the swale beyond the previously identified areas. Please note western swale erosion is not causing any off-site issues but should be addressed quickly to prevent further progression/damage.

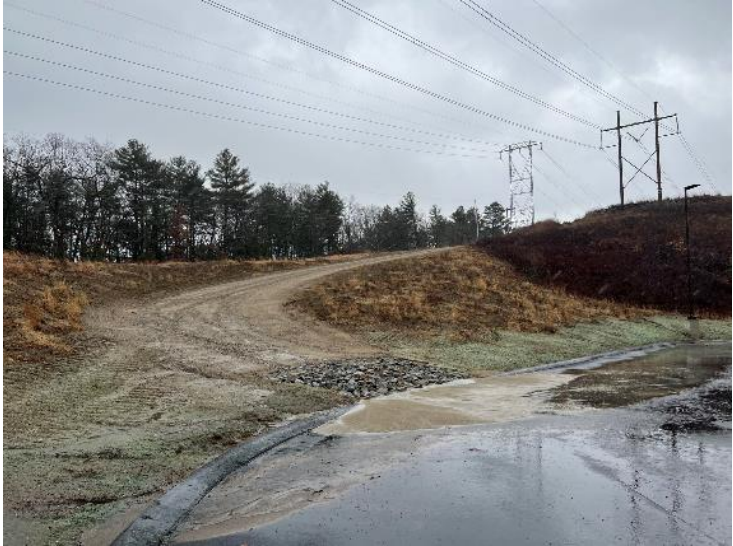
<b>Client Name:</b> Scannell Properties		<b>Photo Location:</b> Blackstone Logistics Center	<b>Project No:</b> 3077.12
<b>Photo No:</b> 9	<b>Date:</b> 12/23/2022

<b>Description:</b> View of the N-Grid transmission tower access driveway. Sediment was observed coming from this area and collecting at the bottom of the access driveway. Contractor shall clean up the accumulated sediment. We suggest adding a compost filter sock on the up-gradient side of the stone to prevent further washout.			
<b>Client Name:</b> Scannell Properties		<b>Photo Location:</b> Blackstone Logistics Center	<b>Project No:</b> 3077.12
<b>Photo No:</b> 10	<b>Date:</b> 12/23/2022

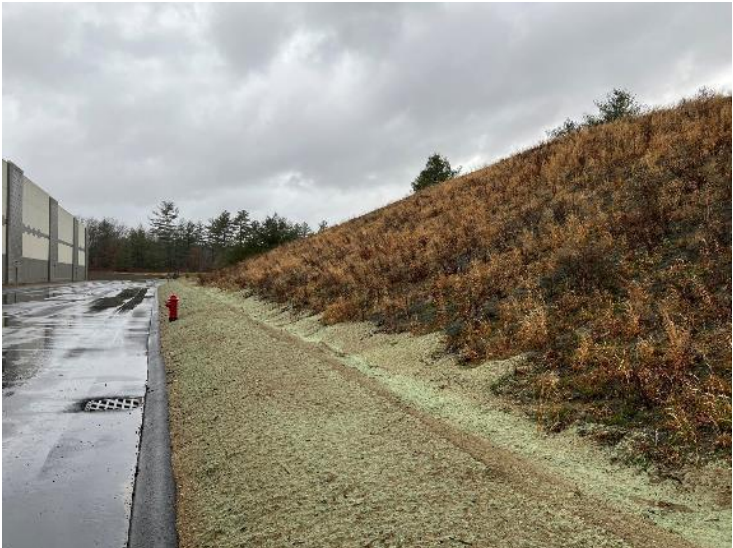
<b>Description:</b> No issues were observed along the northern cut-slope or swale at the base of the hill.

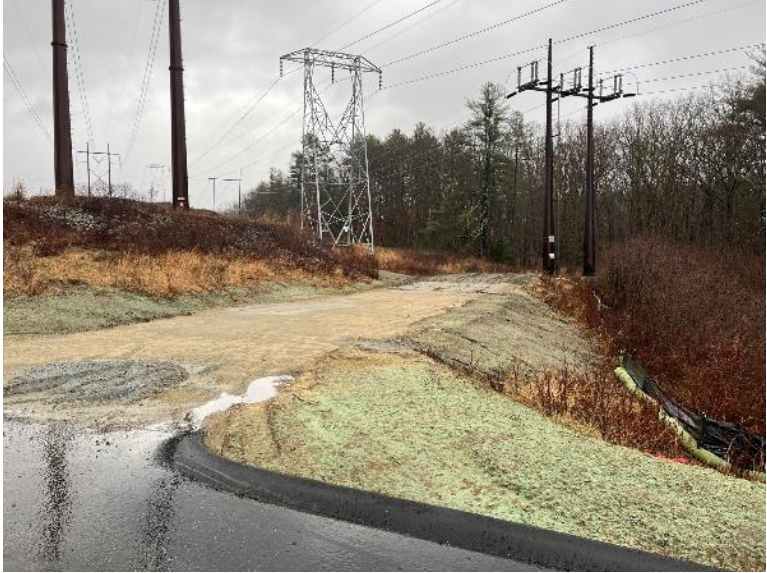
<b>Client Name:</b> Scannell Properties		<b>Photo Location:</b> Blackstone Logistics Center	<b>Project No:</b> 3077.12
<b>Photo No:</b> 11	<b>Date:</b> 12/23/2022

<b>Description:</b> No-issues observed along the eastern N-Grid spur road adjacent to the emergency access driveway. This area will be monitored closely throughout the winter months.			
<b>Client Name:</b> Scannell Properties		<b>Photo Location:</b> Blackstone Logistics Center	<b>Project No:</b> 3077.12
<b>Photo No:</b> 12	<b>Date:</b> 12/23/2022

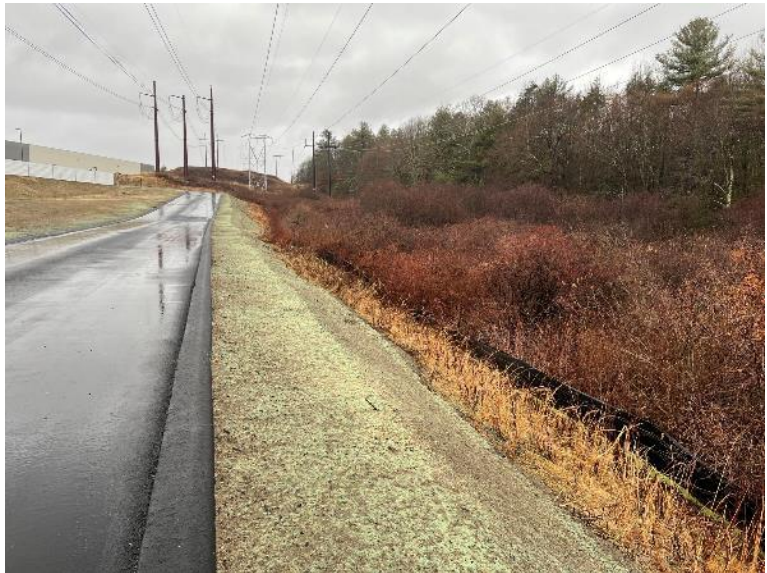
<b>Description:</b> No issues observed along the emergency access driveway and the eastern off-grading slopes.

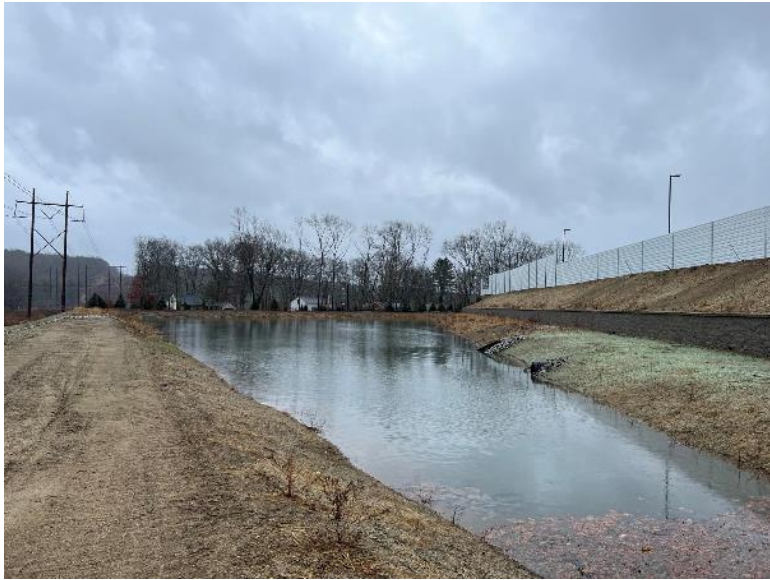
<b>Client Name:</b> Scannell Properties		<b>Photo Location:</b> Blackstone Logistics Center	<b>Project No:</b> 3077.12
<b>Photo No:</b> 13	<b>Date:</b> 12/23/2022

<b>Description:</b> View of Infiltration Basin-1. No issues were observed.			
<b>Client Name:</b> Scannell Properties		<b>Photo Location:</b> Blackstone Logistics Center	<b>Project No:</b> 3077.12
<b>Photo No:</b> 14	<b>Date:</b> 12/23/2022

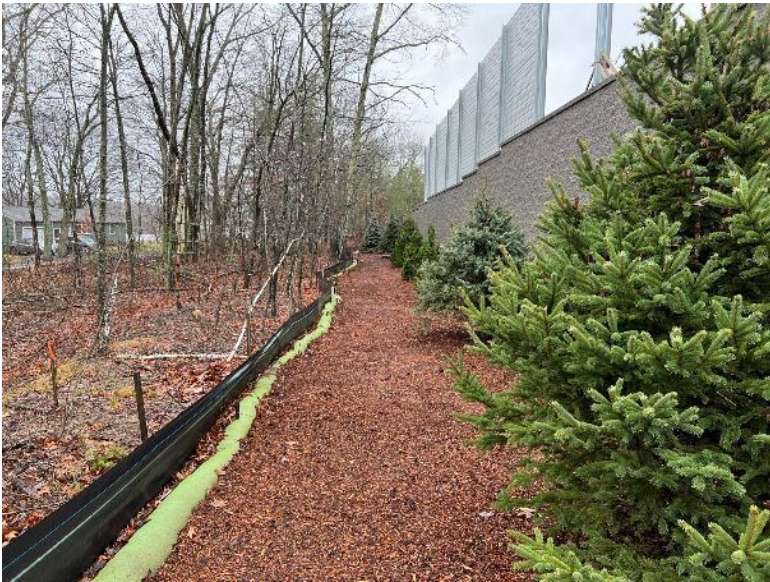
<b>Description:</b> No issues observed along the southern limit of work. Landscape plantings have been completed in this area.
