# Site Visit Report

**Date:** October 19, 2023  
**Client:** Sutton Planning Board  
**Project:** Unified Parkway  
**Contractor:** Walsh Contracting Corp.  
**Contractor Contact:** John Walsh

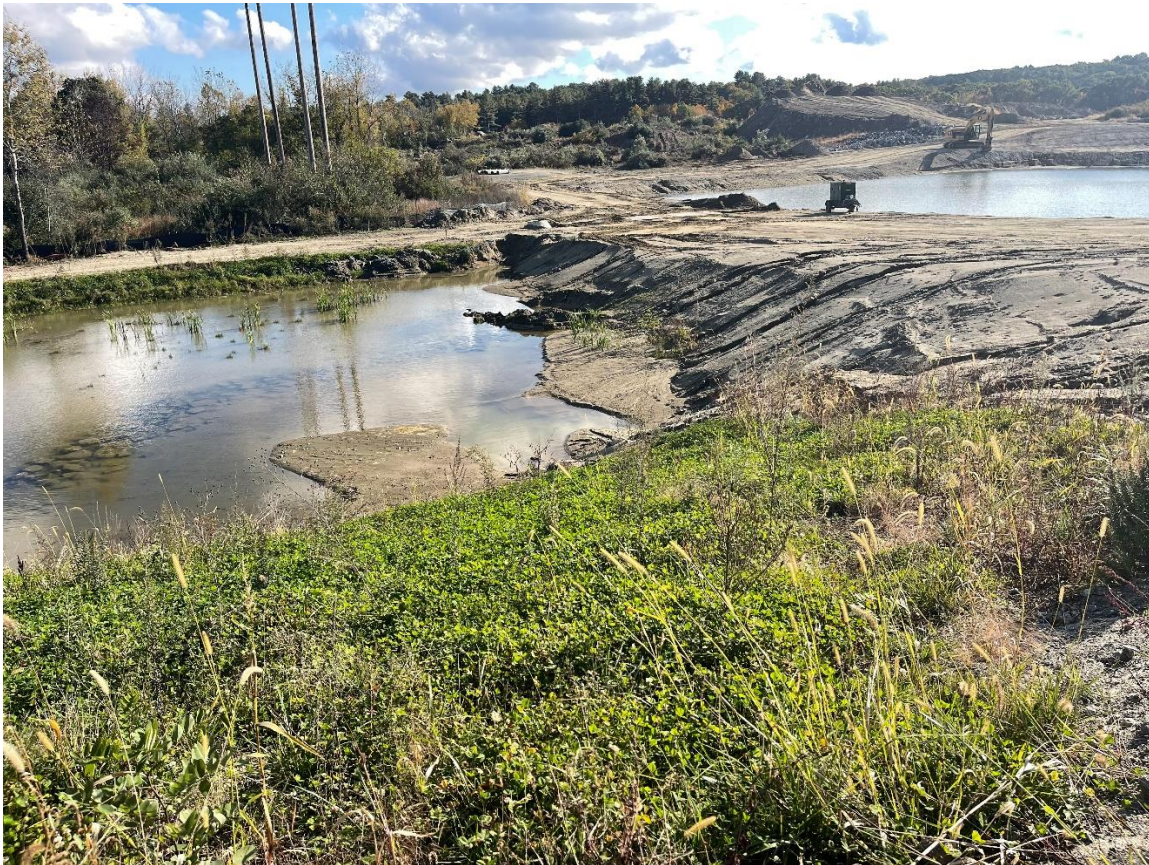
- Stormwater Management Areas (SWMAs) #1 and #2 were dry, and over two feet of water had pooled in SWMA #3.
- The erosion rills in the southern corner of SWMA #3 have not been repaired, nor the sediment cleaned.
- Additional erosion rills had formed along the northern and eastern slopes of SWMA #4.
- The following structures had been installed:

**Photo 1:** The erosion rills at the southern corner of SWMA #3 have not been repaired yet, nor the sediment cleaned.

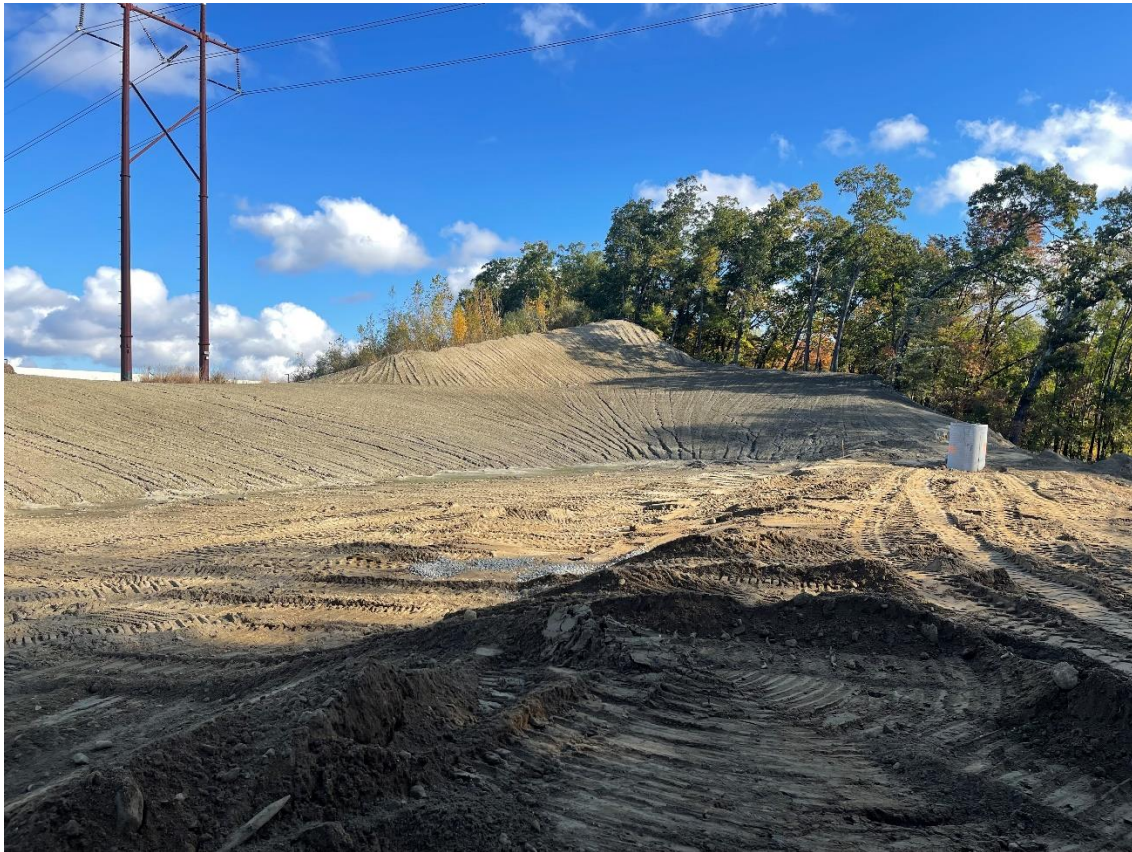
**Photo 2:** Additional erosion rills have formed along the northern and eastern slopes of SWMA #4.

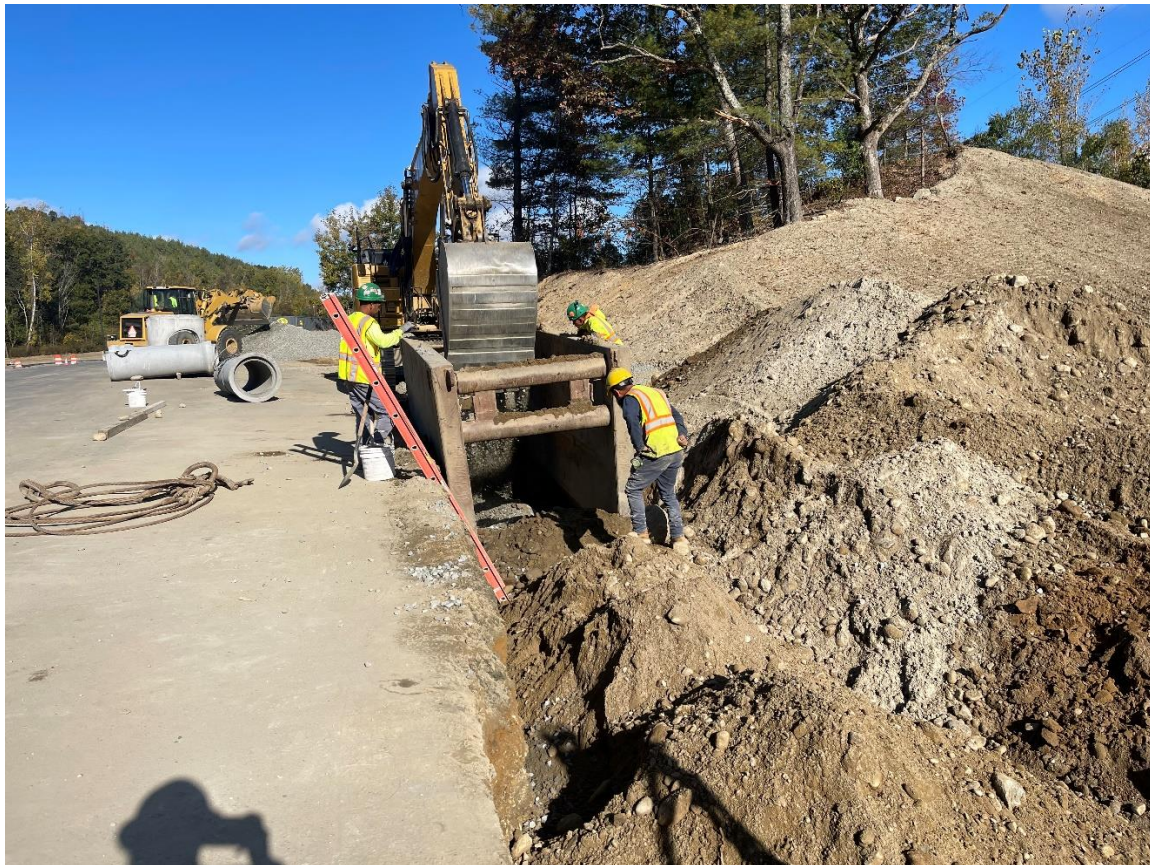
- The contractor was placing three-quarter-inch crushed stone over the last eight feet of pipe between DMHs 11 and 10.
- The pipe connections on the inside of DMH 11 had been sealed with mortar.

**Photo 3:** The contractor placing three-quarter-inch crushed stone over the pipe between DMHs 11 and 10.
