# Site Visit Report

**Date:** October 19, 2023  
**Client:** Sutton Planning Board  
**Project:** Unified Parkway Lots 2 and 3  
**Contractor:** Walsh Contracting Corp.  
**Contractor Contact:** John Walsh

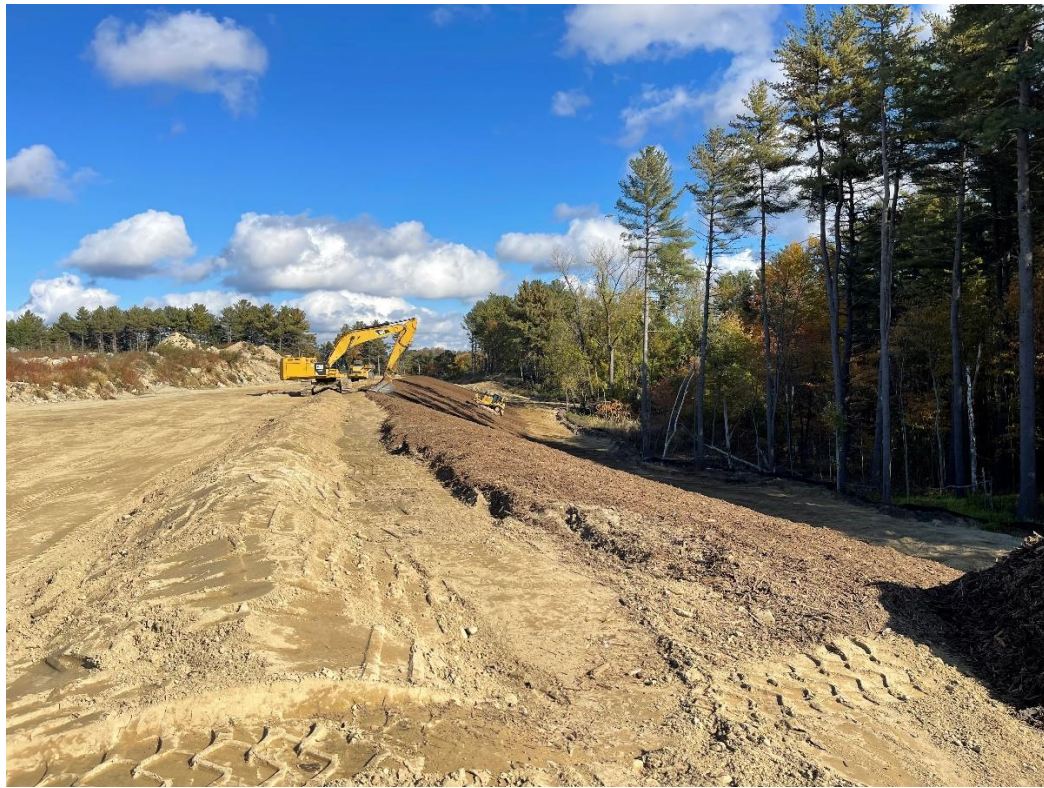
- The contractor was placing mulch in the landscaped area east of the eastern parking lot, as well as along the slopes of the eastern side of Lot 2.
- The stone walkways had been installed on the northern and northwestern sides of the building.

**Photo 1:** The contractor placing mulch along the eastern slope of Lot 2.

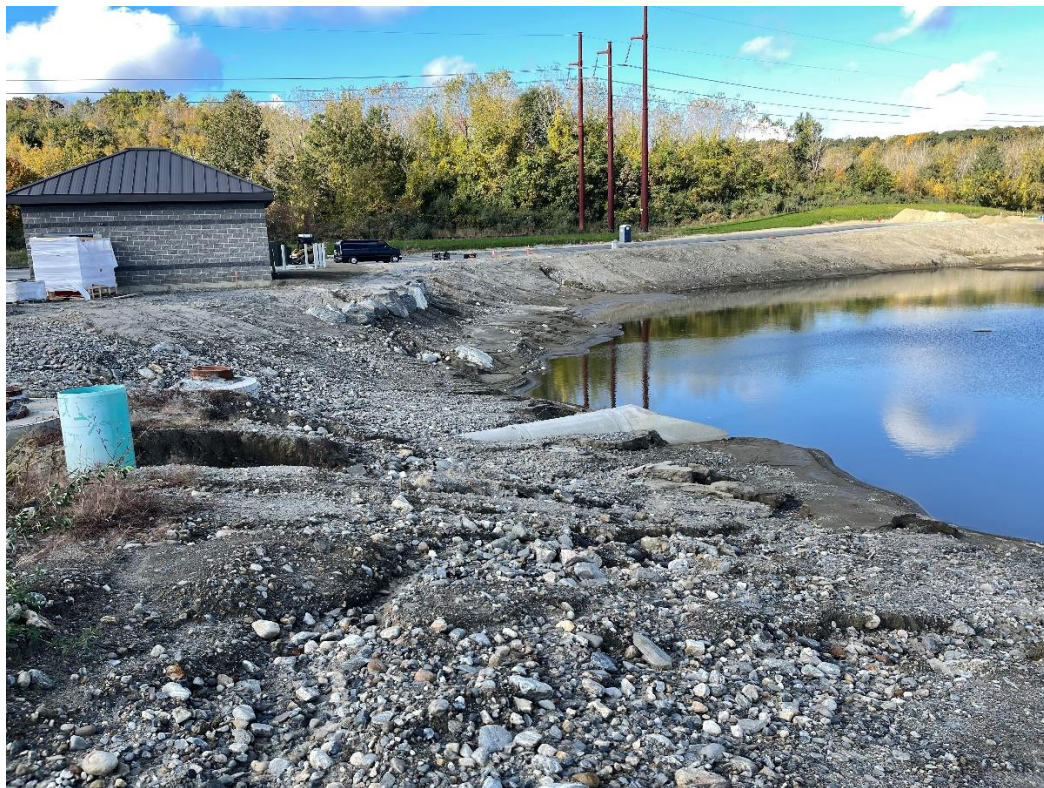
- The contractor was digging holes to plant trees in the landscaped area at the northwestern corner of the site.
- The erosion rills on the southern slope of SWMA B3a have worsened.

**Photo 2:** The erosion rills on the southern side of SWMA B3a have worsened.

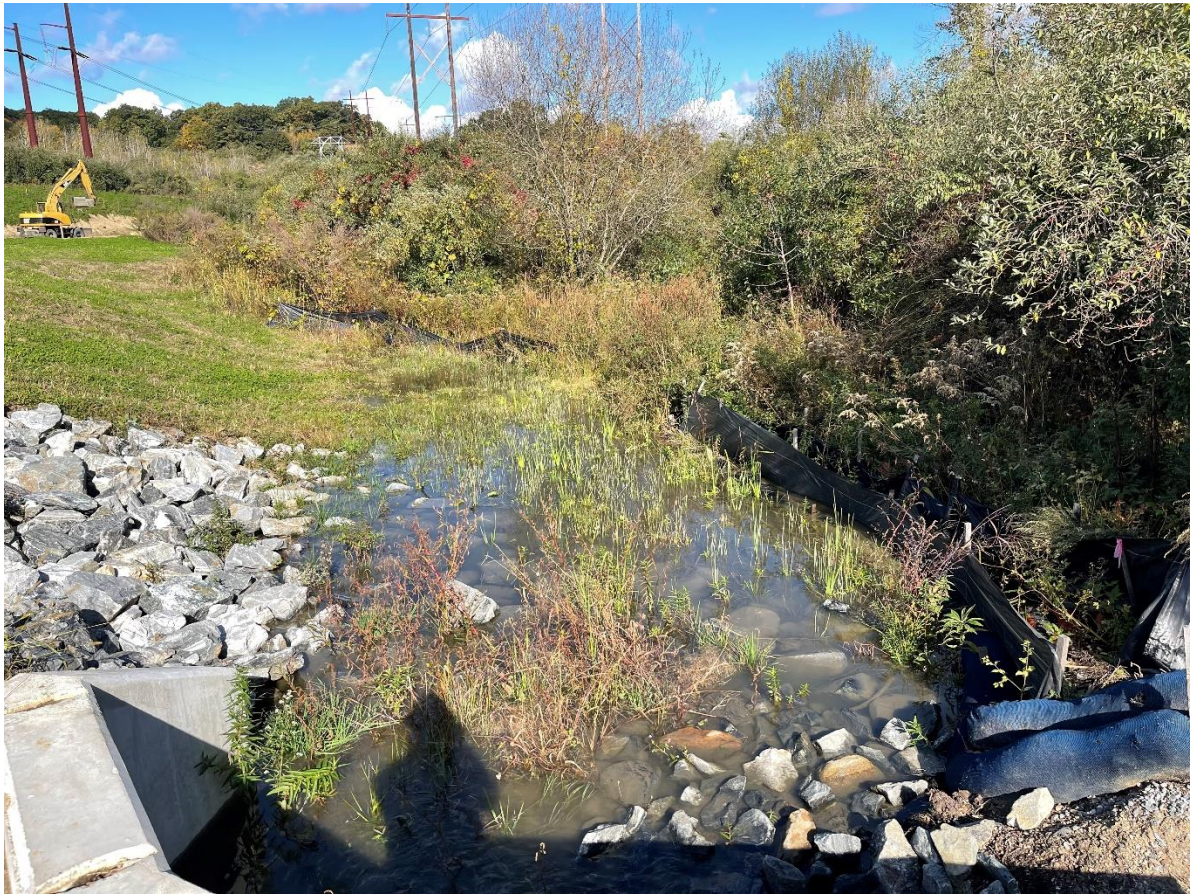
- Water from SWMA B3a is being pumped into Drain Manhole (DMH) 8B. The water exiting the drainage system at Headwall (HW) 7B was clear.
- The turnaround area on the northwestern corner of the building had been paved, and precast concrete curb installed.

**Photo 3:** Water from SWMA B3a was clear.

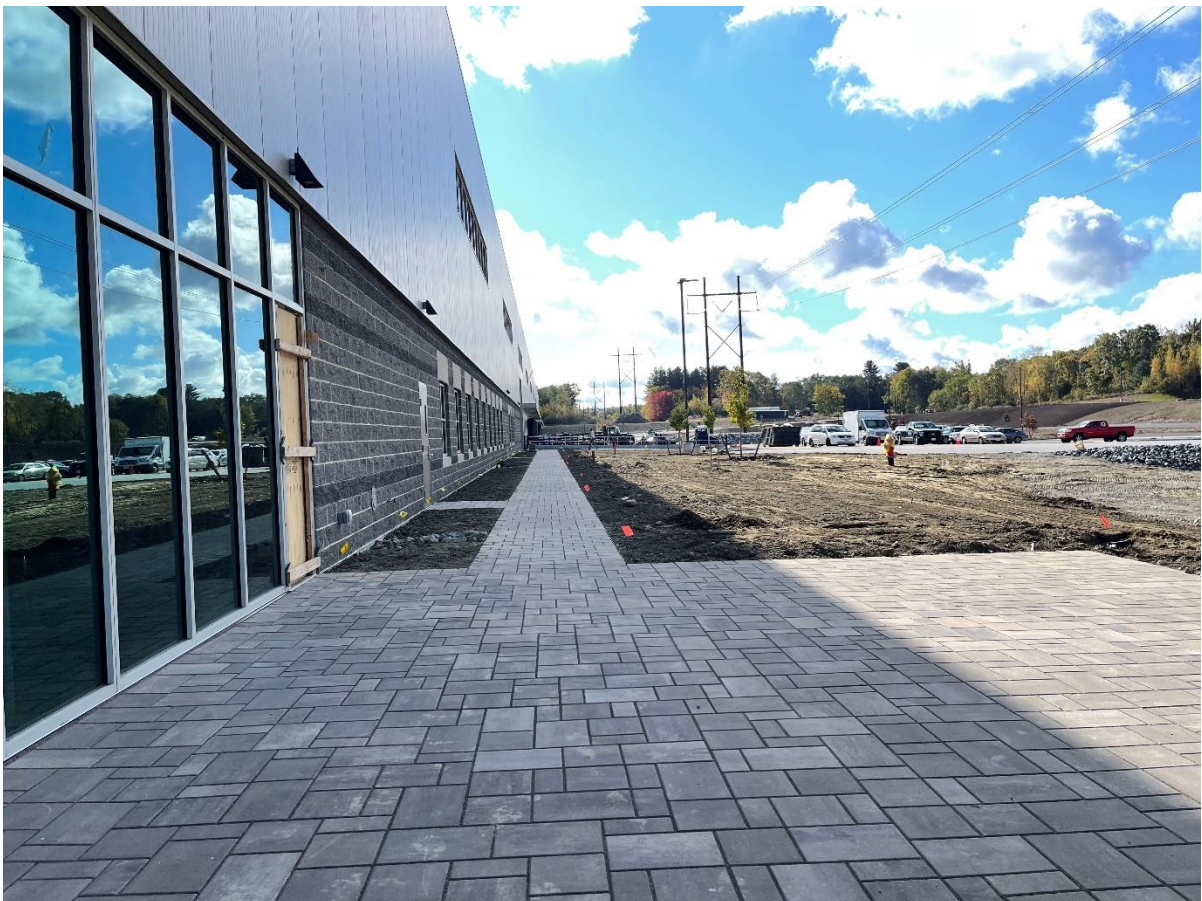
**Photo 4:** The stone walkway had been installed on the northwestern side of the building.

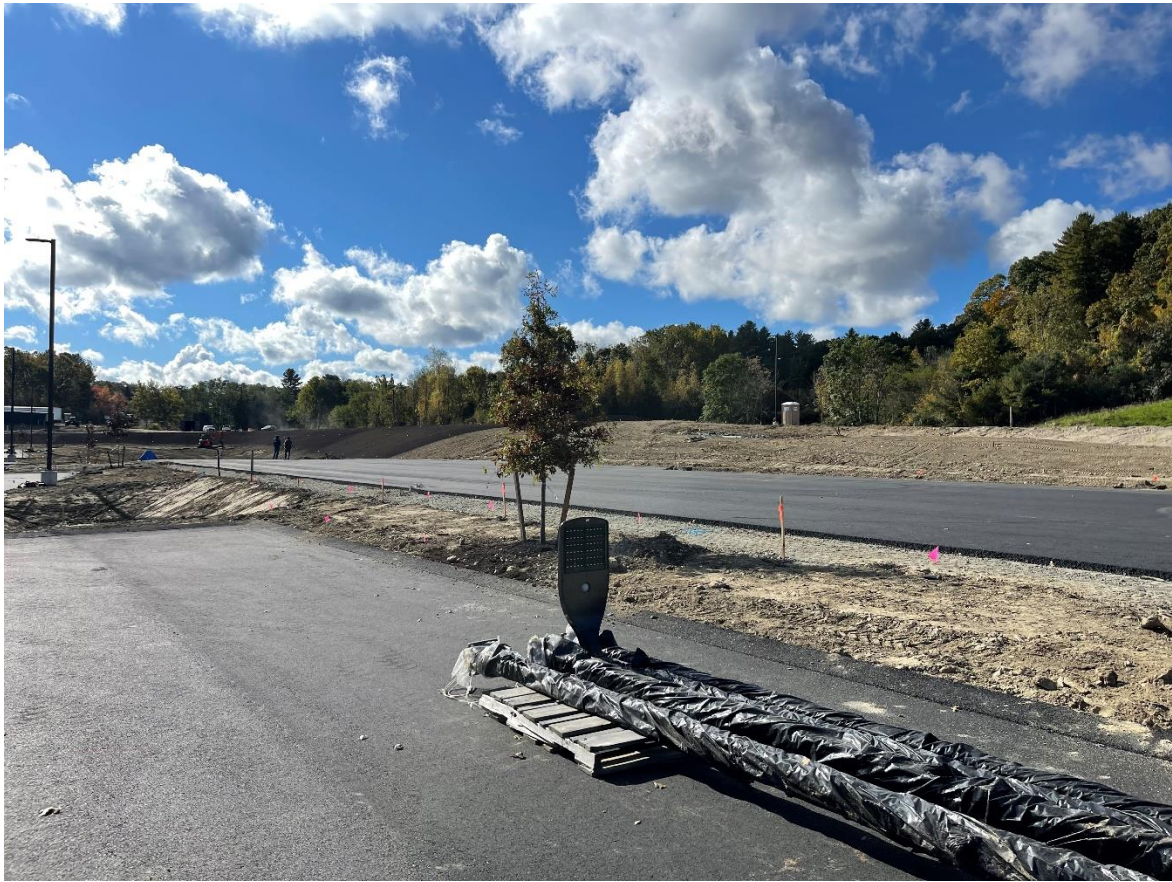
- The tennis and basketball court areas had been paved.
- Additional earth material had been removed from the southern side of Lot 2.
- Additional riprap had been placed along the swale on the western side of Lot 3.

**Photo 5:** The tennis and basketball courts had been paved.

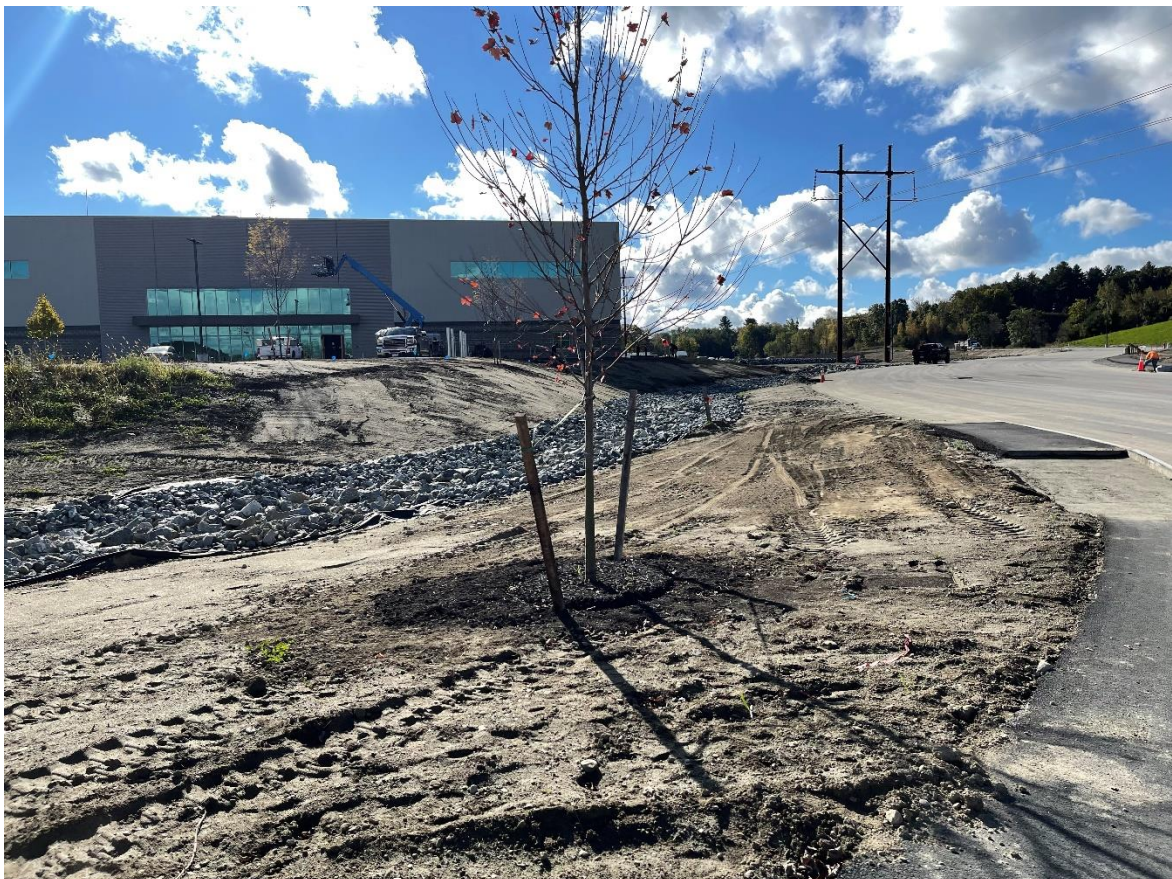
**Photo 6:** Additional riprap had been placed along the swale on the western side of Lot 3.
