Site Visit Report

| Date: | June 9, 2022 | Prepared By: | Daniel Sheehan |
| Project: | Blackstone Logistics Center | Left site: | 11:15 AM |

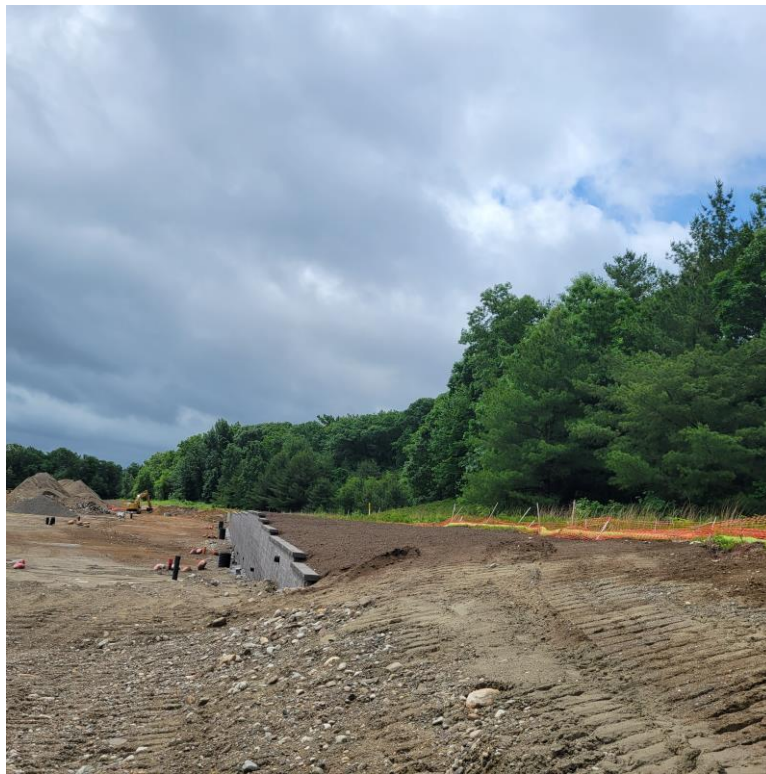
Photo 1: Western slopes along the retaining wall with loam spread.

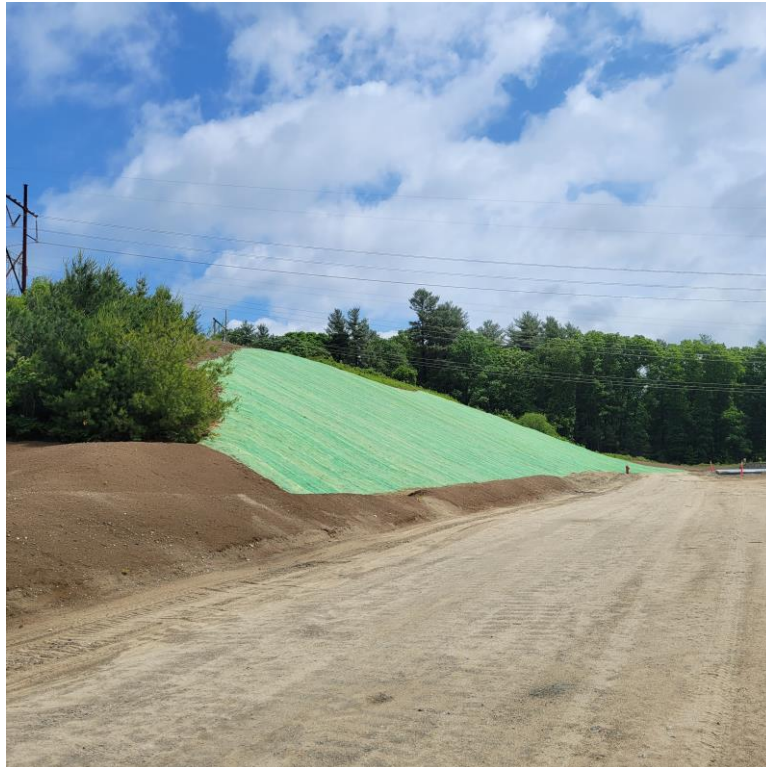
- Building construction continues on the northwestern side.
- Portions of the western slopes have loam placed along the slopes.
- The steep northern 2:1 slope had been temporarily stabilized with erosion control matting. The section spanned between the "Depression to Collect Overland Flow" and the eastern retaining wall.
- Overall, the retaining walls around the site were installed and the majority of the earthwork remaining appears to be bringing the site to finish grade; with exception to the installation of WQI-2 that will be discussed in further detail below.

Photo 2: Erosion control matting installed along the northern 2:1 slope.

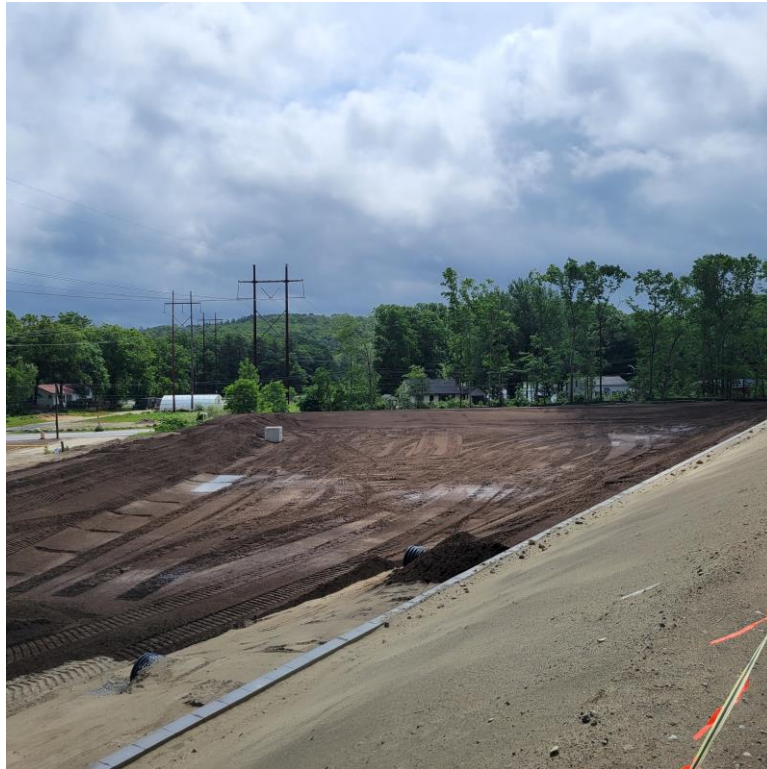
- Infiltration Basin 1:
 - The contractor had spread loam around the interior side slopes and bottom of Infiltration Basin 1. It should be noted that the northwestern side slopes were not entirely covered yet. However, it was evident that the contractor was working from the southern side of the basin towards the northern side.
- To summarize, the majority of the drainage infrastructure is installed. The contractor still needs to install the flared end section FE-14 and the associated drainage system (WQI-2, CB 36 and the associated piping). It is my understanding that this portion has not been installed yet due to logistical constraints (will require the main entrance into the site to be closed for an extended period of time).

Photo 3: Infiltration Basin 1 with loam spread.

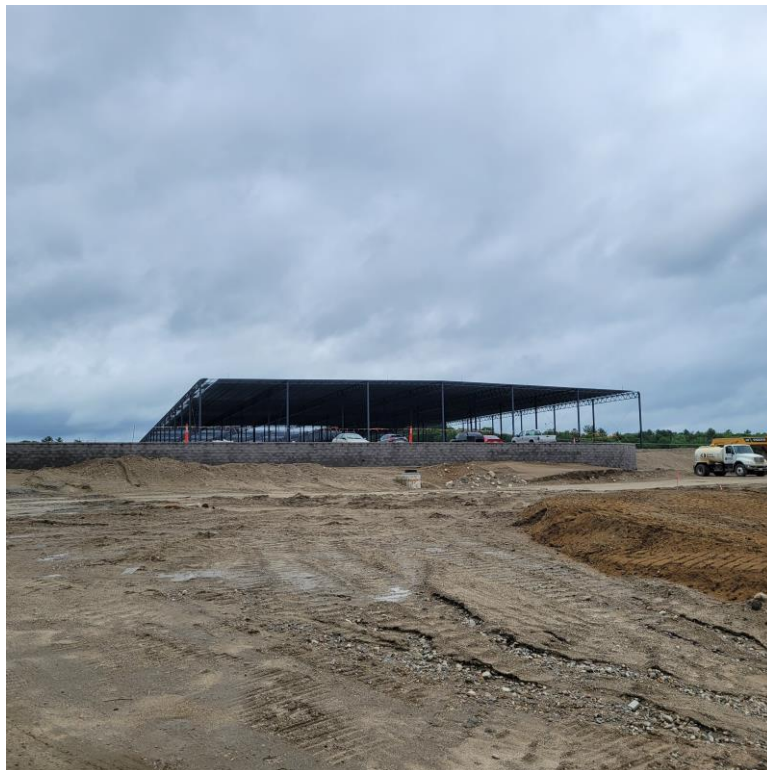
Photo 4: General condition of building construction with southern retaining wall installed.
