Site Visit Report

Date: July 7, 2023
Client: Sutton Planning Board
Project: Unified Parkway
Contractor: Walsh Contracting Corp.
Contractor Contact: John Walsh

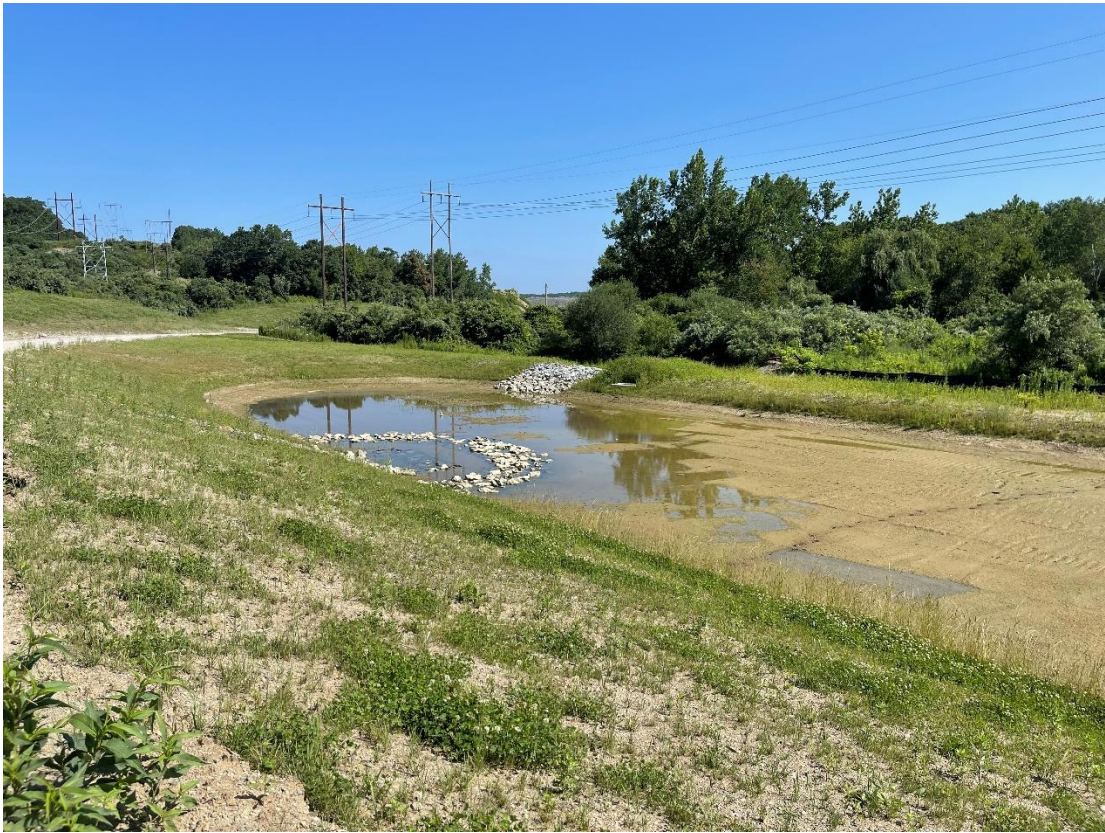
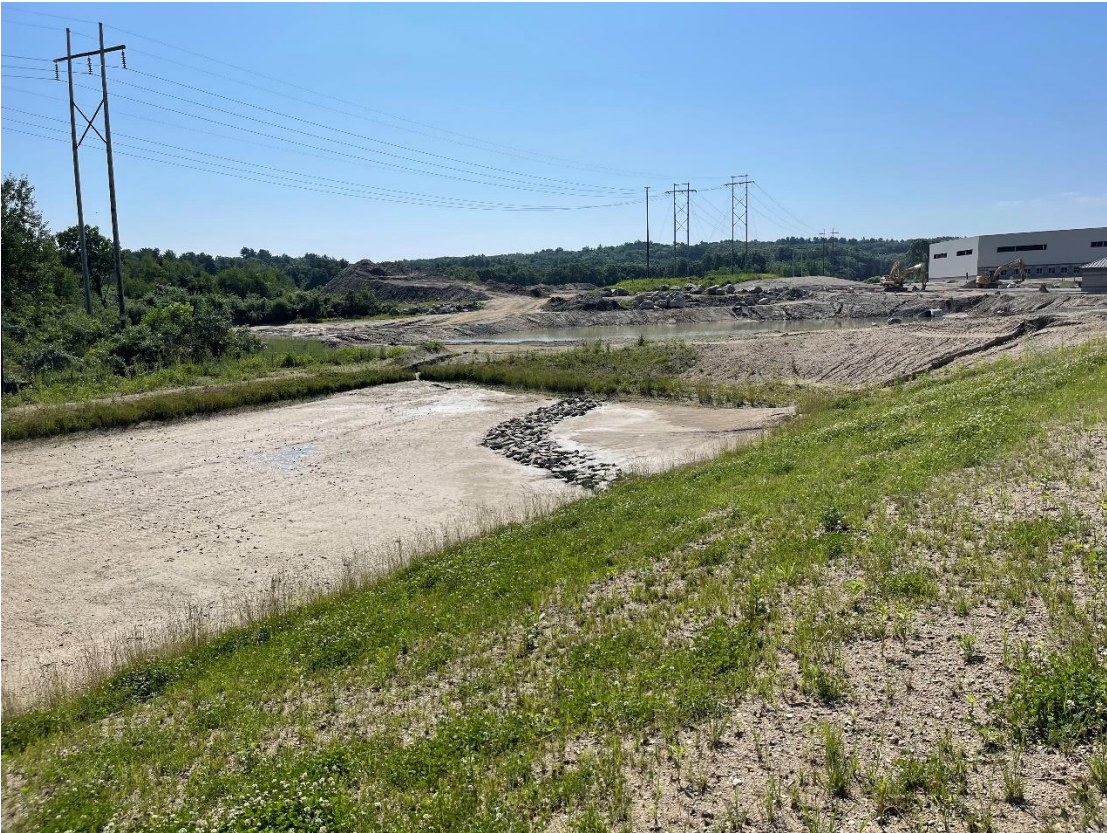
- Stormwater Management Area (SWMA) #1 was experiencing well-established grass growth.
- The slopes along SWMA #2 were experiencing well-established grass growth. The bottom of the management area was experiencing approximately 75% grass growth.
- SWMA #3 was experiencing approximately 50% grass growth along the southeastern slope, 60% along the eastern slope, and 70% along the northern and western slopes. The southwestern corner and bottom showed no signs of grass growth. The area needs to be reseeded and/or augmented to encourage additional grass growth.
- The slope between stations 43+00 and 45+00 was experiencing well-established grass growth.
- SWMAs #1 and #2 were dry. Puddles less than six inches deep had formed in portions of SWMA #3.

Photos 1 and 2: SWMA #3 was experiencing partial grass growth along its slopes and no grass growth along the southwestern corner and bottom.

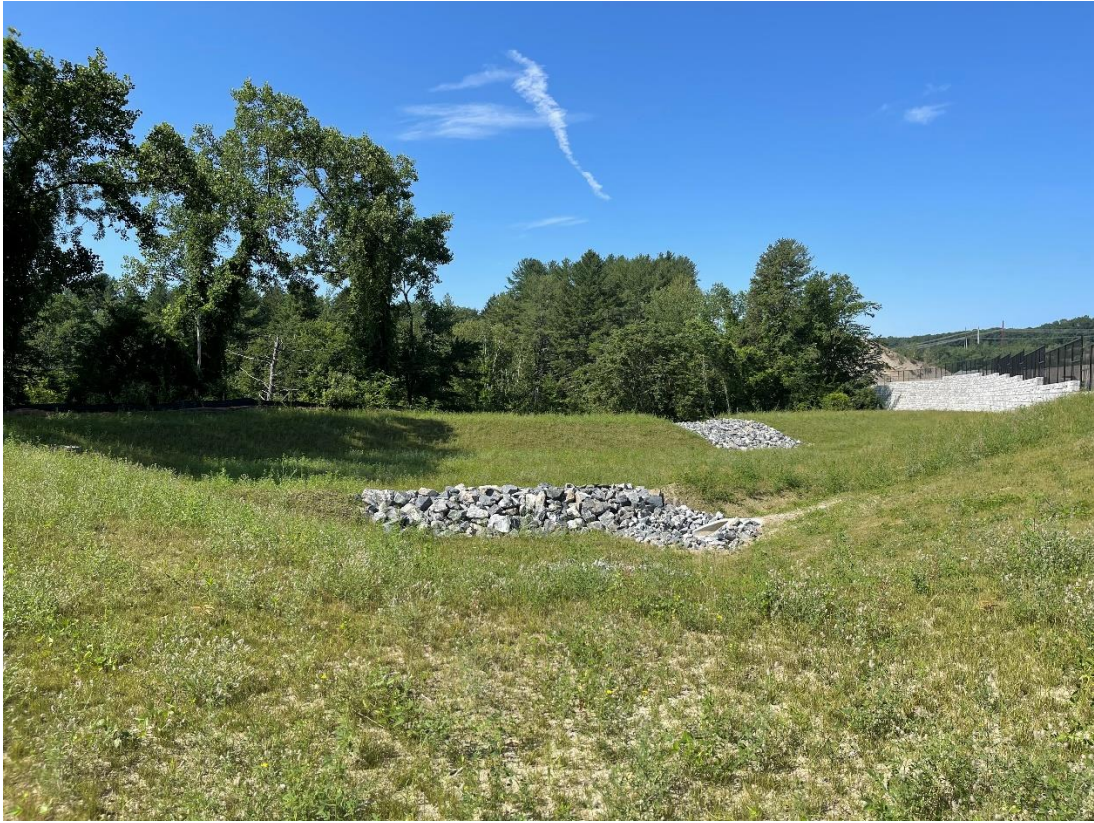
Photo 3: SWMA #1 was experiencing well-established grass growth.
