# Site Visit Report

<b>Date:</b>	July 7, 2023	<b>Prepared By:</b>	Olivia Caton
<b>Client:</b>	Sutton Planning Board	<b>Arrived on site:</b>	9:50 AM
<b>Project:</b>	Unified Parkway Lots 2 and 3	<b>Left site:</b>	10:30 AM
<b>Contractor:</b>	Walsh Contracting Corp.	<b>Site Conditions:</b>	Dry
<b>Contractor Contact:</b>	John Walsh	<b>Weather:</b>	75°, Clear

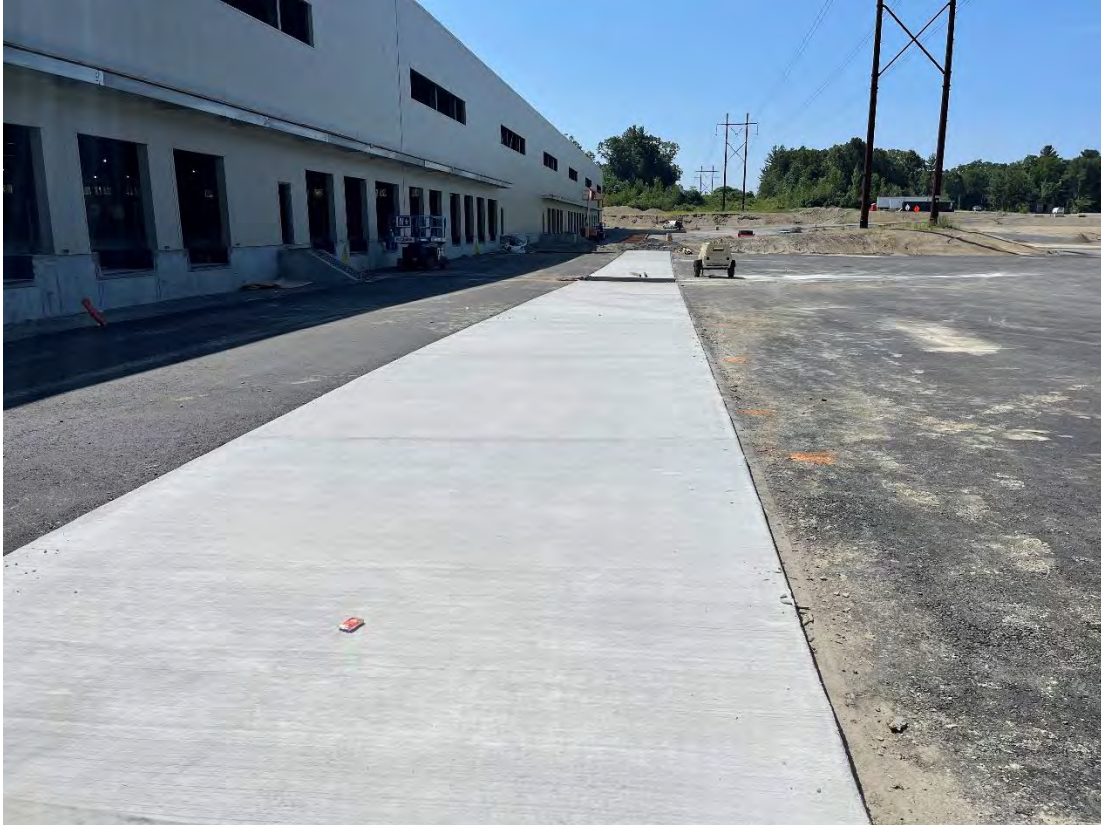
- The contractor continued work on Building 3.
- The contractor was moving earth material at the southern entrance to Lot 3.
- Fill material had been placed along the area immediately northwest of Outlet Control Structure (OCS) 500.
- The concrete pads along the middle of the western side of Building 3 had been installed.

**Photo 1:** The concrete pads along the middle portion of the western side Building 3 had been installed.

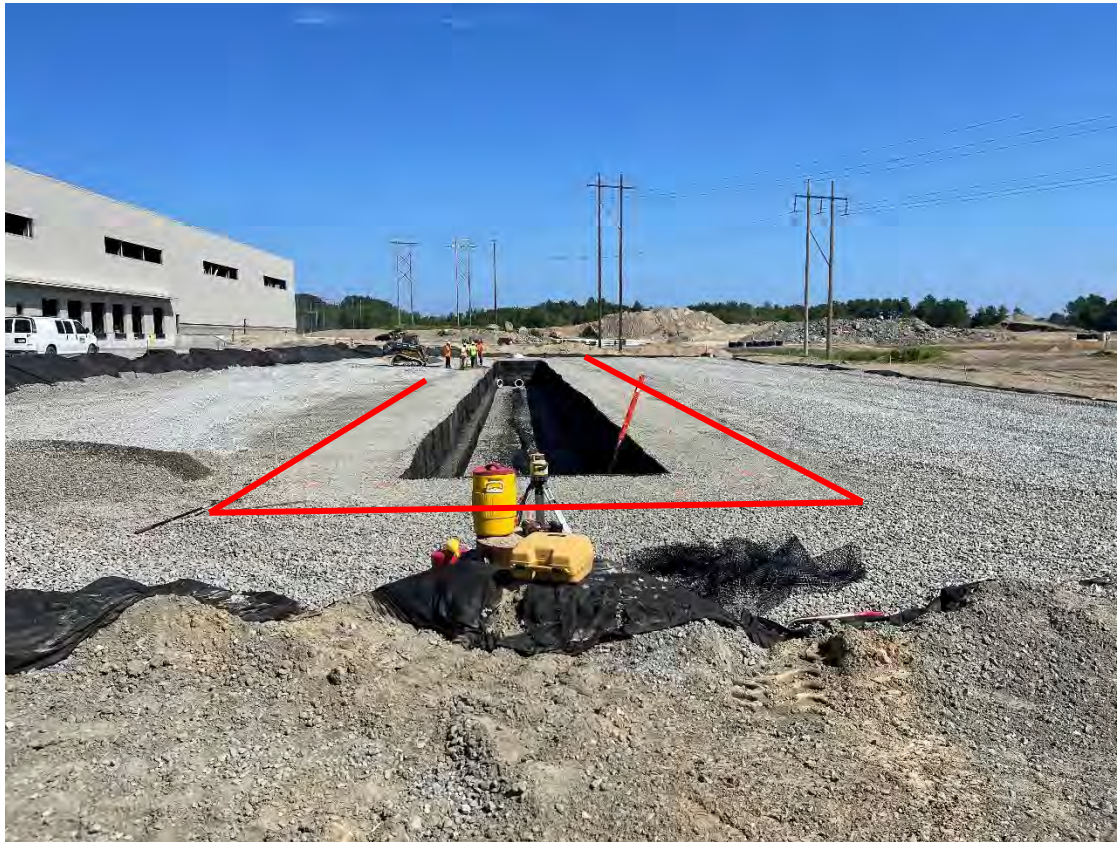
- Additional wire baskets and one-and-a-half-inch crushed stone throughout the entire system had been installed until the top of the baskets and crushed stone were approximately level with the surrounding area.
- Three-quarter-inch crushed stone had been placed and compacted in a six-foot-wide area along the sides of the trench to form the reinforced zone.
- The contractor was confirming stone elevations and compacting the three-quarter-inch crushed stone along the western side of the trench.
- DMH 804 and the area previously being compacted had been backfilled and were no longer visible.

**Photo 2:** Overall progress of SWMA UG3c. A red line has been added to show the separation between the three-quarter-inch and one-and-a-half-inch crushed stone.

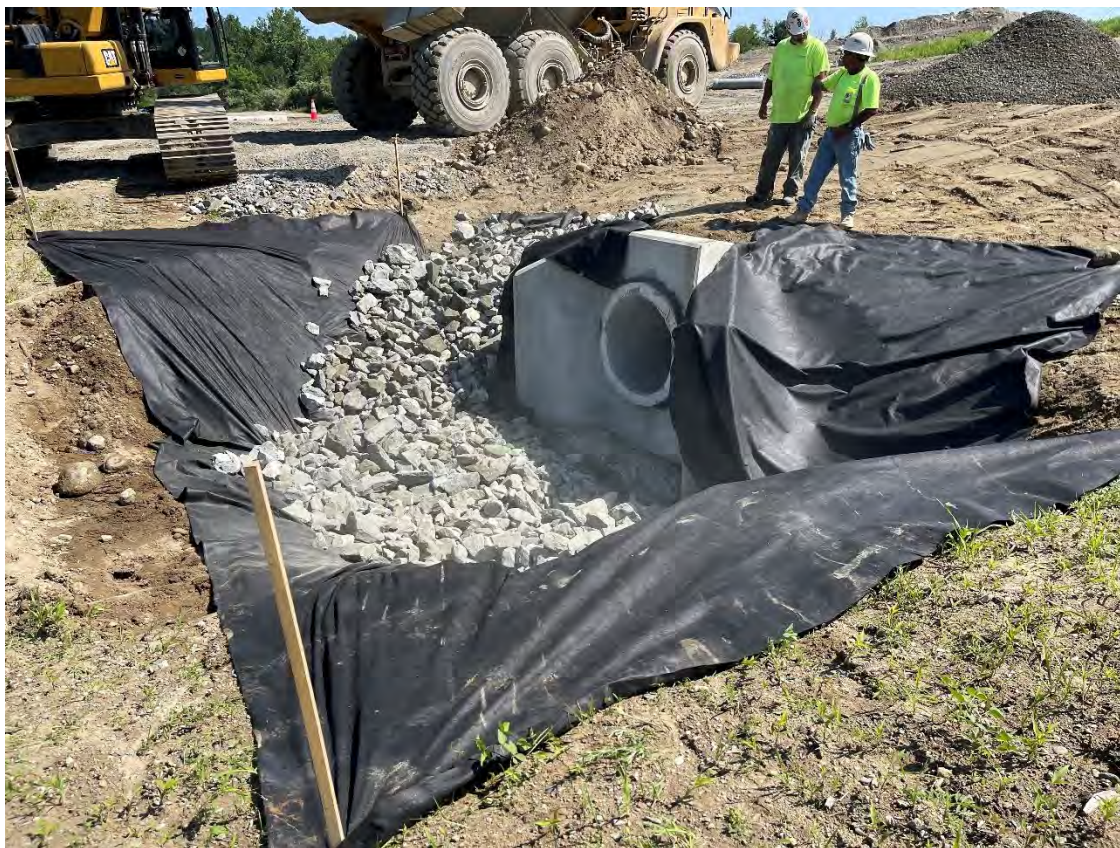
**Photo 3:** The contractor placing riprap around HW 600.

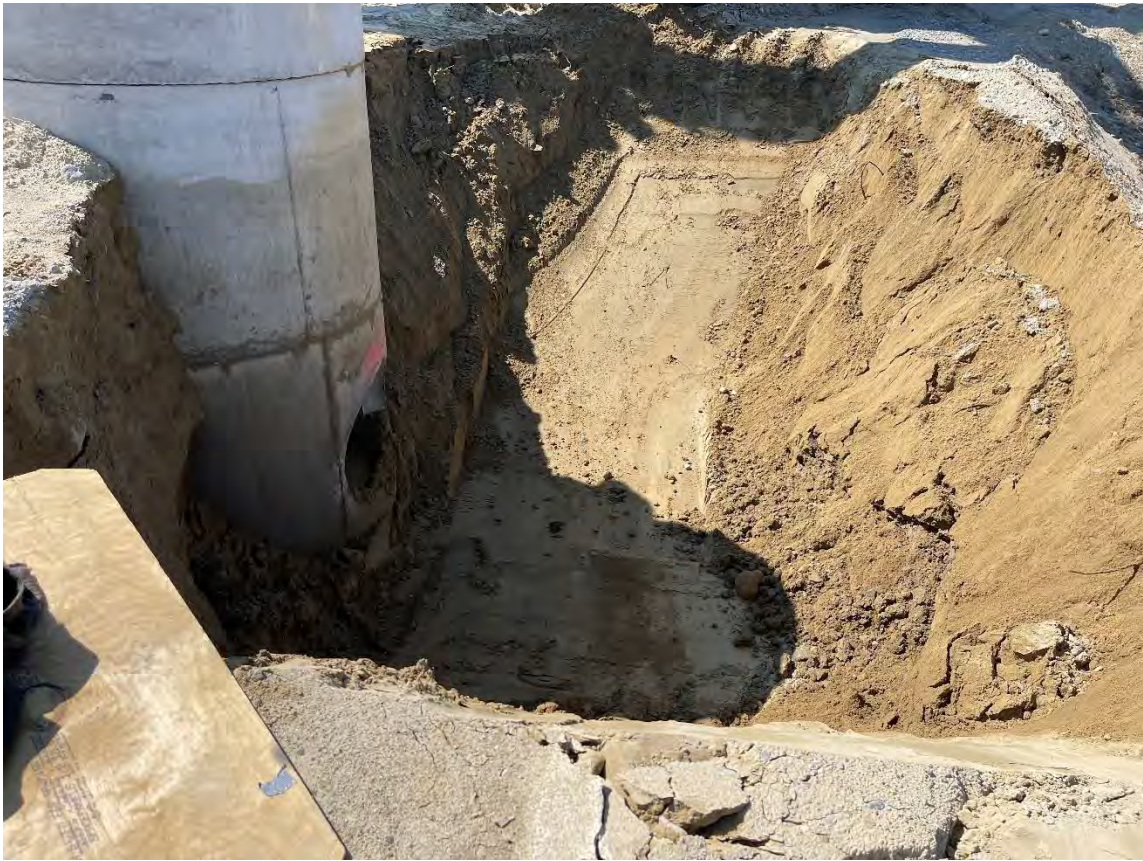
**Photo 4:** The contractor was excavating the trench for the pipe between OCS 500 and SWMA UG2e.

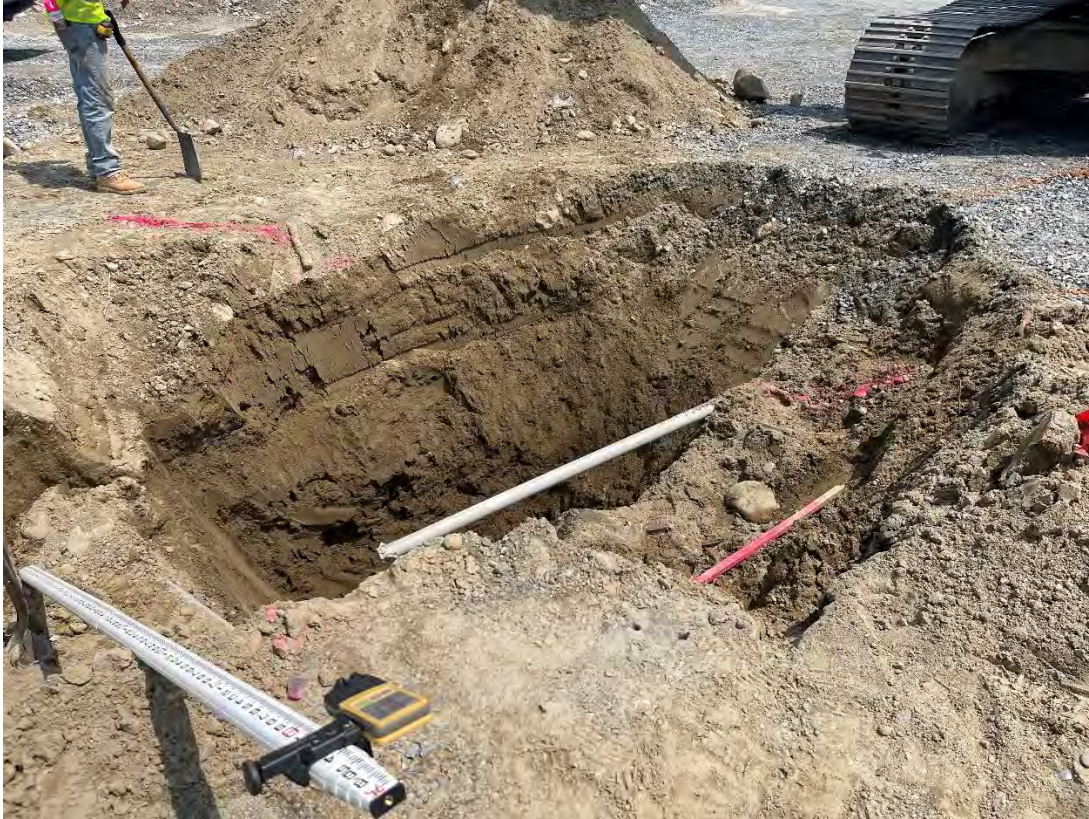
**Photo 1:** The contractor performing work on various utilities east of the pumphouse.

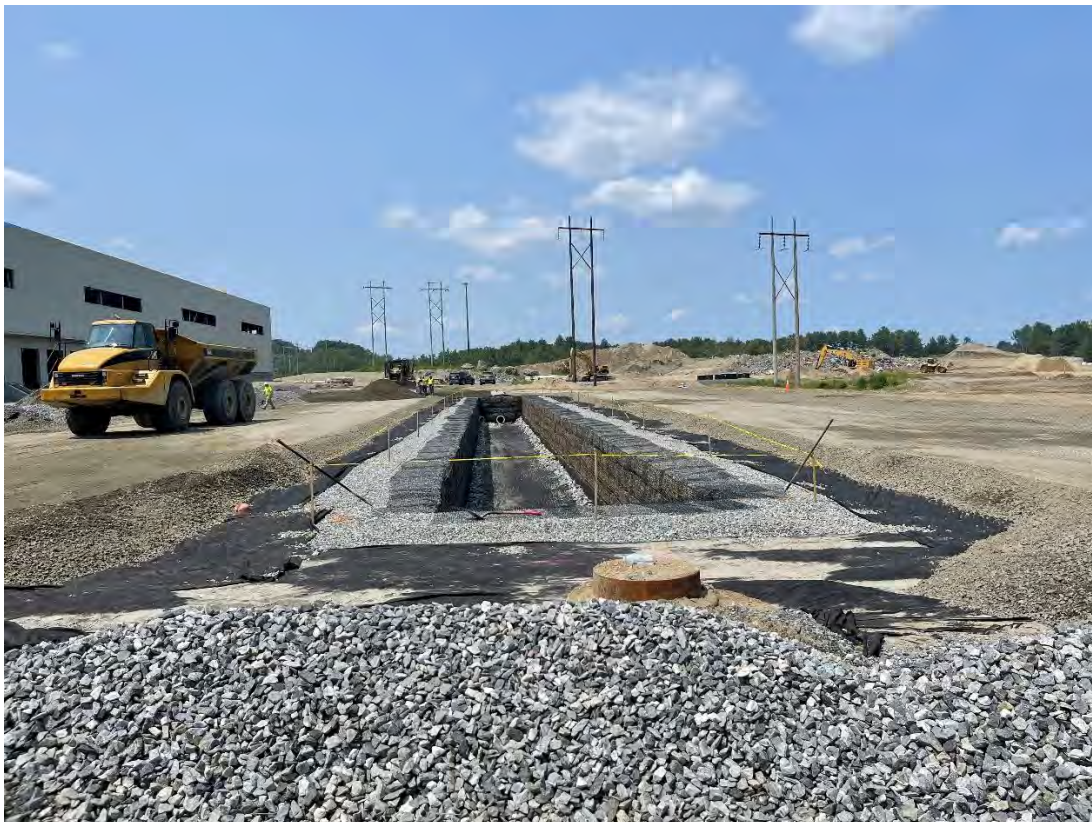
- Geogrid had been placed along the walls of the trench and across the reinforced zone.
- Approximately one foot of dense-graded crushed stone had been placed over the one-and-a-half-inch crushed stone. Geotextile fabric was visible underneath the dense-graded crushed stone.

**Photo 2:** Overall progress of SWMA UG3c.

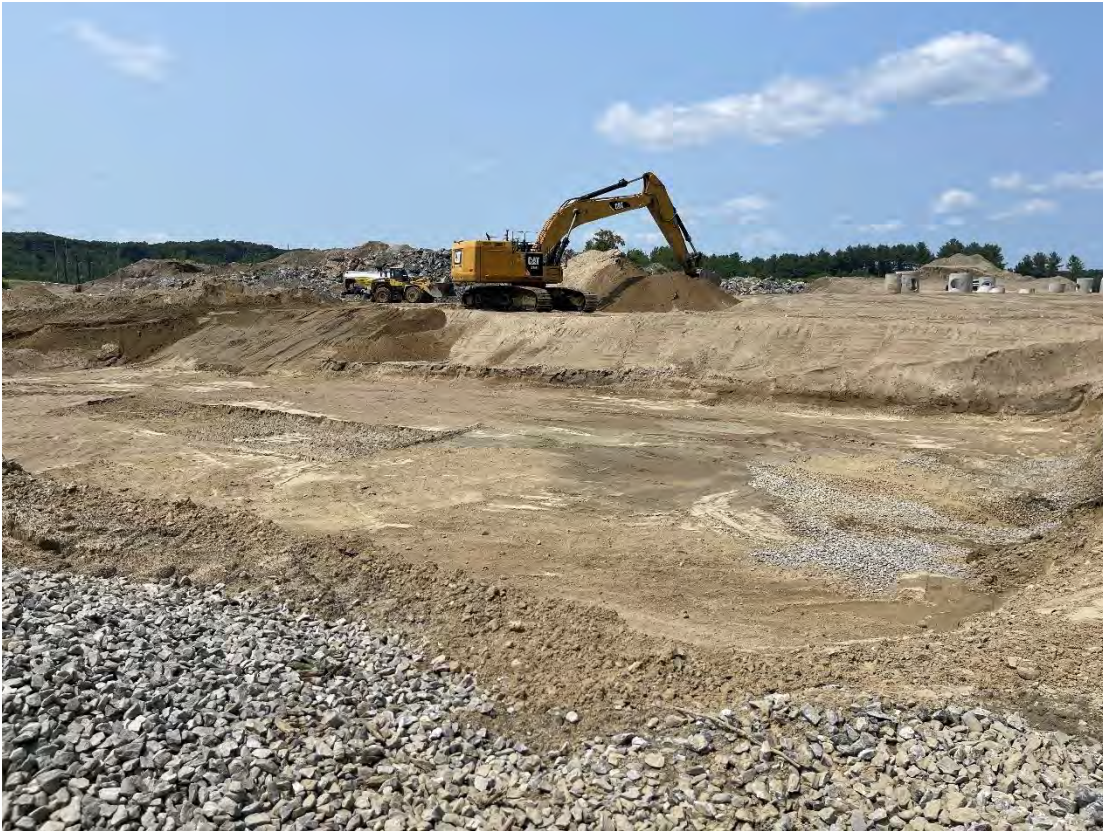
- The location of the stormwater management area had been excavated to a width of  $\pm 74$  feet, a length of  $\pm 136$  feet, and a depth of  $\pm 12$  feet.
- The contractor was placing fill material along the northern slope.
- John Walsh informed us that sand still needed to be placed along the bottom of the stormwater management area, and they would begin to install the system tomorrow or Thursday.

**Photo 3:** The contractor placing fill material along the northern slope of SWMA UG2e.

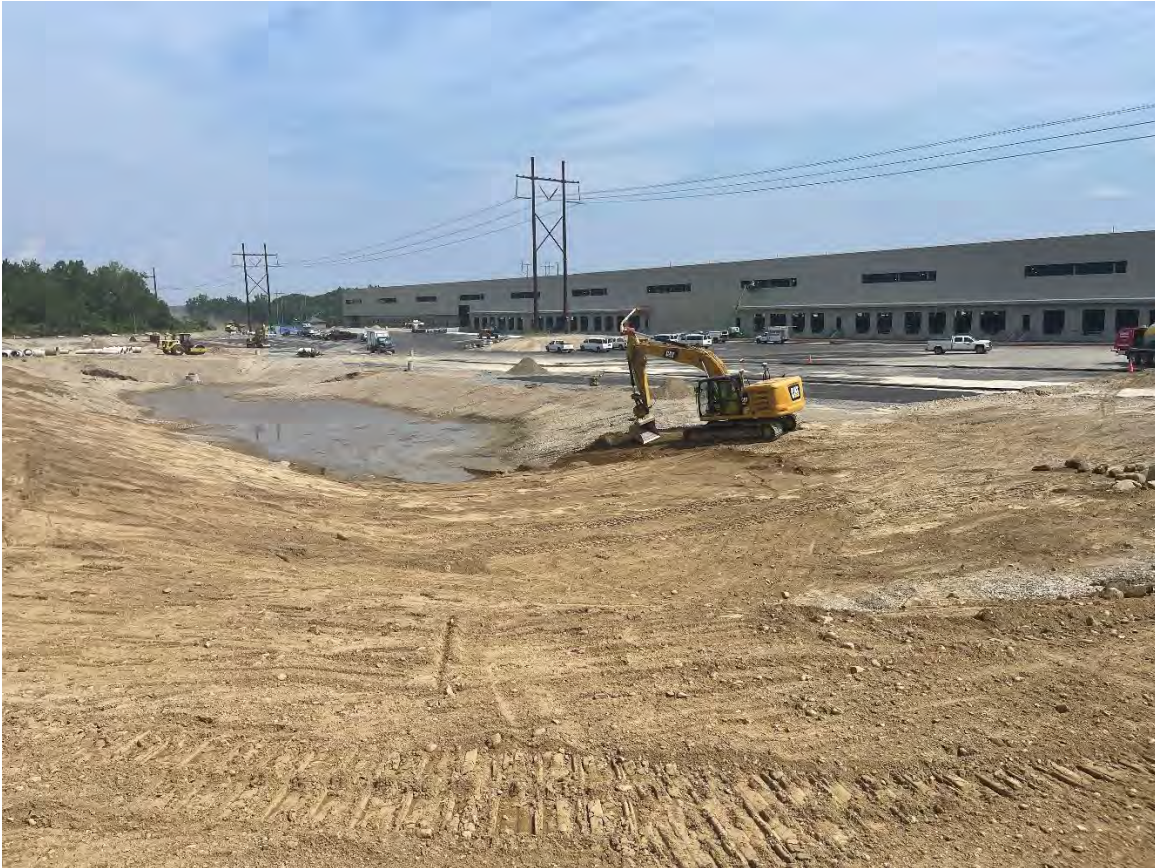
**Photo 1:** The contractor placing fill material along the slopes of BA 3b.

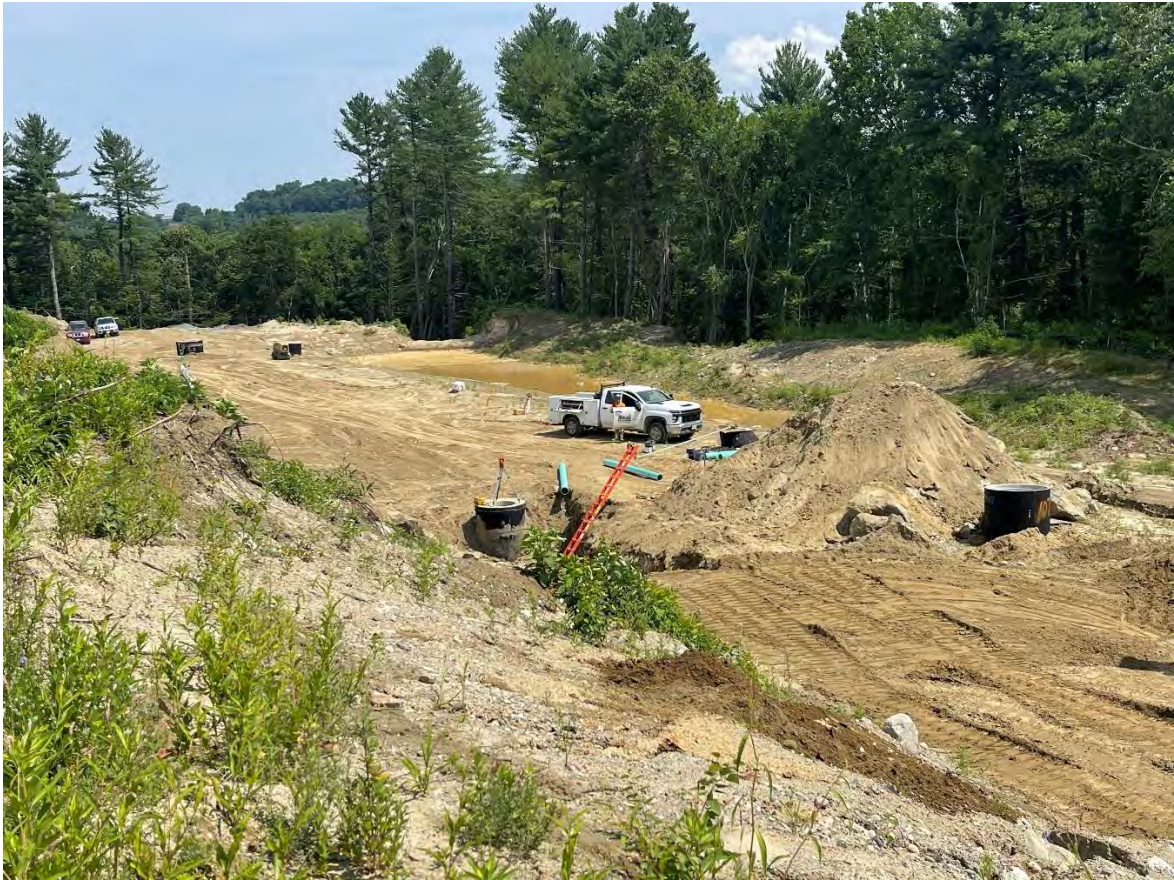
- Approximately 180 feet of 8-inch PVC pipe had been installed and backfilled between the two structures. An additional 16 feet of pipe had been installed past SMH 107 towards SMH 108.

**Photo 2:** SMHs 106 and 107 were installed, and the pipe between them backfilled.

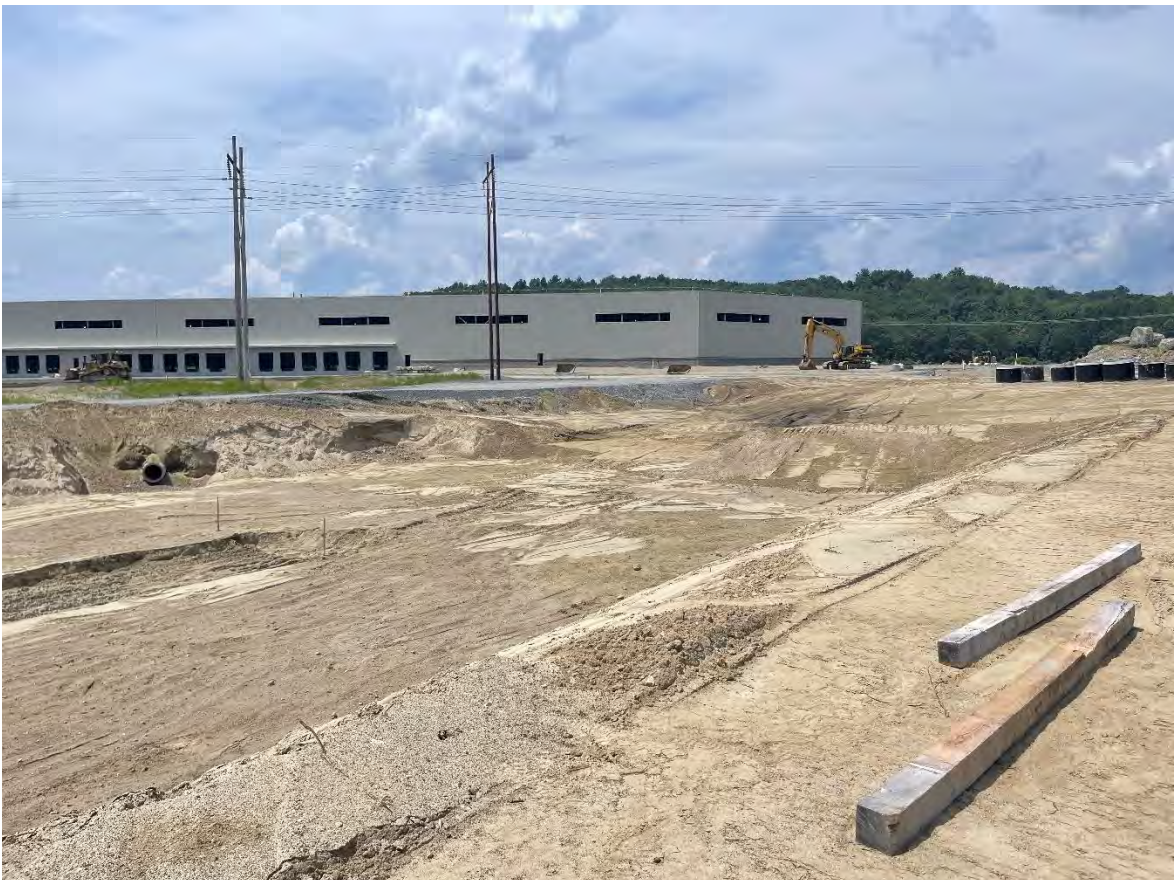
- The location of the stormwater management area had been further excavated to a width of  $\pm 90$  feet and a length of  $\pm 150$  feet.
- Additional fill material had been placed along the northern slope.
- Large erosion rills were present along the eastern slope.

- From the location where the pipe from Drain Manhole (DMH) 503 intersects with the management area to the western side of UG2e, the width increased to approximately 100 feet.

**Photo 3:** SWMA UG2e was further excavated. The width increased to 160 feet where the pipe from DMH 503 intersects with the stormwater management area (middle left).

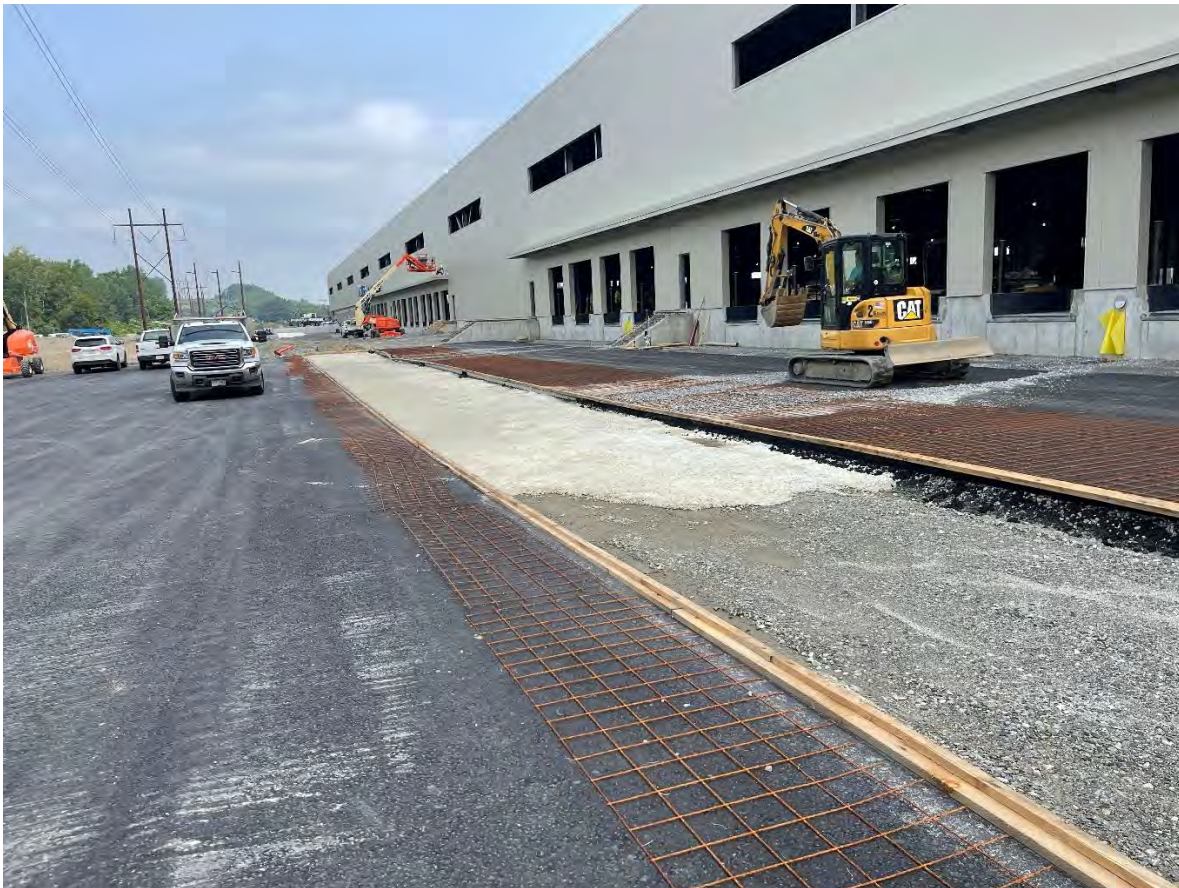
**Photo 1:** Approximately half of the concrete for the pad adjacent to the southern portion of the western side of the building had been poured.

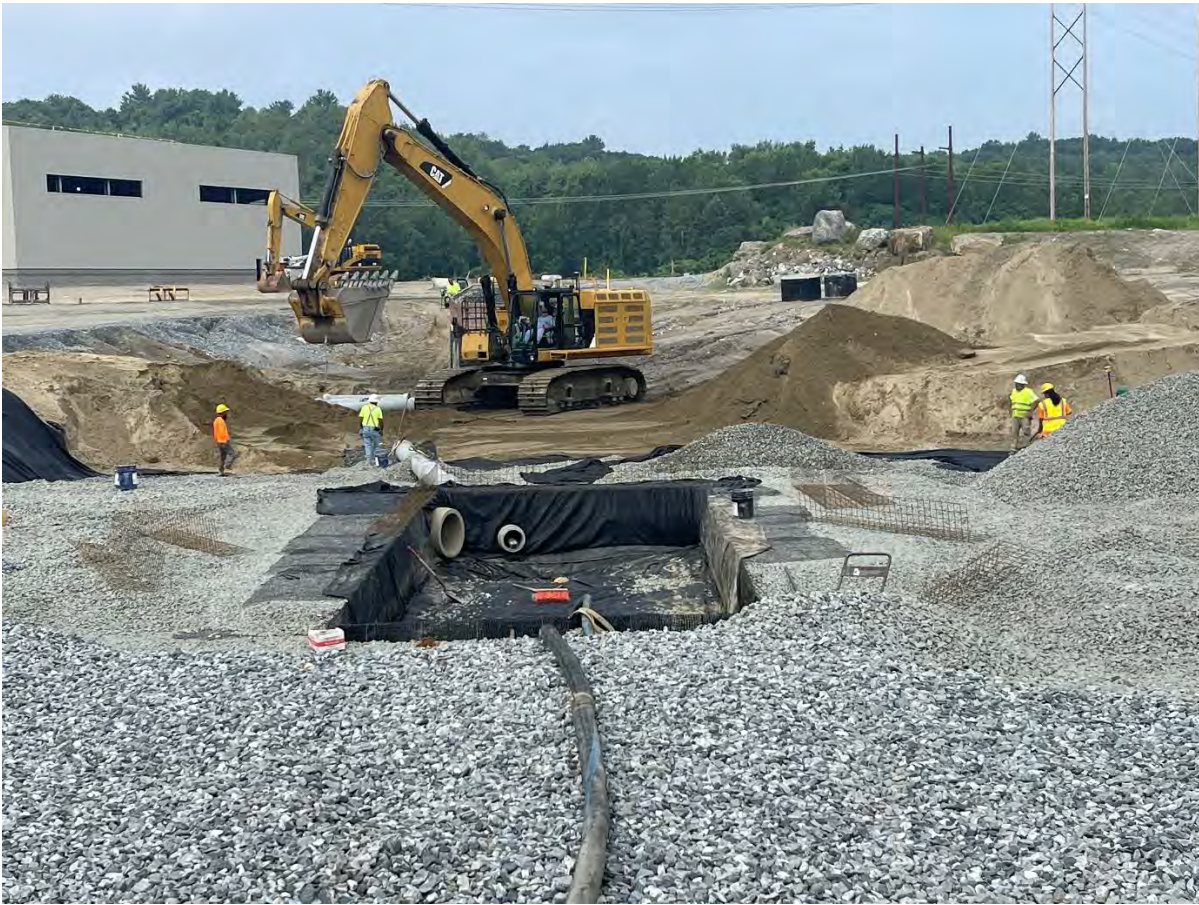
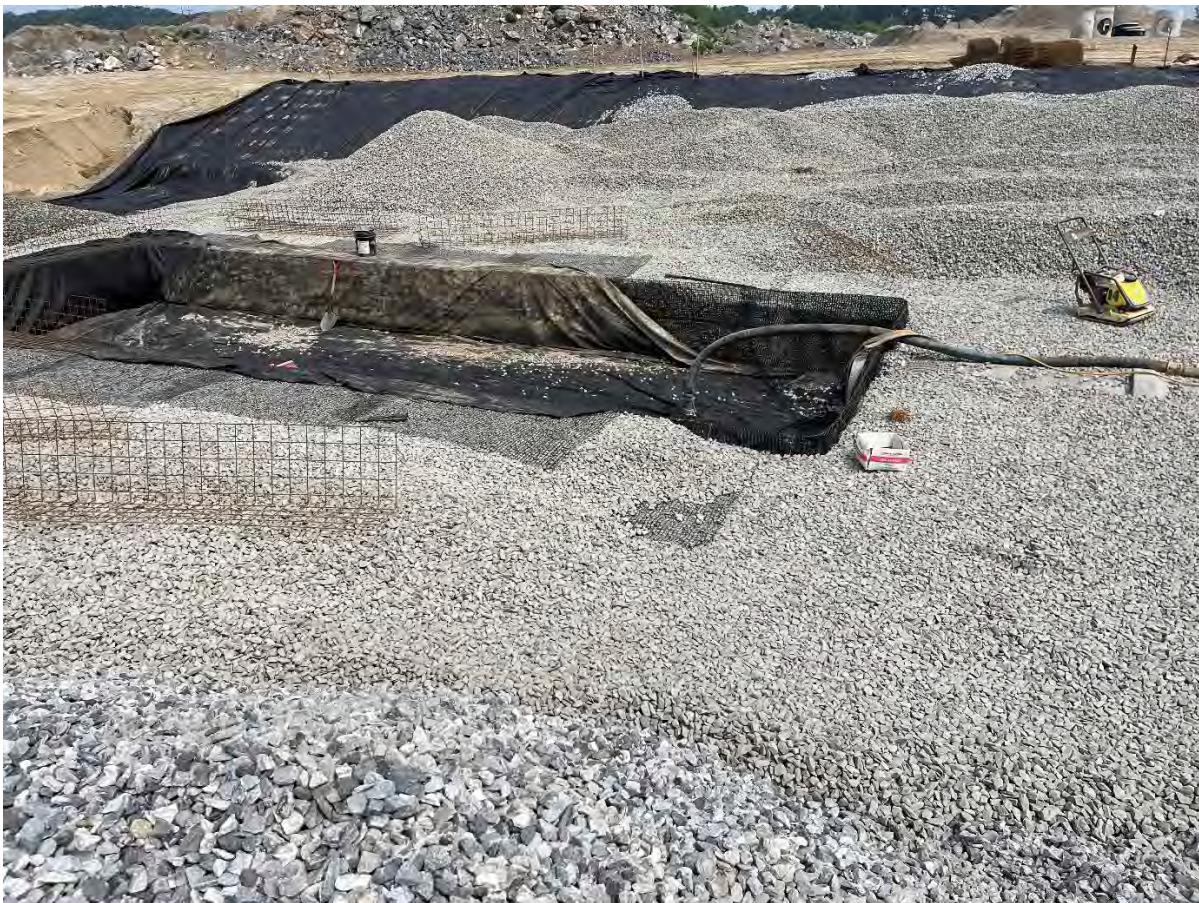
**Photos 2 and 3: General progress of SWMA UG2e.**

- Two rows of wire baskets had been installed around the trench. One-and-a-half-inch crushed stone had been placed and compacted behind the baskets. Geogrid was visible between the lifts of stone.
- One-and-a-half-inch crushed stone had been placed along the space between the trench and sides of UG2e. The crushed stone depth was approximately equal to the current grade of the surrounding area along the eastern and southeastern sides. The depth varied throughout the rest of the SWMA, with the lowest depth being level with the top of the baskets.
- Geotextile fabric had been installed along the sides of the trench. Geogrid was visible under the geotextile fabric along the top of the trench.
- The following pipe had been installed (outlet control structure = OCS, catch basin = CB, reinforced concrete pipe = RCP):

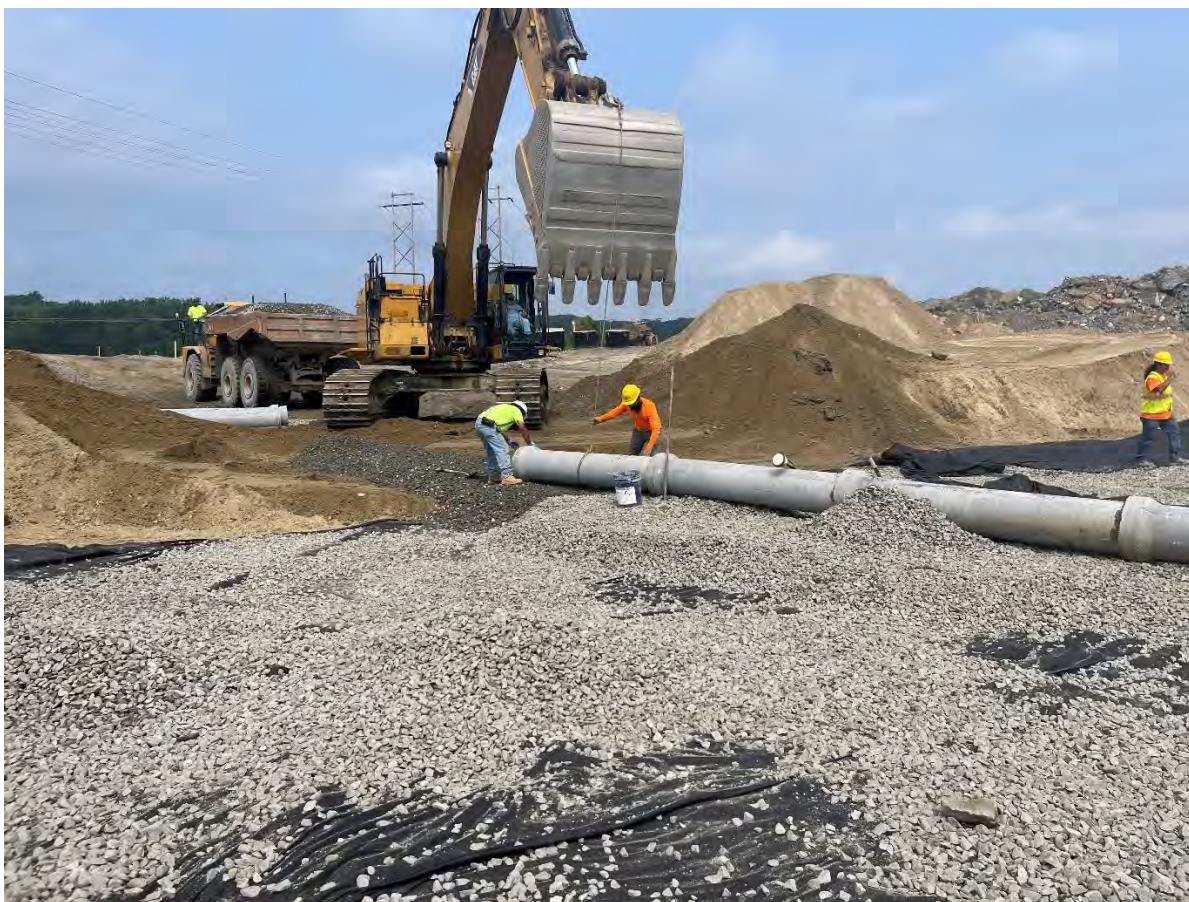
- The pipes between OCS 500, DMH 503, and UG2e were partially covered in one-and-a-half-inch crushed stone. The pipe towards CB 507 was uncovered.
- The contractor placed three-quarter-inch crushed stone bedding material past the end of the pipe towards CB 507, then installed an additional 8 feet of pipe in a satisfactory manner.

**Photo 4:** The contractor installing 12-inch RCP from SWMA UG2e towards CB 507.

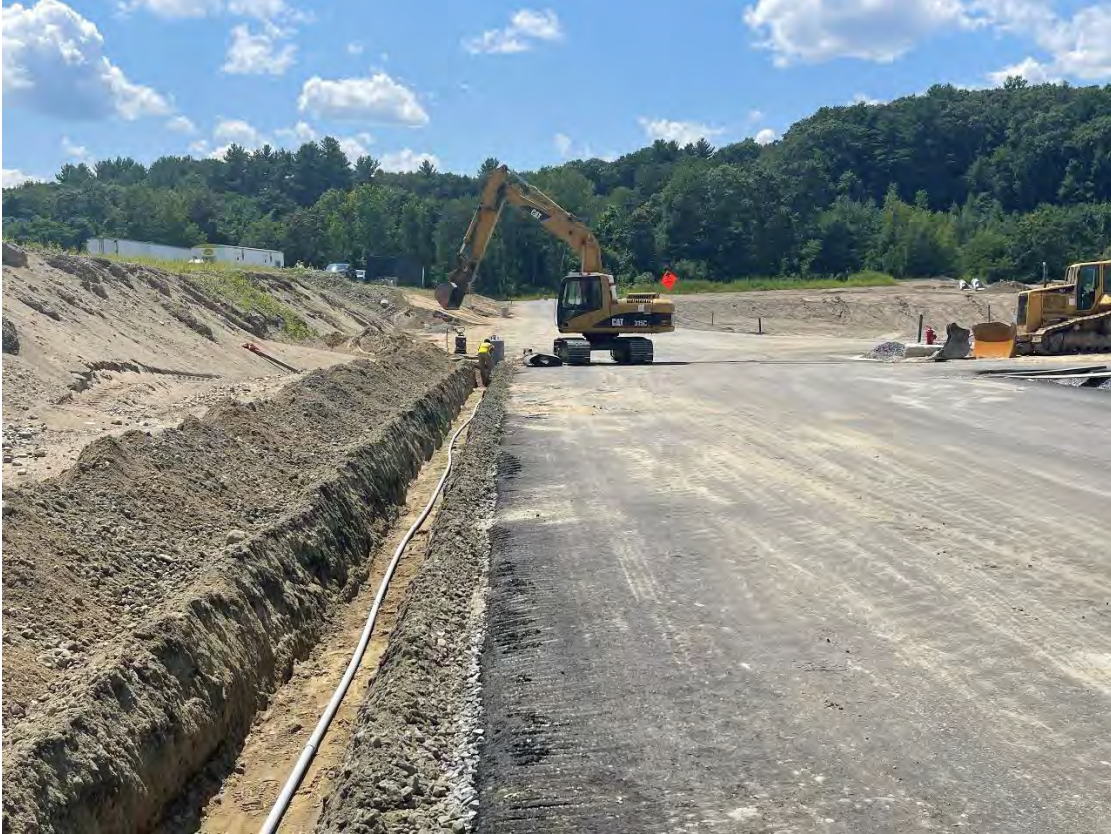
**Photo 1:** The contractor backfilling electrical conduit pipe along the road eastmost of Building 3.

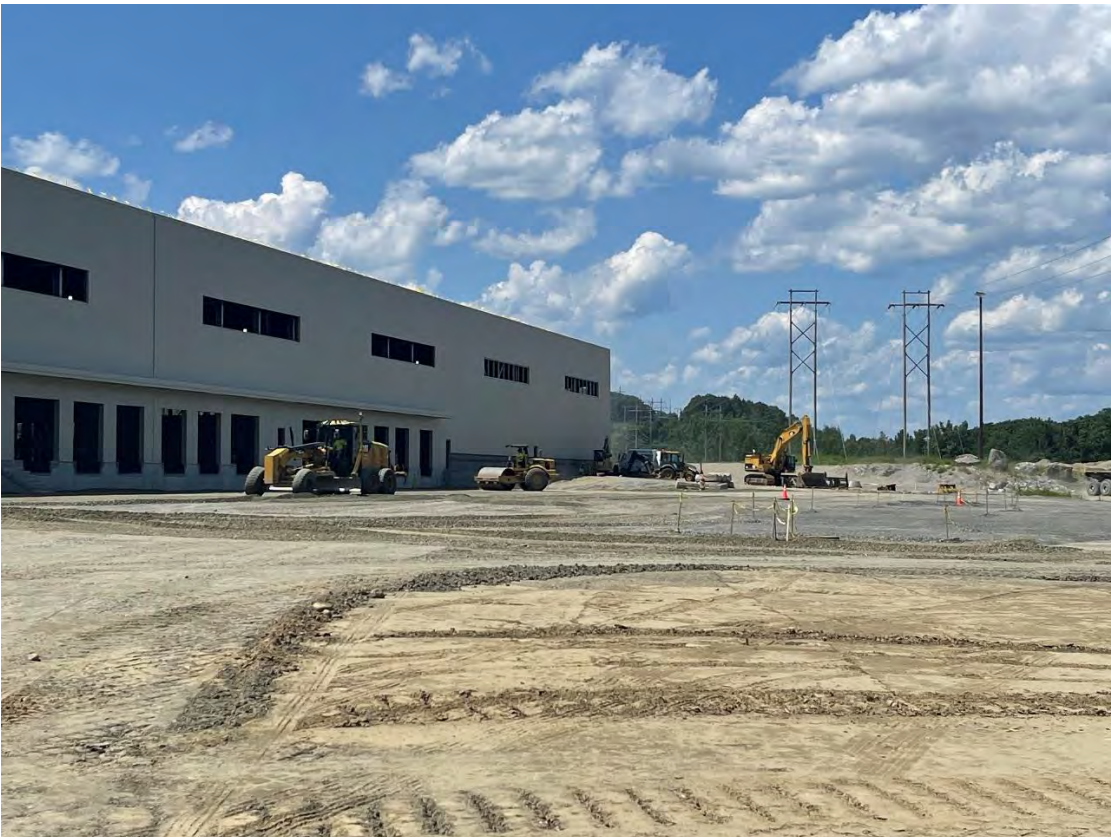
**Photo 2:** The contractor fine-grading and compacting the eastern parking lot.

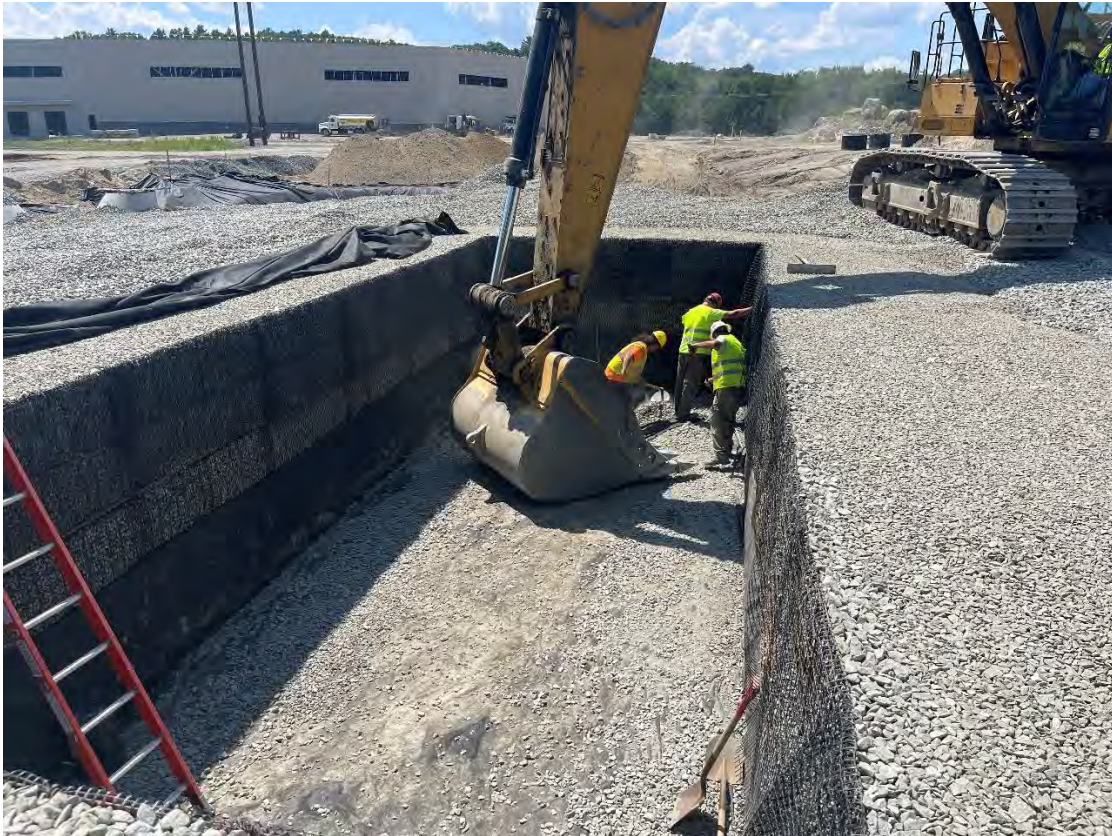
- Three additional rows of wire baskets had been installed.
- Geogrid was visible along the sides of the trench.
- One-and-a-half-inch crushed stone had been placed and compacted along the space between the trench and sides of UG2e until the SWMA was approximately equal to the current grade of the surrounding area.
- Three-quarter-inch crushed stone had been placed and compacted in a six-foot-wide area adjacent to the trench to form the reinforced zone.
- The previously installed pipe had been backfilled or covered in one-and-a-half-inch crushed stone and was no longer visible.
- The contractor was removing excess crushed stone that had fallen into the trench area during construction.

**Photo 3:** The contractor removing excess crushed stone that had fallen into the trench of SWMA UG2e. Geogrid is visible along the sides of the trench, and the top of the reinforced zone can be seen adjacent to the trench.
