Site Visit Report

Date:	May 10, 2023	Prepared By:	Olivia Caton
Client:	Sutton Planning Board	Arrived on site:	11:00 AM
Project:	Unified Parkway Lots 2 and 3	Left site:	11:30 AM
Contractor:	Walsh Contracting Corp.	Site Conditions:	Dry
Contractor Contact:	John Walsh	Weather:	60°, Clear

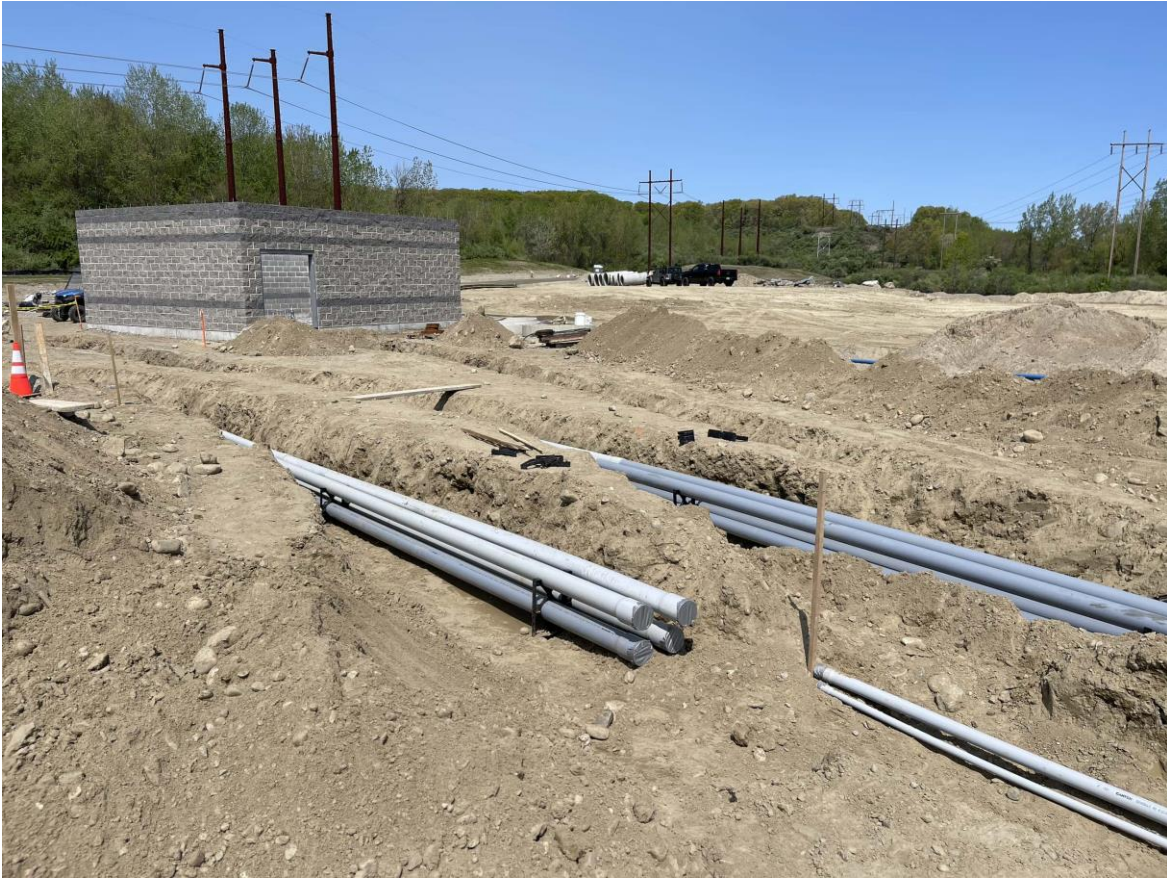
Photo 1: Electric conduit had been installed from the pump house towards Building 3.

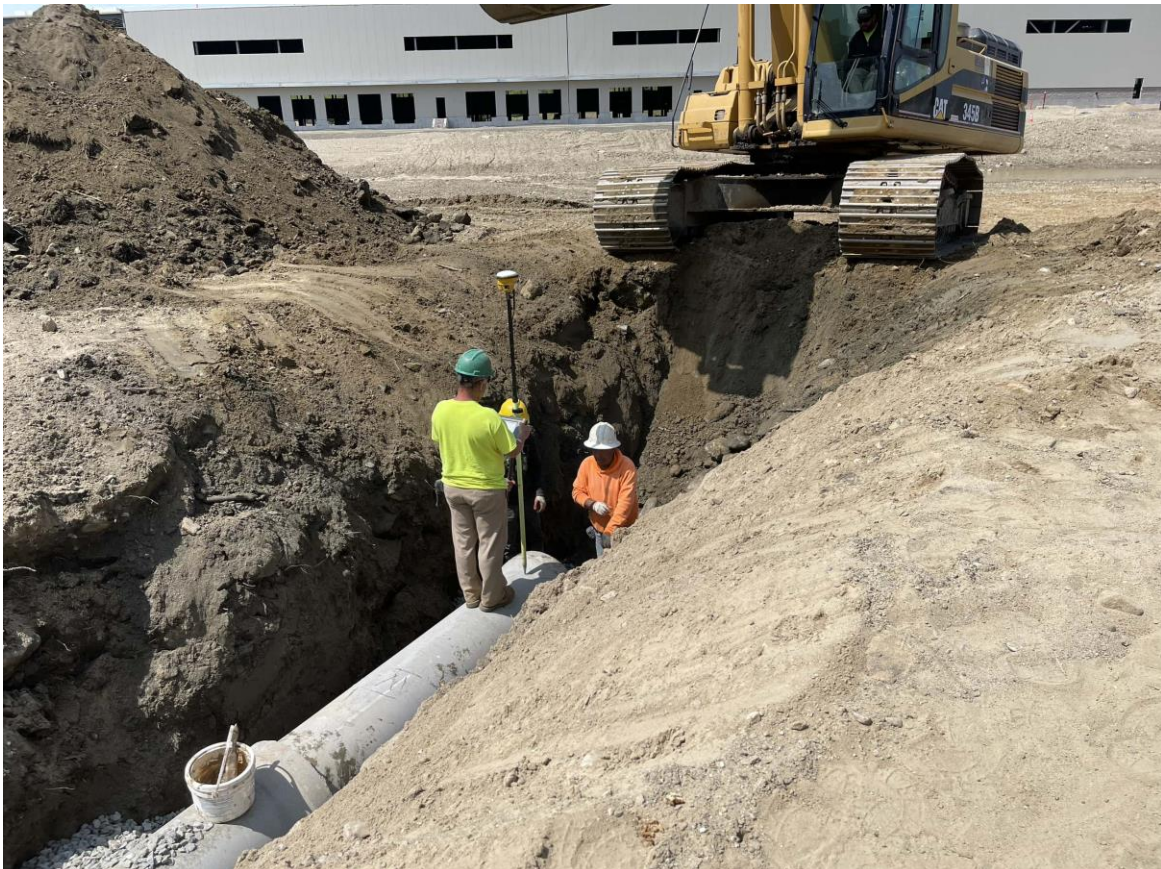
- Drain Manholes (DMHs) 500 and 807 had been installed and partially backfilled.
- From DMH 807 towards DMH 807A, approximately 50 feet of 18-inch reinforced concrete pipe (RCP) had been installed. The 34 feet closest to DMH 807 was backfilled, while the remaining portion was covered in three-quarter-inch crushed stone.
- From DMH 500 towards DMH 501, an indeterminate length of 15-inch RCP had been installed and backfilled.
- The contractor installed an additional 8 feet of 18-inch RCP between DMH 807 and DMH 807A in a satisfactory manner. The pipe was placed on bedding material consisting of three-quarter-inch crushed stone. The contractor covered and chinked the pipe with three-quarter-inch crushed stone before beginning to further excavate the utility trench.

Photo 2: The contractor confirming the elevation of the pipe between DMH 807 and DMH 807A.
