Site Visit Report

Date:	May 15, 2023	Prepared By:	Olivia Caton
Client:	Sutton Planning Board	Arrived on site:	10:50 AM
Project:	Unified Parkway Lots 2 and 3	Left site:	11:30 AM
Contractor:	Walsh Contracting Corp.	Site Conditions:	Dry
Contractor Contact:	John Walsh	Weather:	60°, Clear

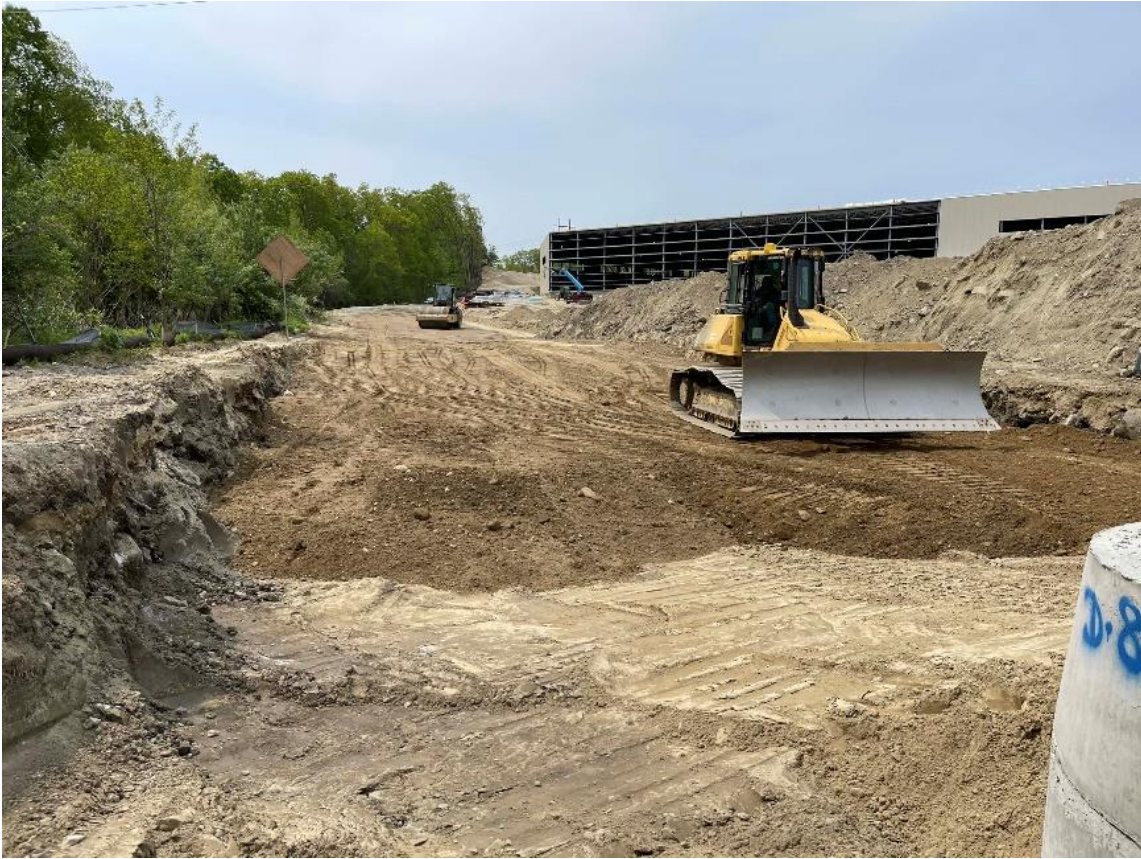
- From the pipe previously installed at Drain Manhole (DMH) 807 towards DMH 807A, approximately 210 feet of 18-inch reinforced concrete pipe (RCP) had been installed and backfilled. The pipe connection in DMH 807A had been sealed with mortar.
- The contractor was placing fill material along the aforementioned pipe, as well as the roadway adjacent to DMH 807, in an approximately one-foot lift.

Photo 1: The contractor was placing fill material along the roadway adjacent to DMH 807.

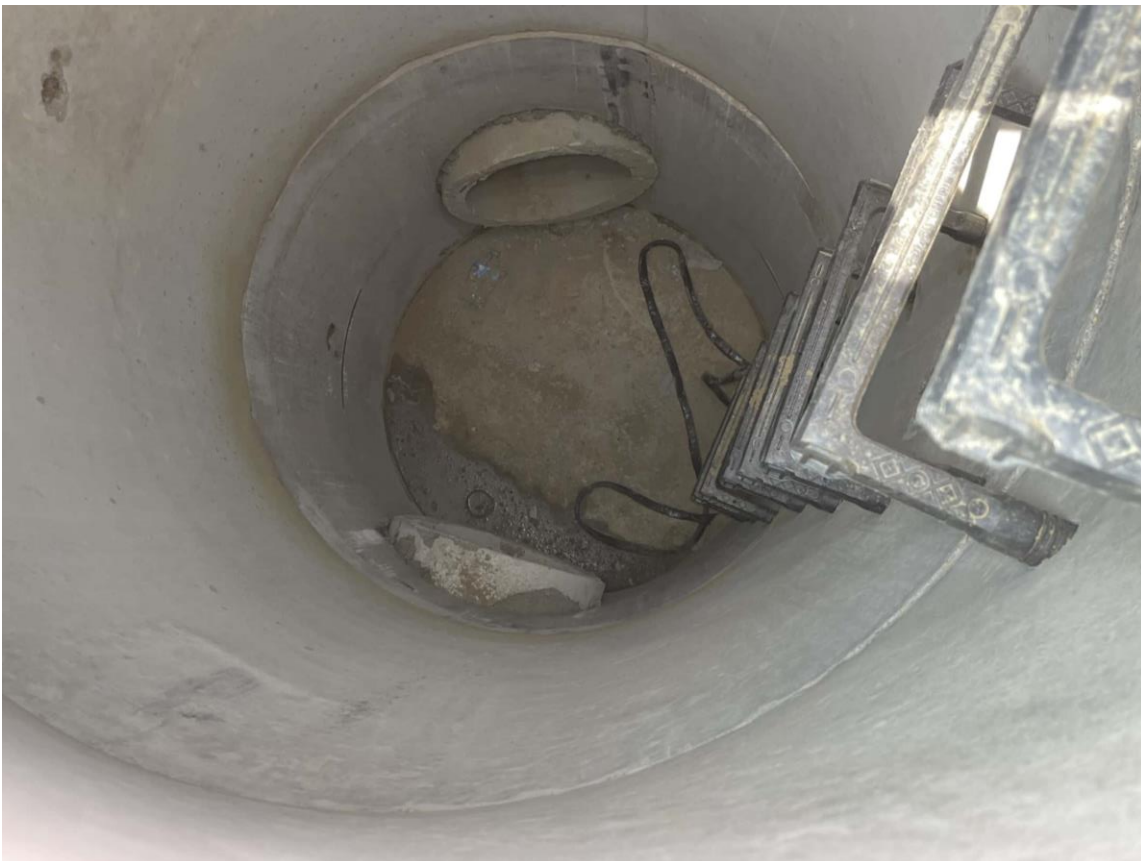
Photo 2: The pipe connection in DMH 807A for the pipe leading towards DMH 807 (bottom pipe in photo) was sealed with mortar.
