Site Visit Report

Date:	August 24, 2023	Prepared By:	Olivia Caton
Client:	Sutton Planning Board	Arrived on site:	1:30 PM
Project:	Unified Parkway Lots 2 and 3	Left site:	2:00 PM
Contractor:	Walsh Contracting Corp.	Site Conditions:	Dry
Contractor Contact:	John Walsh	Weather:	76°, Partly Cloudy

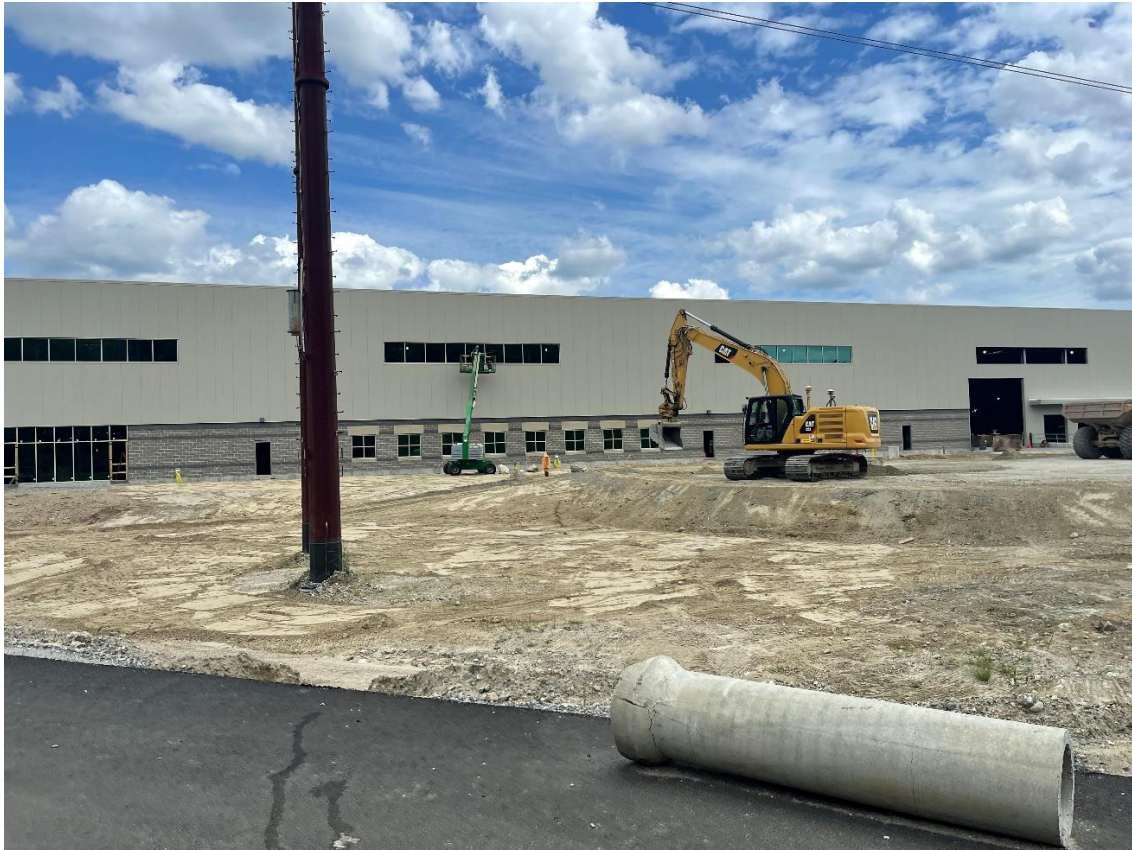
Photo 1: The contractor moving earth material near the northwestern corner of Building 3.

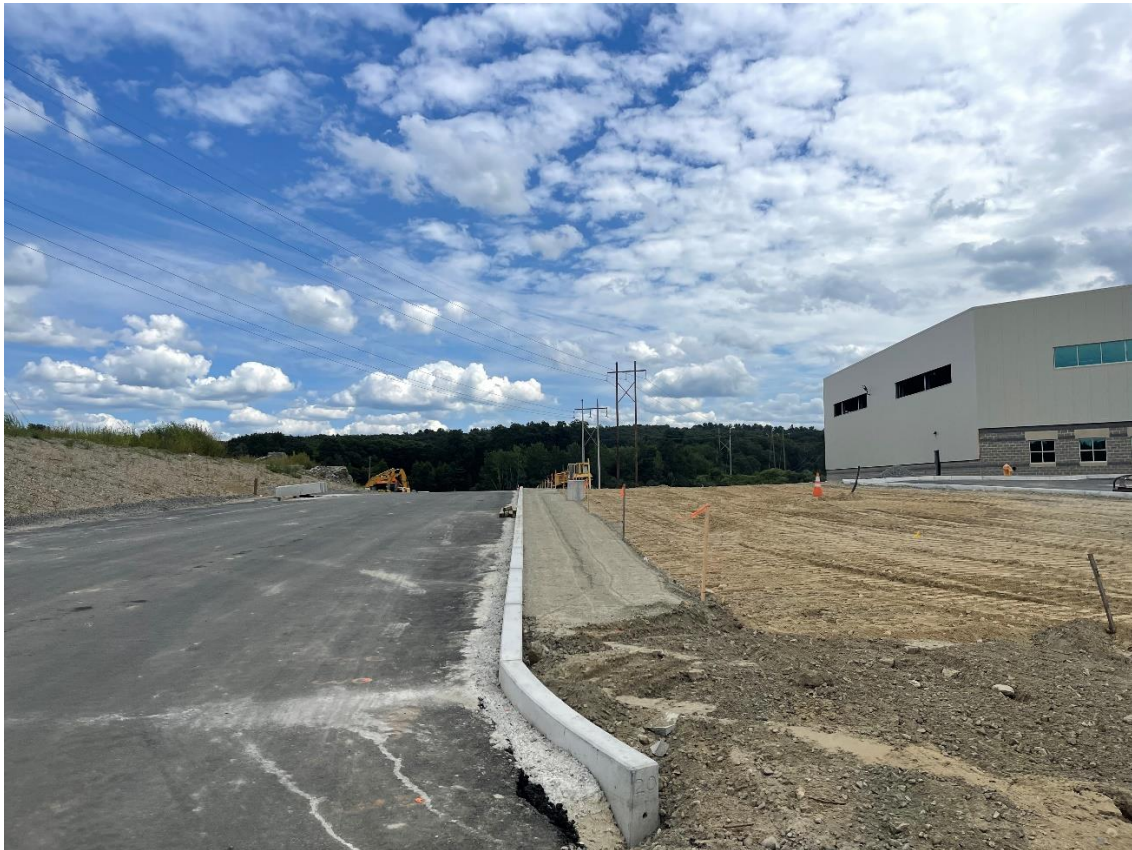
Photo 2: The area for the sidewalk along the northern driveway leading to the back roadway of the site had been prepared, and precast concrete curb installed. The contractor can be seen spreading fill material in the distance.
