Site Visit Report

Date:	August 16, 2023	Prepared By:	Olivia Caton
Client:	Sutton Planning Board	Arrived on site:	12:30 PM
Project:	Unified Parkway	Left site:	1:15 PM
Contractor:	Walsh Contracting Corp.	Site Conditions:	Damp
Contractor Contact:	John Walsh	Weather:	67°, Overcast/Lightly Raining

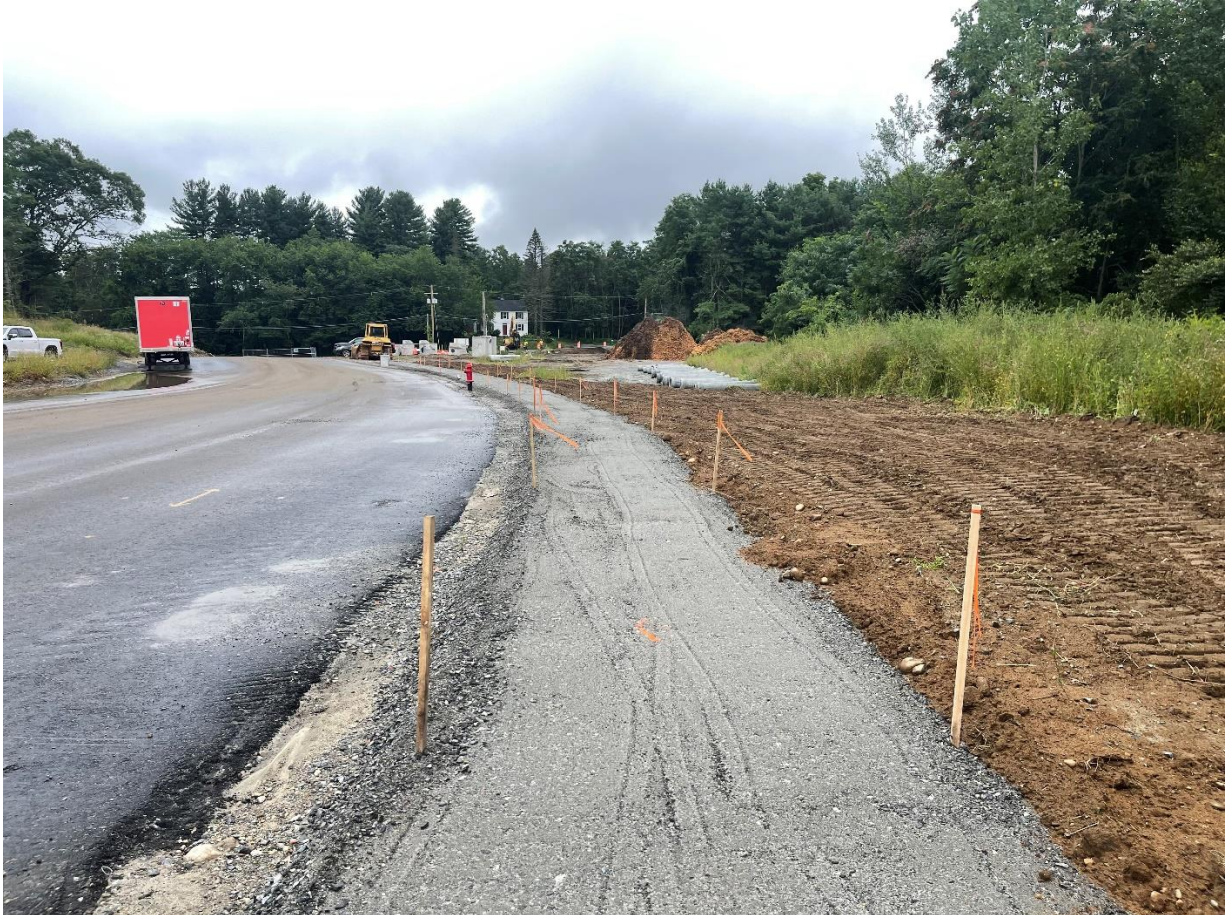
- Eight inches of dense grade crushed stone had been placed and compacted along the sidewalk from station 35+50 to approximately station 53+30. An approximately twelve-foot section was left without stone to allow access to offroad areas.

Photo 1: Dense grade crushed stone was placed and compacted along the sidewalk between stations 35+50 and 53+30.

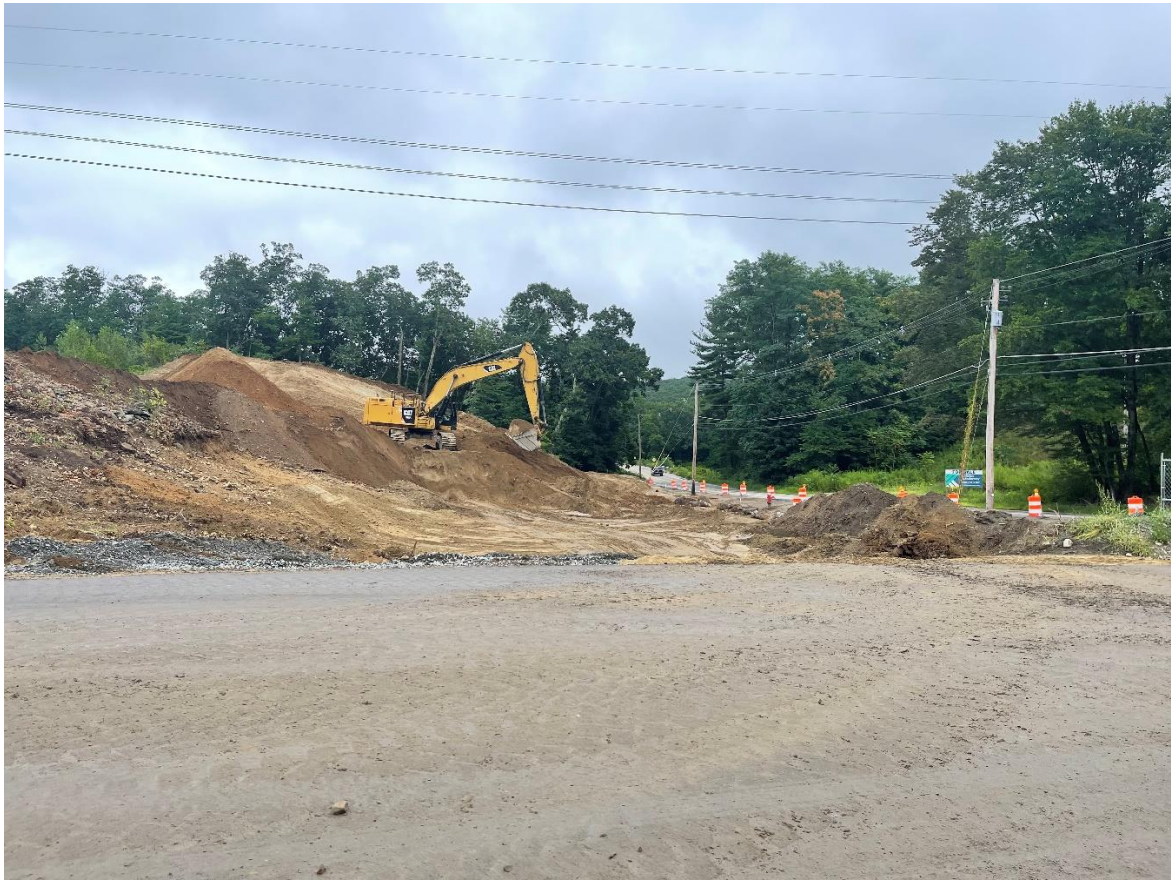
- Additional trees had been cleared at station 53+00.
- The contractor was excavating SWMA #4.

Photo 2: The contractor excavating SWMA #4.

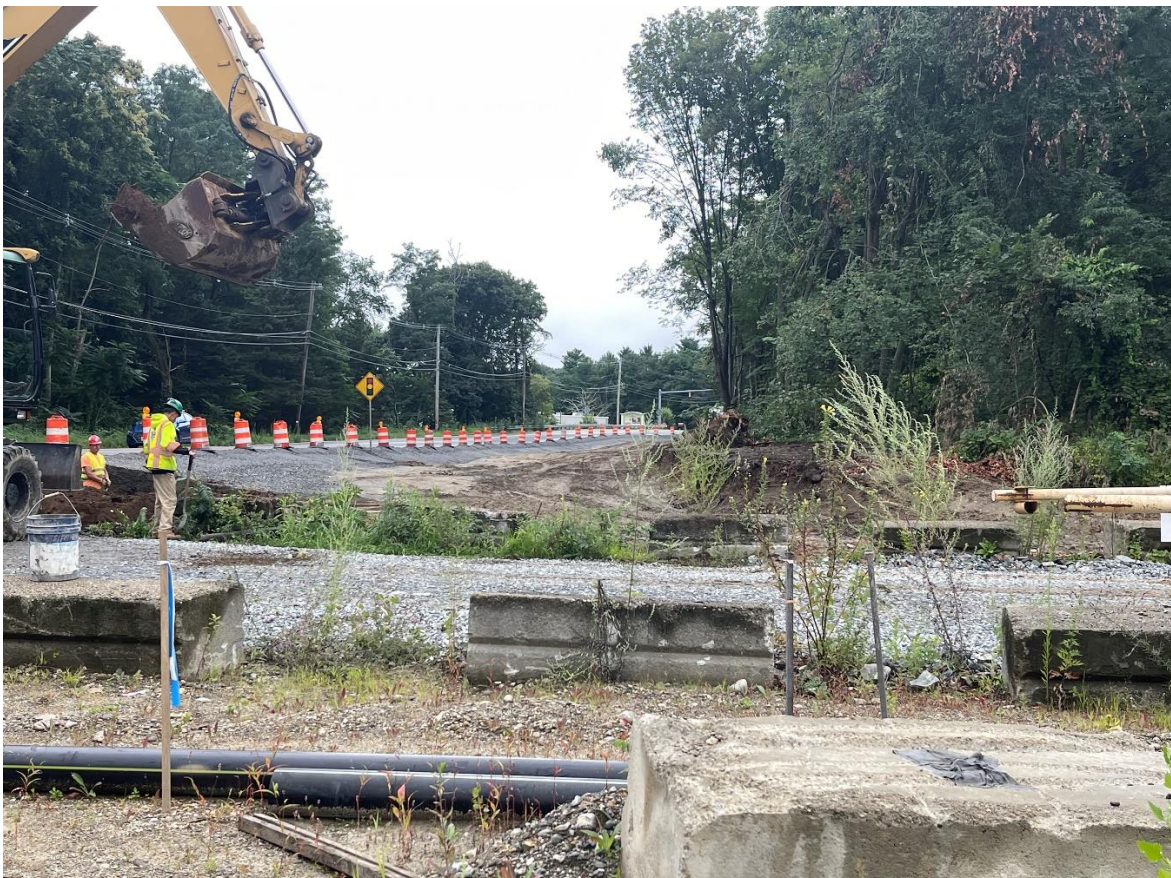
- Trees had been cleared from the areas adjacent to the site.
- The area for the roadway widening had been excavated. Dense grade crushed stone had been placed along the roadway side of the area to create a slope from the pavement to the earth material.

Photo 3: The area for the roadway widening along Boston Road had been excavated.

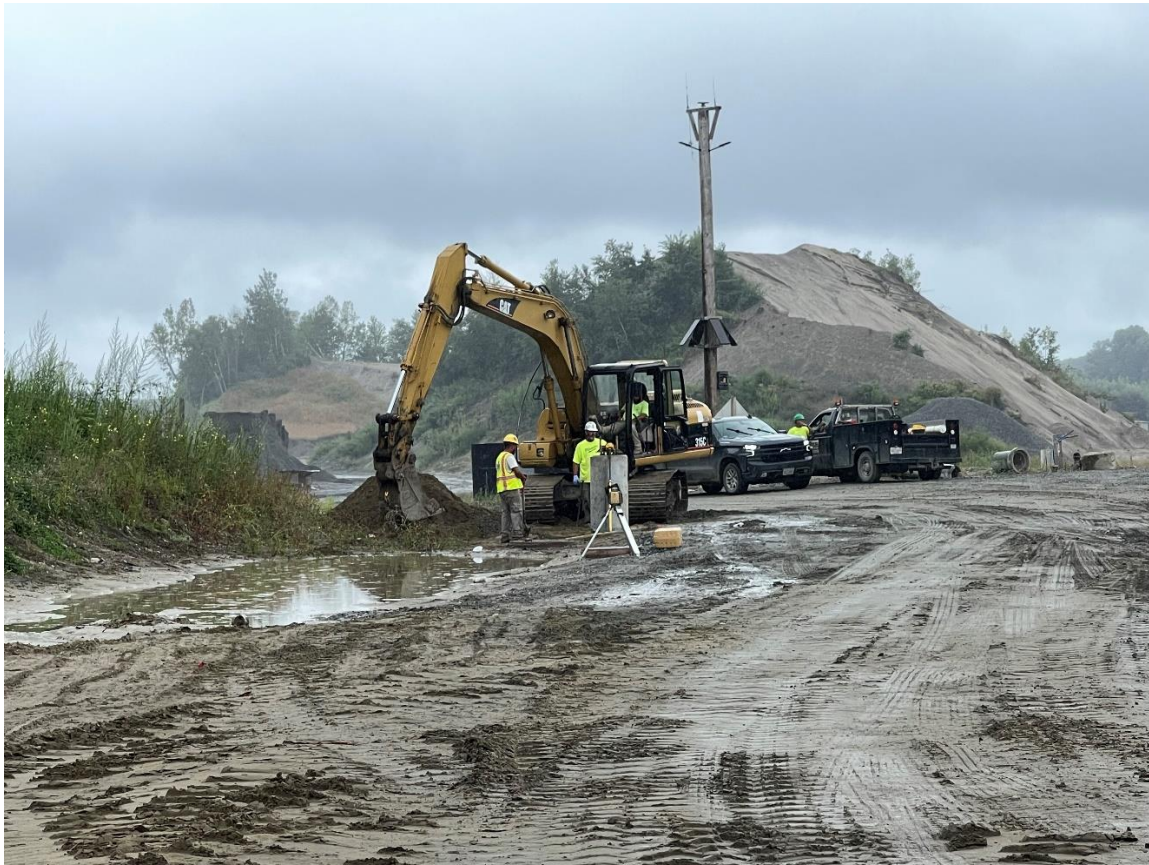
- Riprap had been installed at Drop Inlet (DI) 6A. Silt fence had been installed along the roadway side of the structure.
- The contractor was installing a light pole base at approximately station 23+50.

Photo 4: The contractor installing a light pole base at station 23+50.
