# Site Visit Report

**Date:** August 24, 2023  
**Client:** Sutton Planning Board  
**Project:** Unified Parkway  
**Contractor:** Walsh Contracting Corp.  
**Contractor Contact:** John Walsh

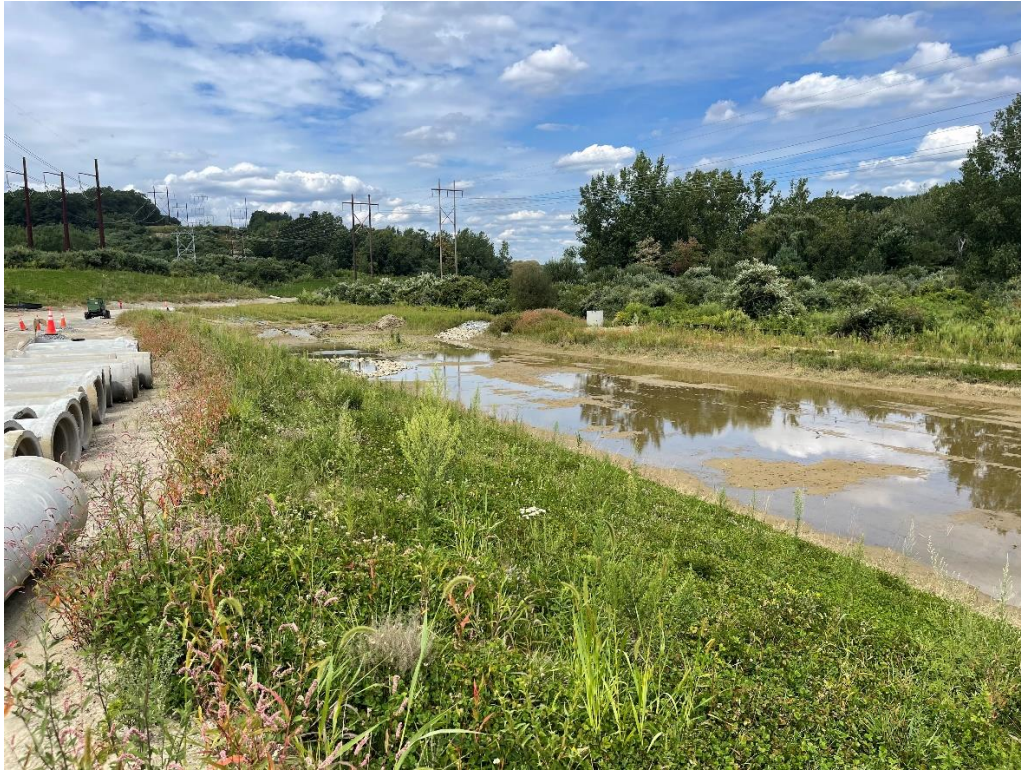
**Photo 1:** Water was being pumped from SWMA #3 to CB 210.

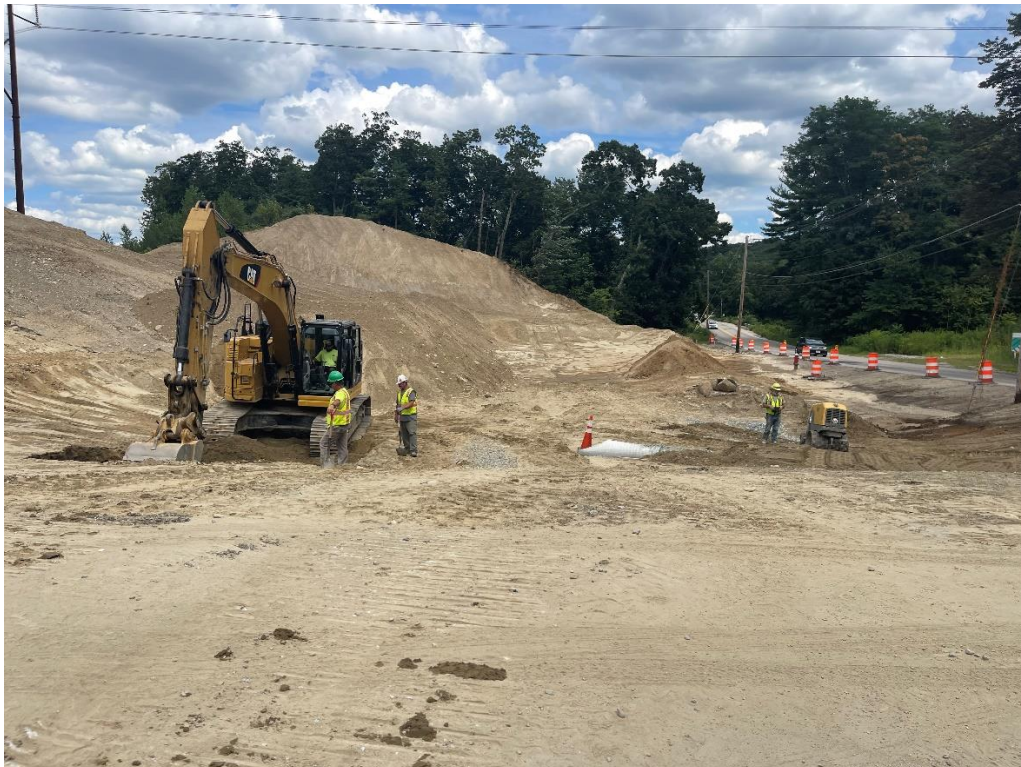
- The contractor continued excavating SWMA #4.
- Flared End Section (FE) 1 had been installed.
- The contractor was compacting backfill material over the 12-inch reinforced concrete pipe (RCP) from FE 1 towards Drain Manhole (DMH) 3 (part of the Boston Road modifications). GEI could not determine the length of this pipe.

**Photo 2:** The contractor excavating SWMA #4 and backfilling the drainage pipe.

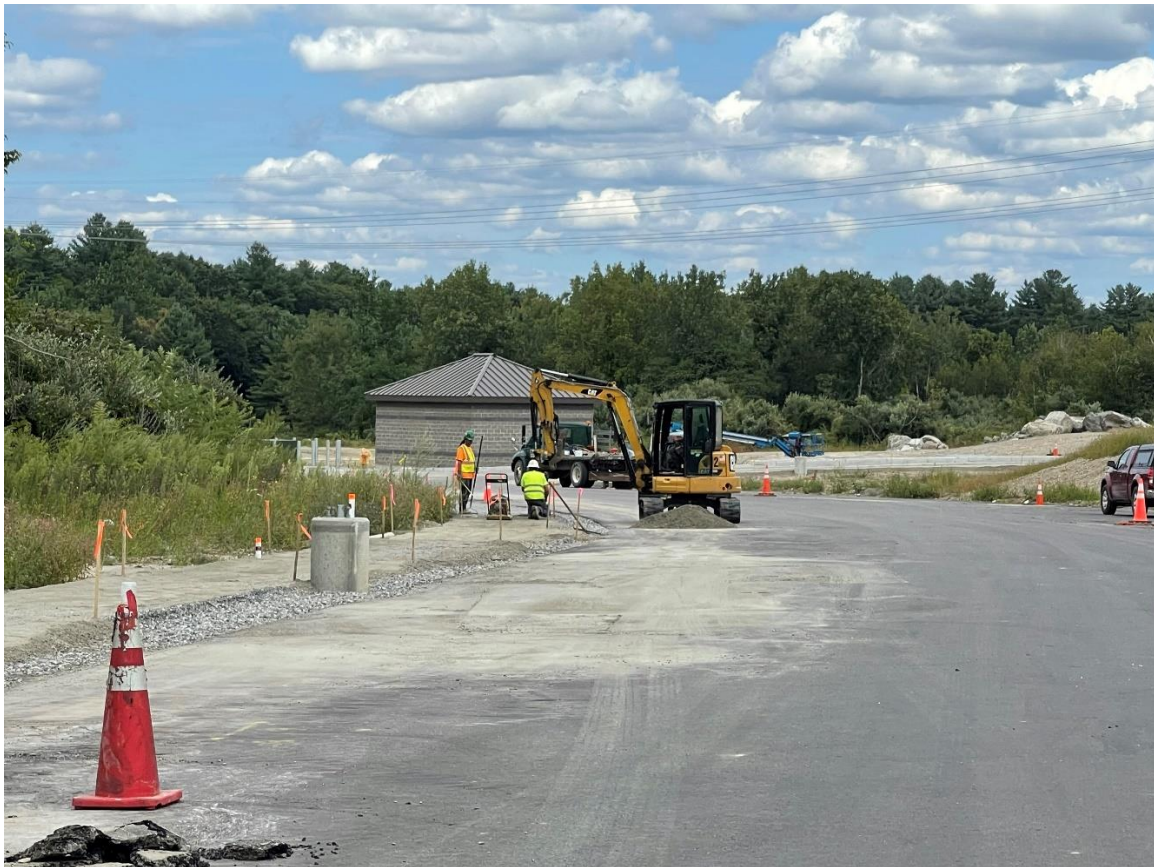
**Photo 3:** The contractor spreading dense grade crushed stone along the sidewalk.

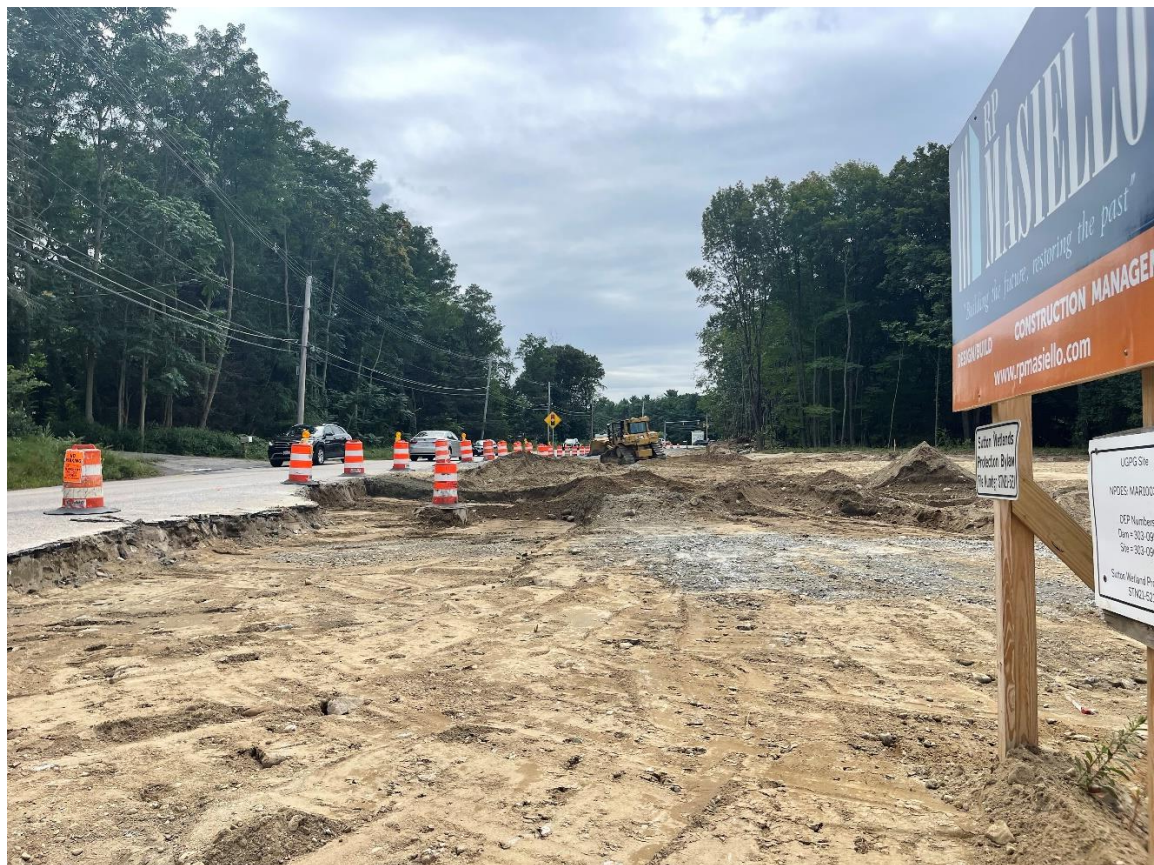
- The contractor was excavating and moving earth material throughout the modifications area west of the Boston Road entrance.

**Photo 4:** The contractor excavating and moving earth material in the Boston Road modification area west of the entrance.
