# Site Visit Report

**Date:** August 9, 2023  
**Client:** Sutton Planning Board  
**Project:** Unified Parkway  
**Contractor:** Walsh Contracting Corp.  
**Contractor Contact:** John Walsh

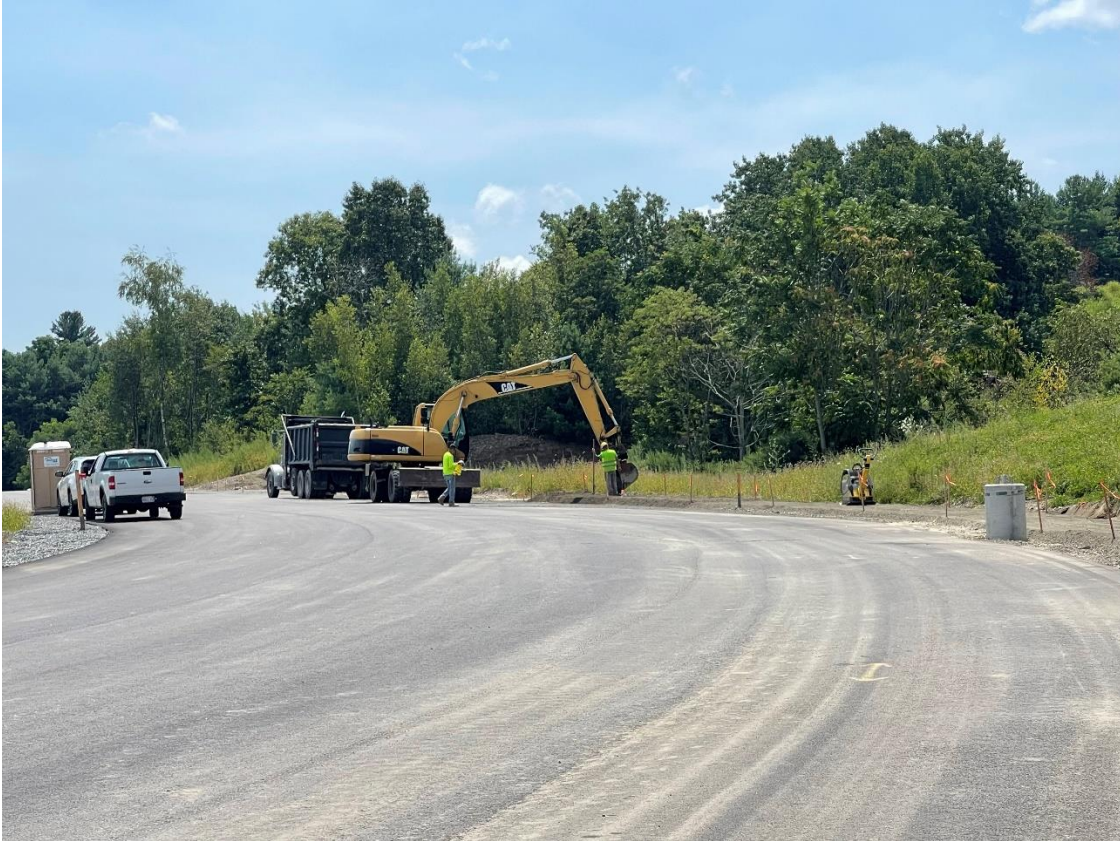
- The contractor was placing eight inches of dense grade crushed stone along the sidewalk between stations 37+00 and 46+00.
- The contractor was clearing trees at station 53+00. Cleared trees were being stored at the Boston Road entrance.

**Photo 1:** The contractor placing dense-graded crushed stone at station 46+00.

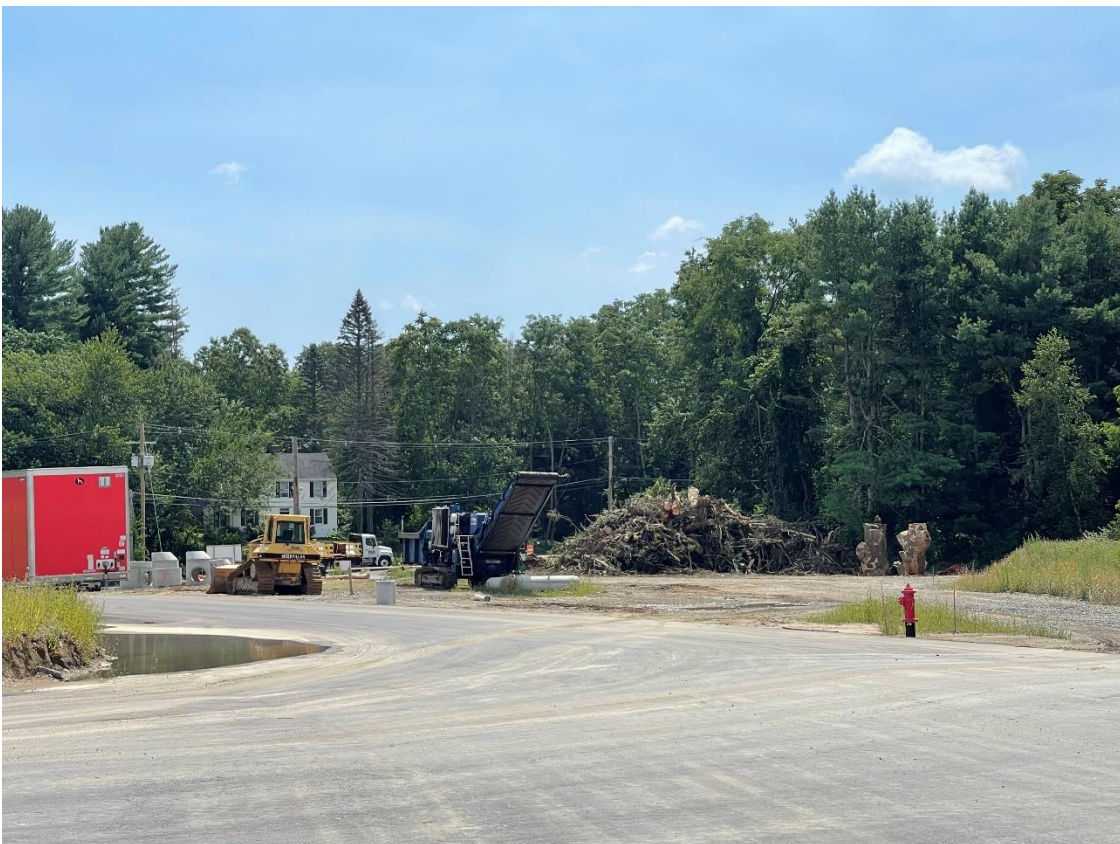
**Photo 2:** Cleared trees were stockpiled at the Boston Road entrance.
