Site Visit Report

Date: February 14, 2023
Client: Sutton Planning Board
Project: Unified Parkway
Contractor: Walsh Contracting Corp.
Contractor Contact: John Walsh

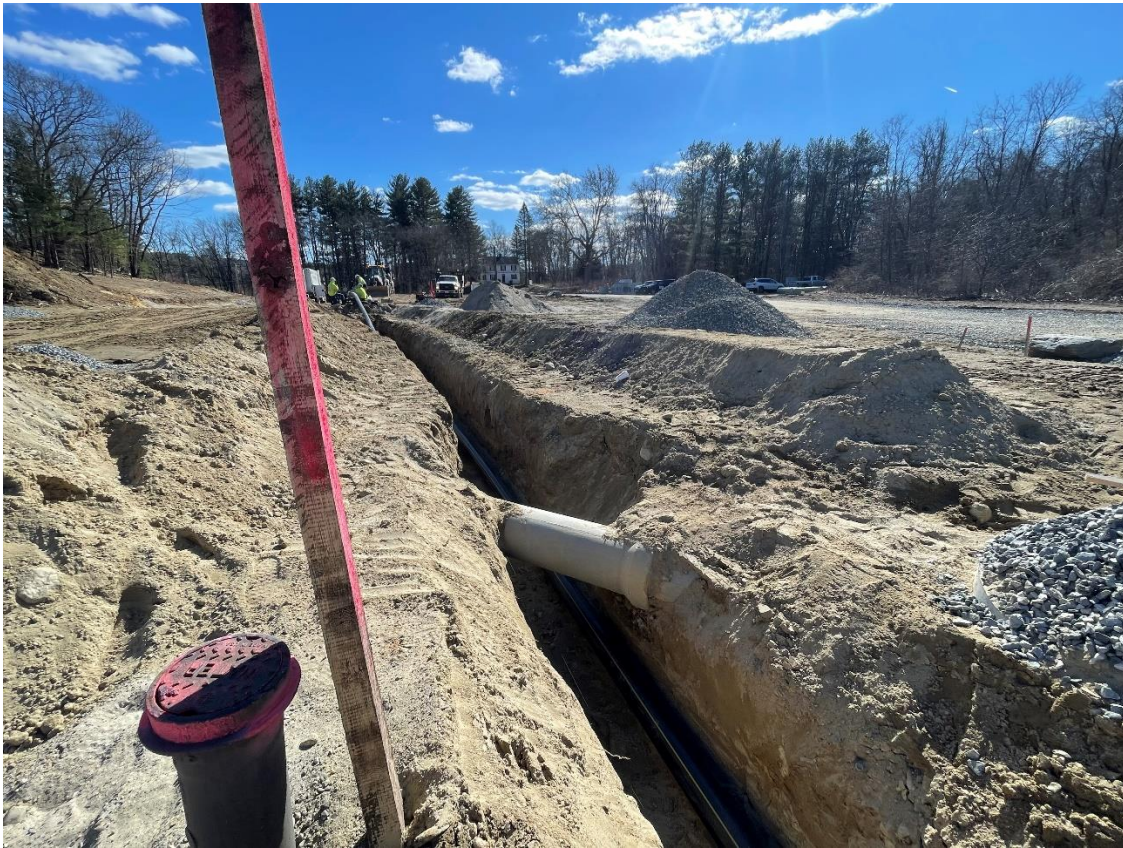
Photo 1: At approximately station 53+75, the contractor was installing gas utility pipe. There was approximately six inches of space between the drainage pipe and gas pipe.

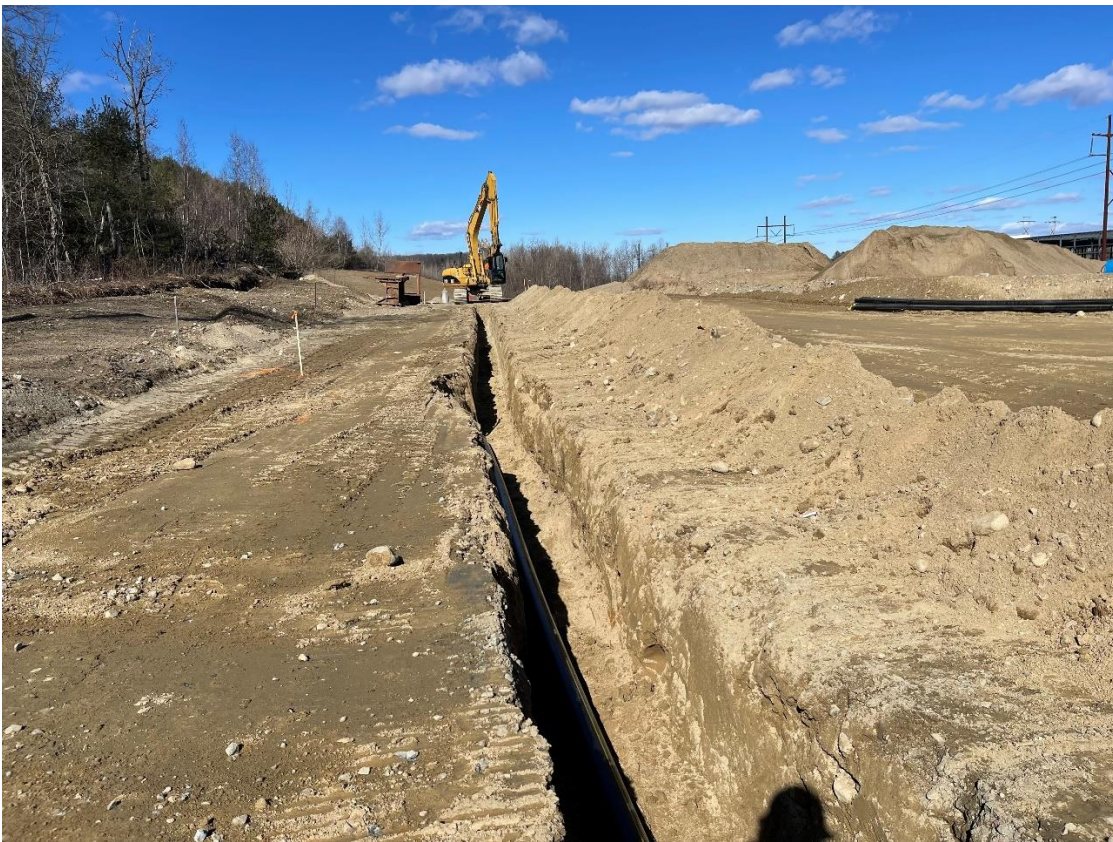
Photo 2: The gas utility pipe had been installed until station 51+00. At station 50+00, the contractor was excavating the utility trench.
