Site Visit Report

Date: November 3, 2023
Client: Sutton Planning Board
Project: Unified Parkway
Contractor: Walsh Contracting Corp.
Contractor Contact: John Walsh

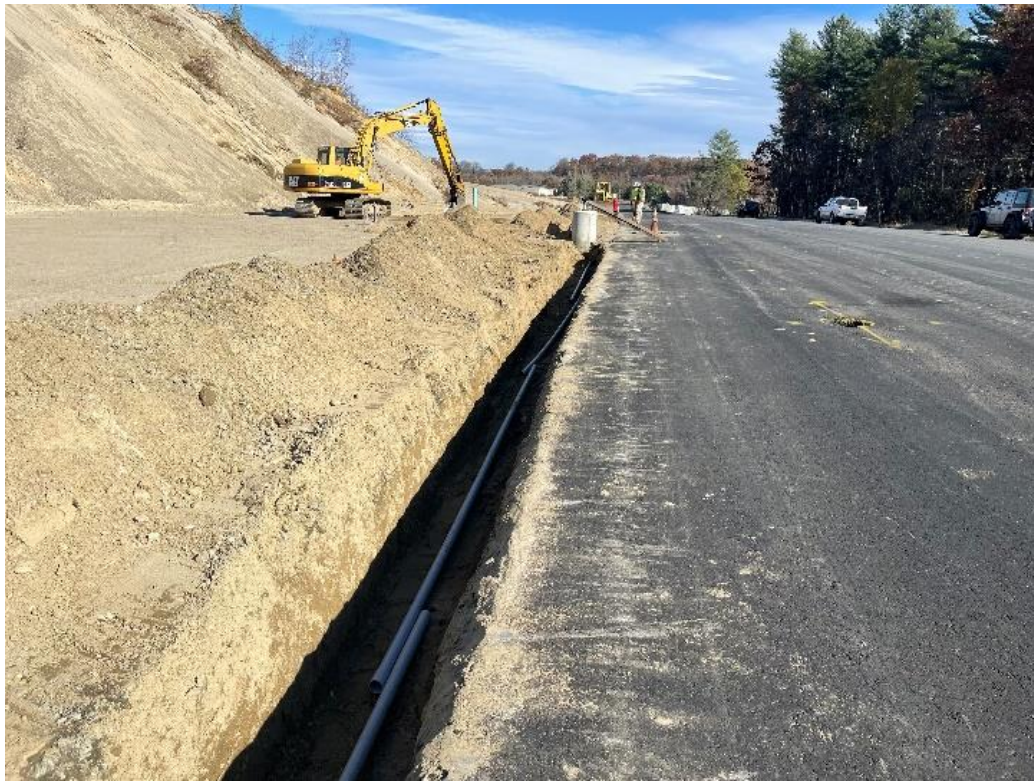
- The previously excavated portions of roadway at station 32+00 and 52+50 had been backfilled and repaved.
- The contractor was performing work on the utility pole at station 2+00, and was installing electrical conduit between approximately stations 15+00 and 23+00.
- Between stations 32+00 and 35+50, the location of the sidewalk had been prepared for installation.

Photo 1: The contractor installing electrical conduit between stations 15+00 and 23+00.

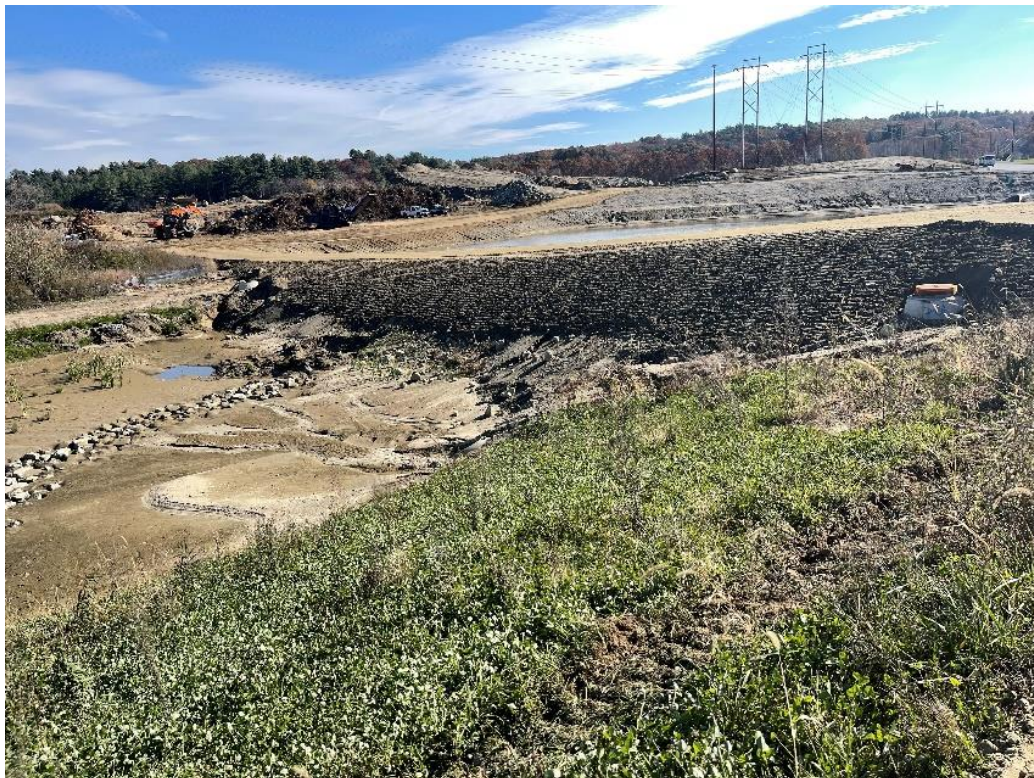
Photo 2: Loam had been placed along the southern slope of SWMA #3, and the erosion rills were repaired.

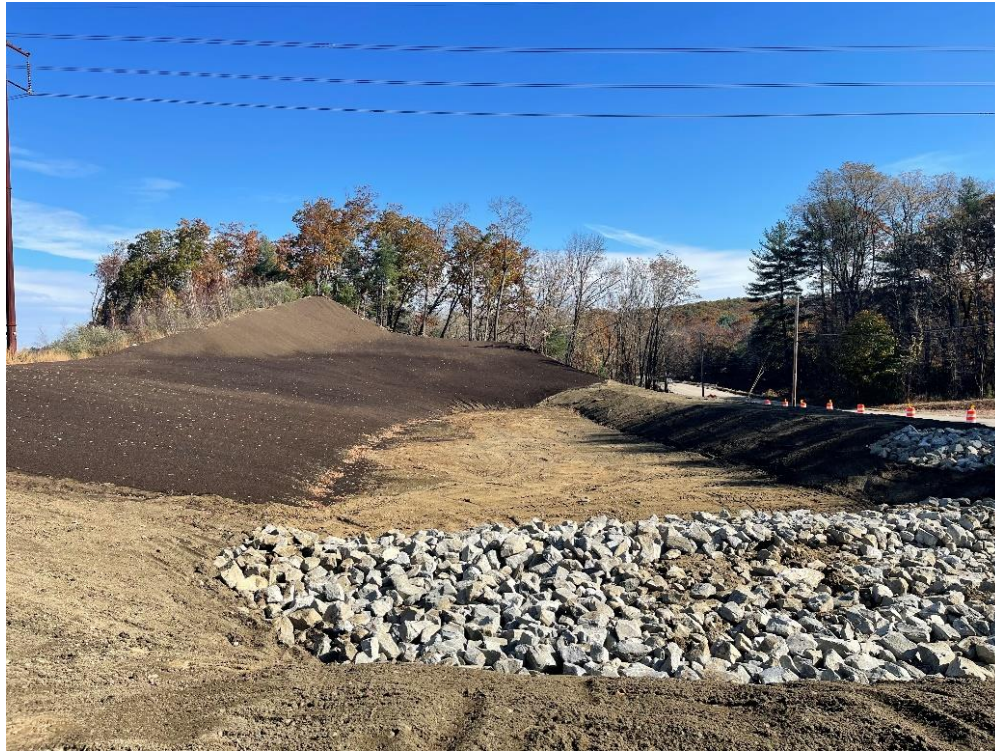
- Stormwater Management Areas (SWMAs) #1, #2, and #3 were dry. SWMA #3 had been mowed.
- Loam had been placed along the northern and eastern slopes of SWMA #4, as well as along the berm.
- The erosion rills along the northern and eastern slopes of SWMA #4 had been repaired.
- The forebay and emergency spillway of SWMA #4 had been installed.
- The following structures had been installed:

Photo 3: Loam had been placed along the northern and eastern slopes of SWMA #4, as well as the berm. The forebay and emergency spillway stones are also visible.
