# Site Visit Report

<b>Date:</b>	June 27, 2023	<b>Prepared By:</b>	Olivia Caton
<b>Client:</b>	Sutton Planning Board	<b>Arrived on site:</b>	11:00 AM
<b>Project:</b>	Unified Parkway Lots 2 and 3	<b>Left site:</b>	12:00 PM
<b>Contractor:</b>	Walsh Contracting Corp.	<b>Site Conditions:</b>	Slightly Damp
<b>Contractor Contact:</b>	John Walsh	<b>Weather:</b>	73°, Overcast/Lightly Raining

<b>Date:</b>	June 29, 2023	<b>Prepared By:</b>	Olivia Caton
<b>Client:</b>	Sutton Planning Board	<b>Arrived on site:</b>	11:00 AM
<b>Project:</b>	Unified Parkway Lots 2 and 3	<b>Left site:</b>	11:50 AM
<b>Contractor:</b>	Walsh Contracting Corp.	<b>Site Conditions:</b>	Dry/Slightly Damp
<b>Contractor Contact:</b>	John Walsh	<b>Weather:</b>	72°, Mostly Sunny

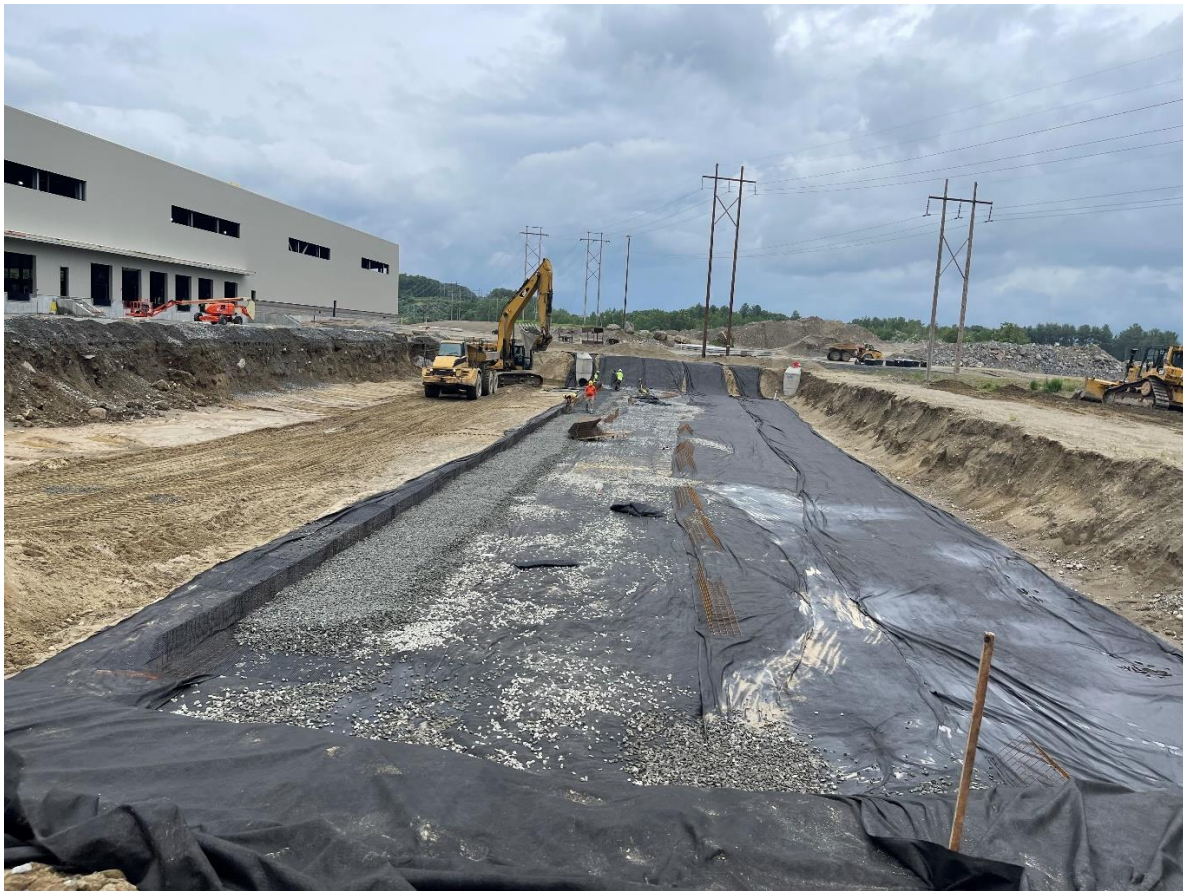
**Photo 1:** Geotextile fabric was placed along the bottom, northern, and southern sides of the eastern portion of SWMA UG3c.

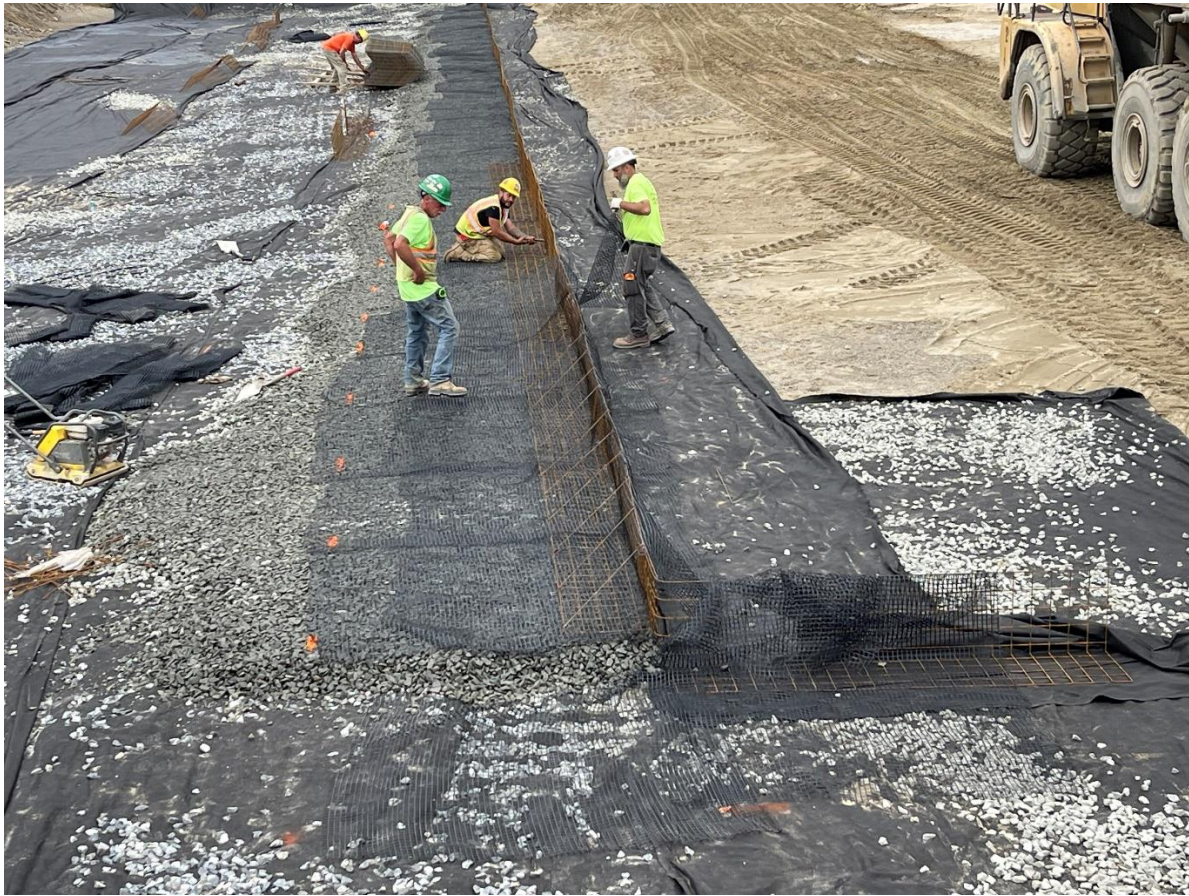
**Photo 2:** The contractor installing the second row of wire baskets.

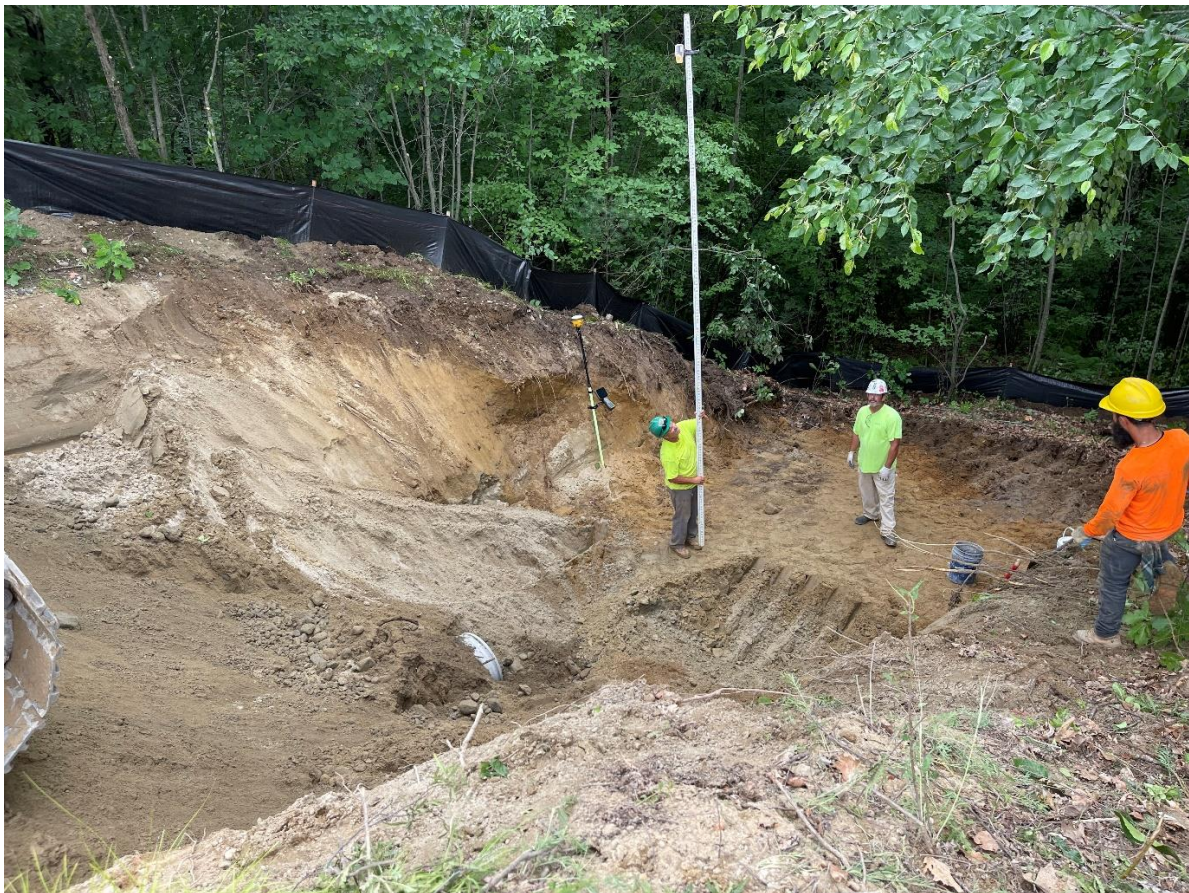
**Photo 3:** The contractor confirming elevations adjacent to the end of the pipe past DMH 506.

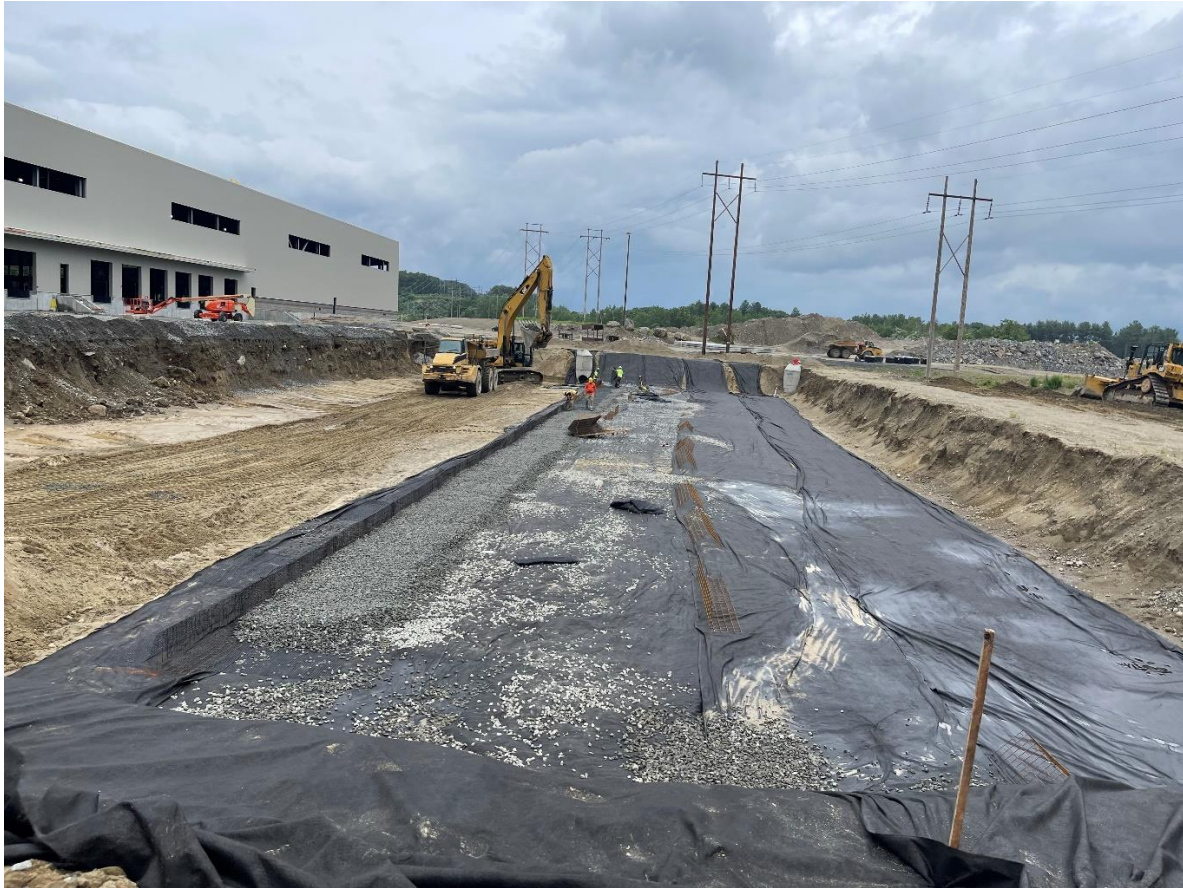
**Photo 1:** Geotextile fabric was placed along the bottom, northern, and southern sides of the eastern portion of SWMA UG3c.

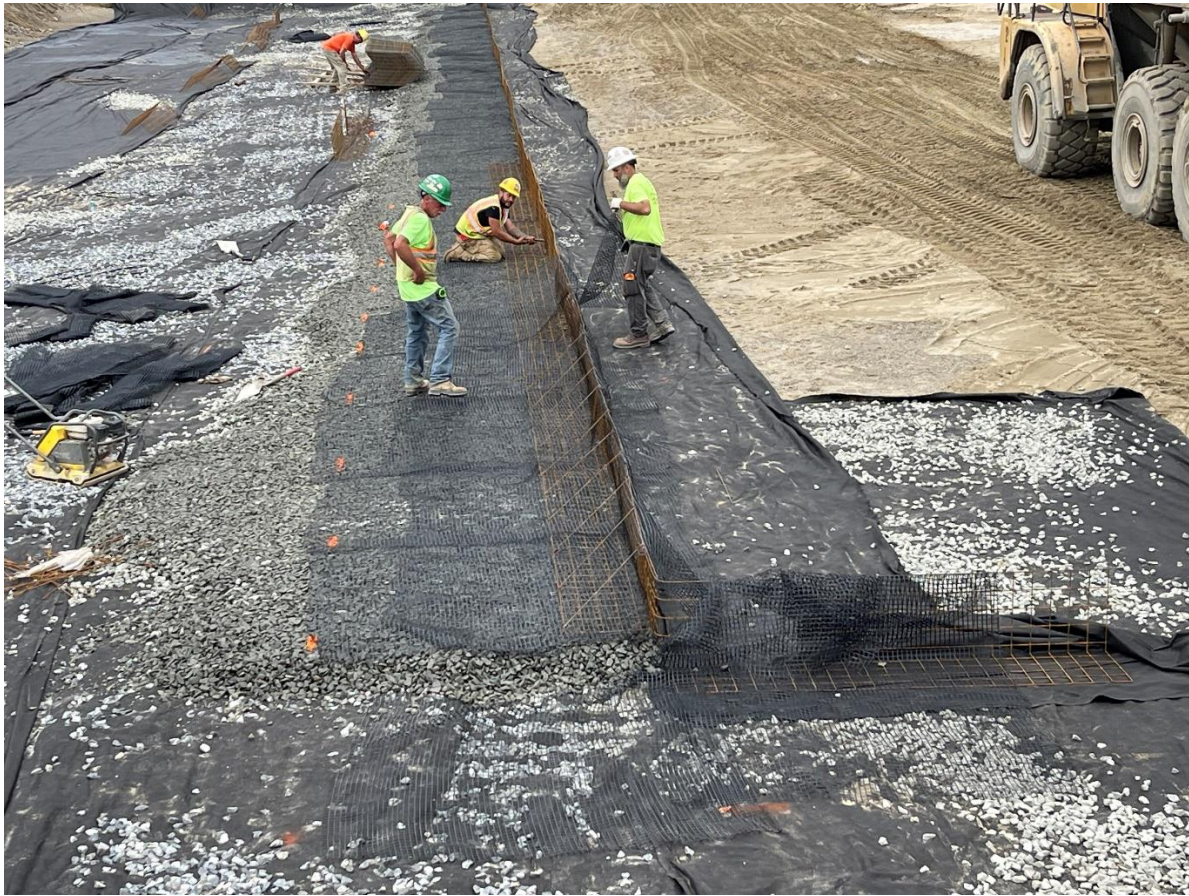
**Photo 2:** The contractor installing the second row of wire baskets.

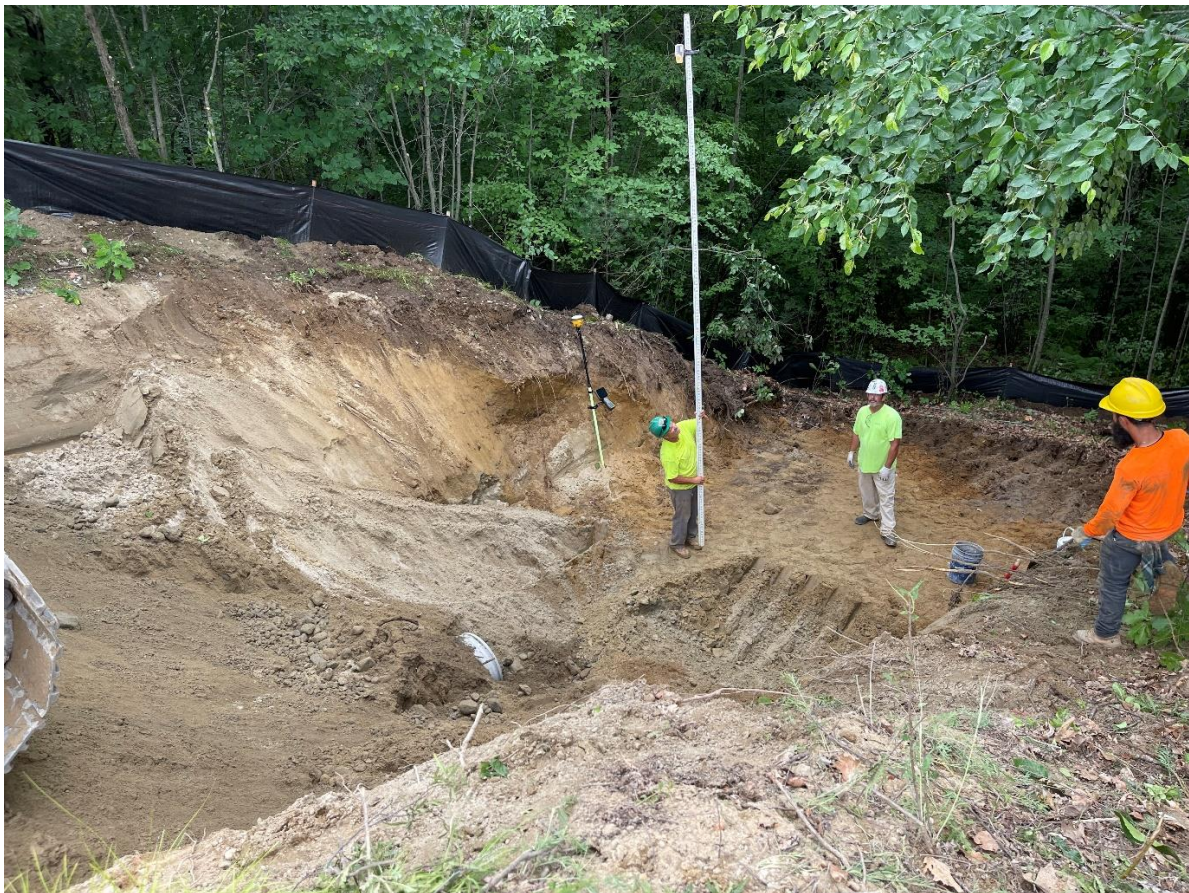
**Photo 3:** The contractor confirming elevations adjacent to the end of the pipe past DMH 506.

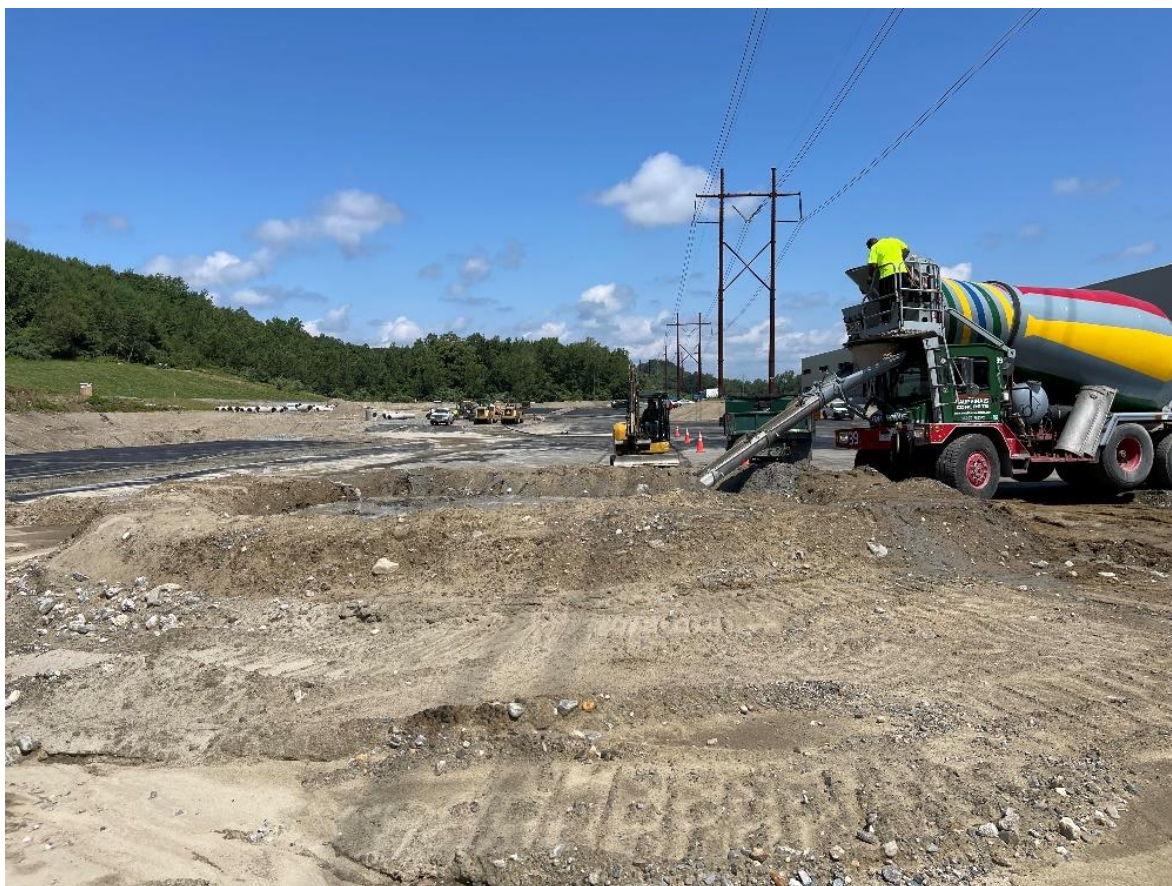
**Photo 1:** The contractor cleaning a concrete truck in the southern corner of the western parking lot.

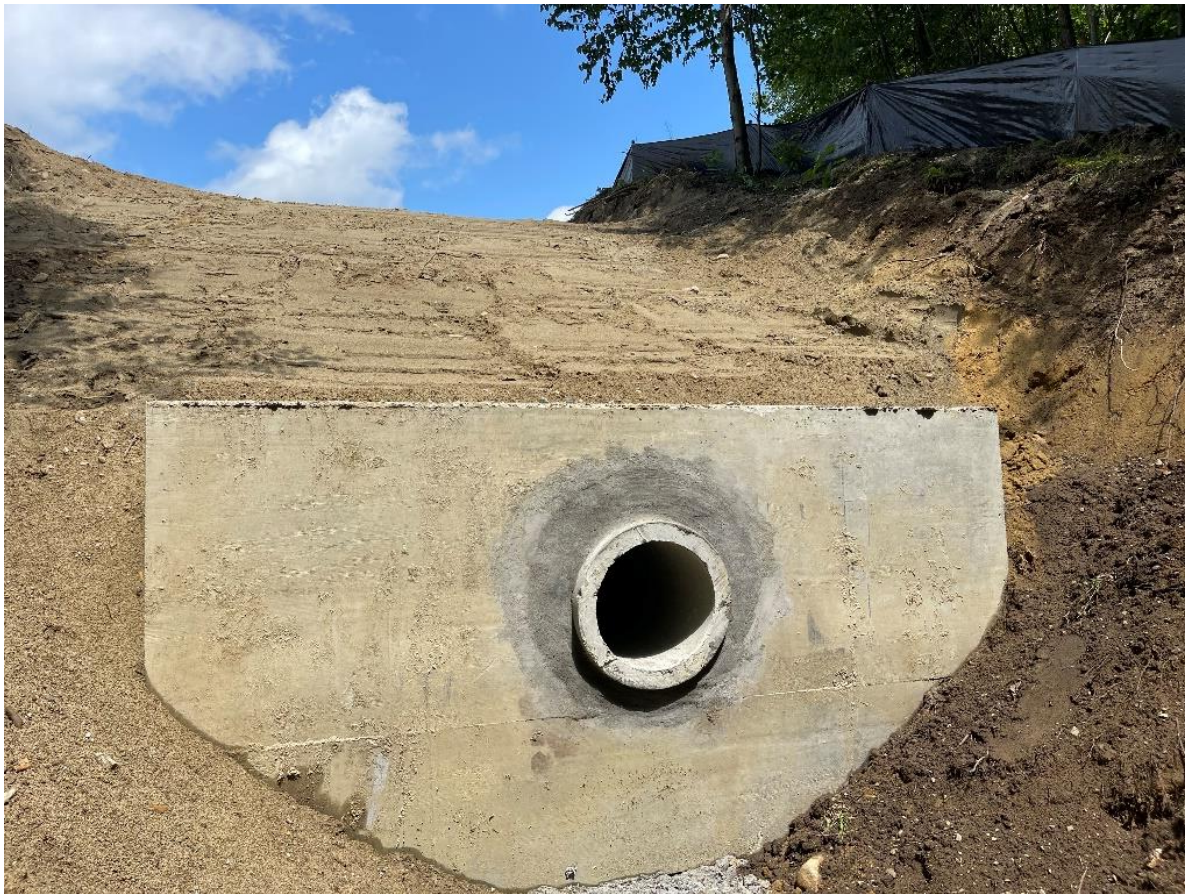
- Headwall (HW) 500 had been installed.
- The pipe connection at HW 500 had been sealed with mortar.

**Photo 2:** HW 500 was installed and its pipe connection sealed with mortar.

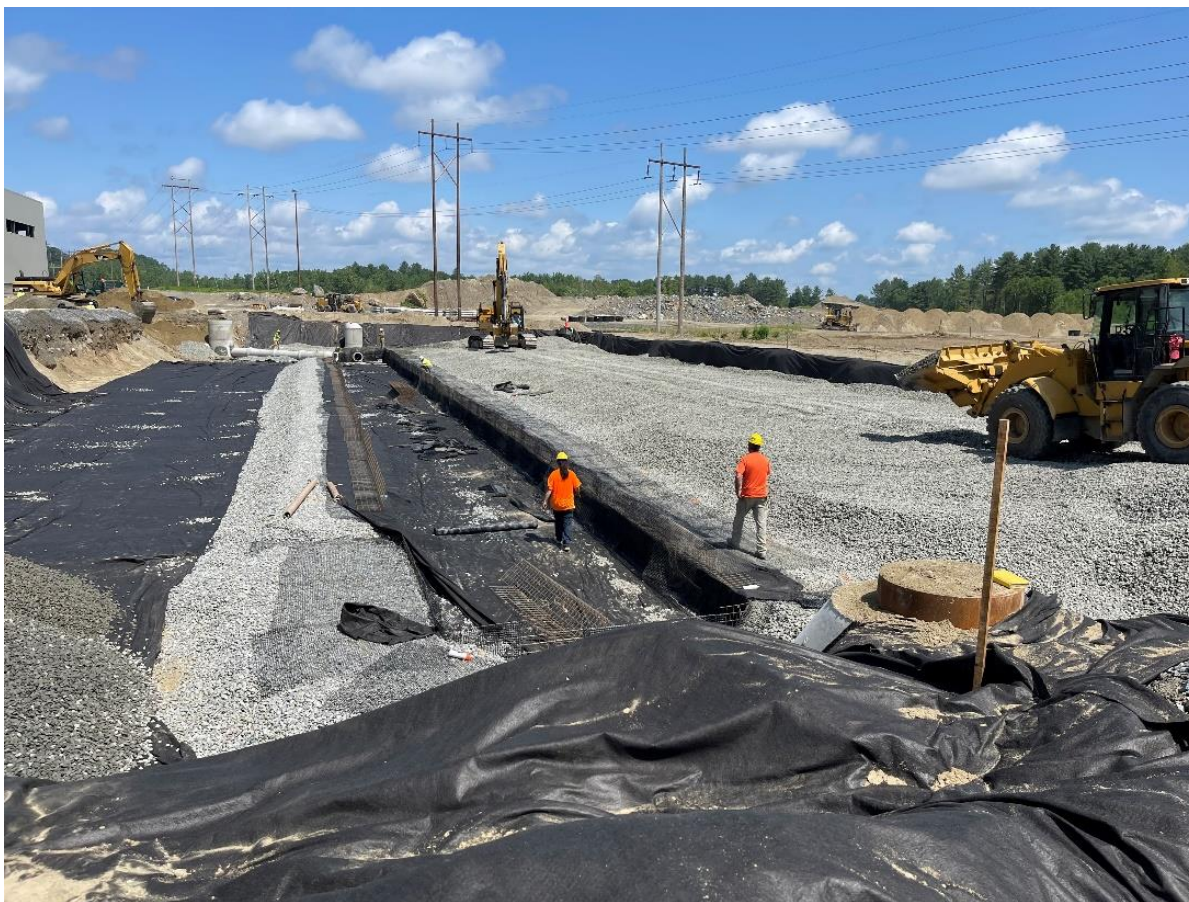
**Photo 3:** Overall progress of SWMA UG3c.
