Site Visit Report

Date:	December 20, 2022	Prepared By:	Olivia Caton
Client:	Sutton Planning Board	Arrived on site:	11:15 AM
Project:	Unified Parkway Lots 2 and 3	Left site:	11:45 AM
Contractor:	Walsh Contracting Corp.	Site Conditions:	Dry/Slightly Damp
Contractor Contact:	John Walsh	Weather:	34°, Clear

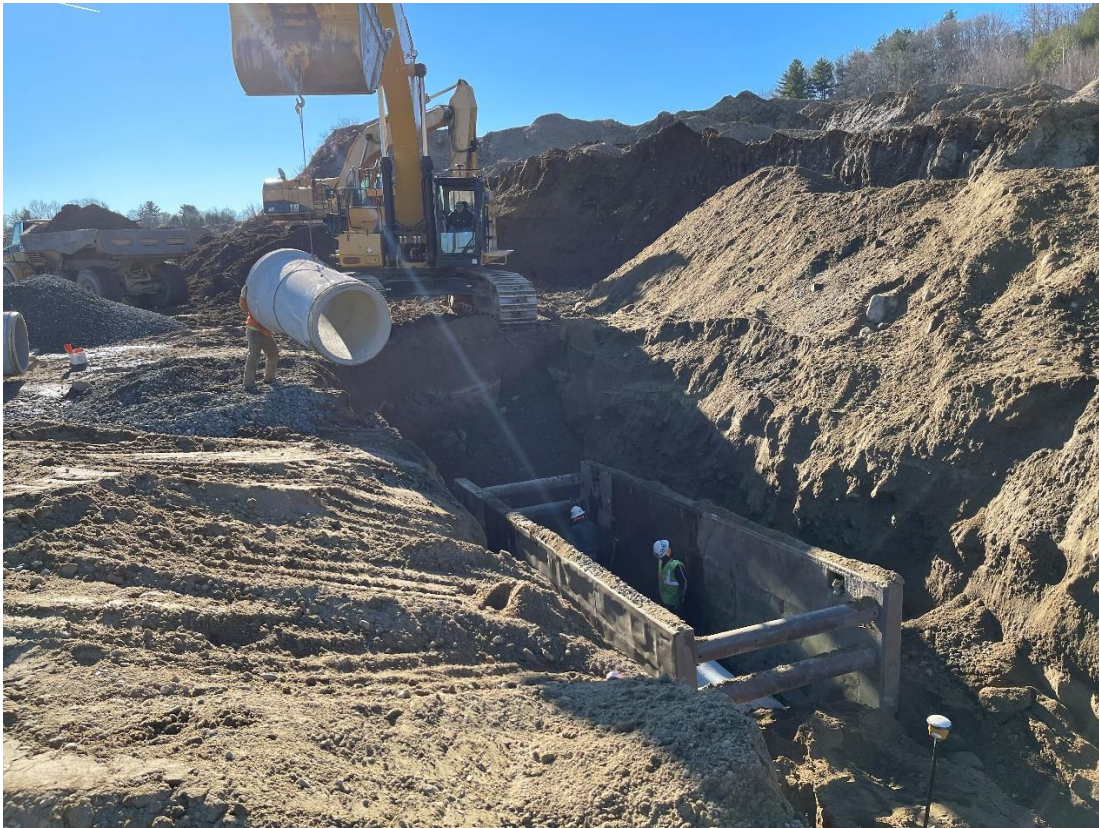
- The pipe installed between DMH 605 and DMH 604 had been backfilled and was no longer visible. The first 180 feet of pipe extending from DMH 604 towards DMH 603 was backfilled, and the remaining length of pipe was partially backfilled.
- The contractor installed 16 feet of additional pipe between DMH 604 and DMH 603, then chinked the pipe with bedding material consisting of three-quarter-inch crushed stone.
- The connections between DMH 604 and the pipes were sealed with mortar.

Photo 1: The contractor installed 16 feet of 36-inch RCP between DMH 604 and DMH 603.

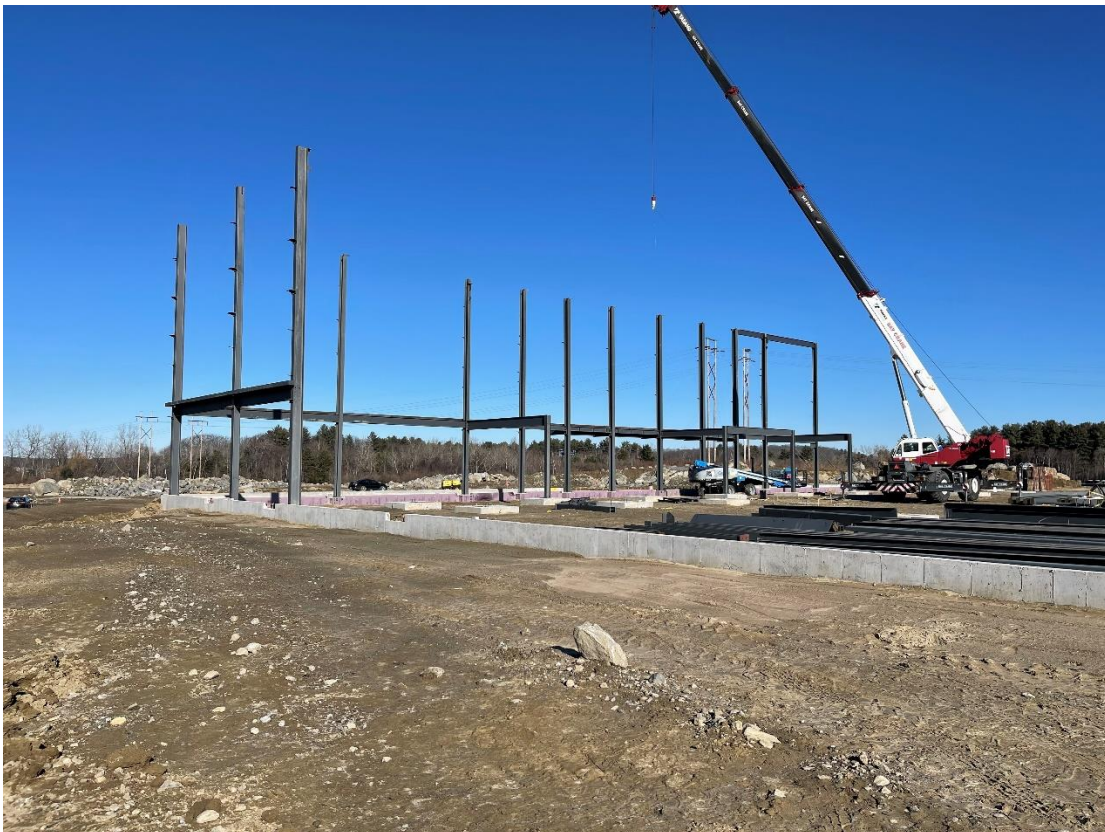
- The contractor continued installing the foundation of Building 3. Construction had begun on a portion of the building frame.
- The contractor was moving earth material north of Sewer Manhole (SMH) 111.
- The previously installed electrical conduit pipe near Drain Manhole (DMH) 701 had been backfilled.

Photo 2: Construction began on the frame of Building 3.
