# Site Visit Report

<b>Date:</b>	January 4, 2022	<b>Prepared By:</b>	Olivia Caton
<b>Client:</b>	Sutton Planning Board	<b>Arrived on site:</b>	12:45 PM
<b>Project:</b>	Unified Parkway Lots 2 and 3	<b>Left site:</b>	1:15 PM
<b>Contractor:</b>	Walsh Contracting Corp.	<b>Site Conditions:</b>	Damp
<b>Contractor Contact:</b>	John Walsh	<b>Weather:</b>	45°, Overcast

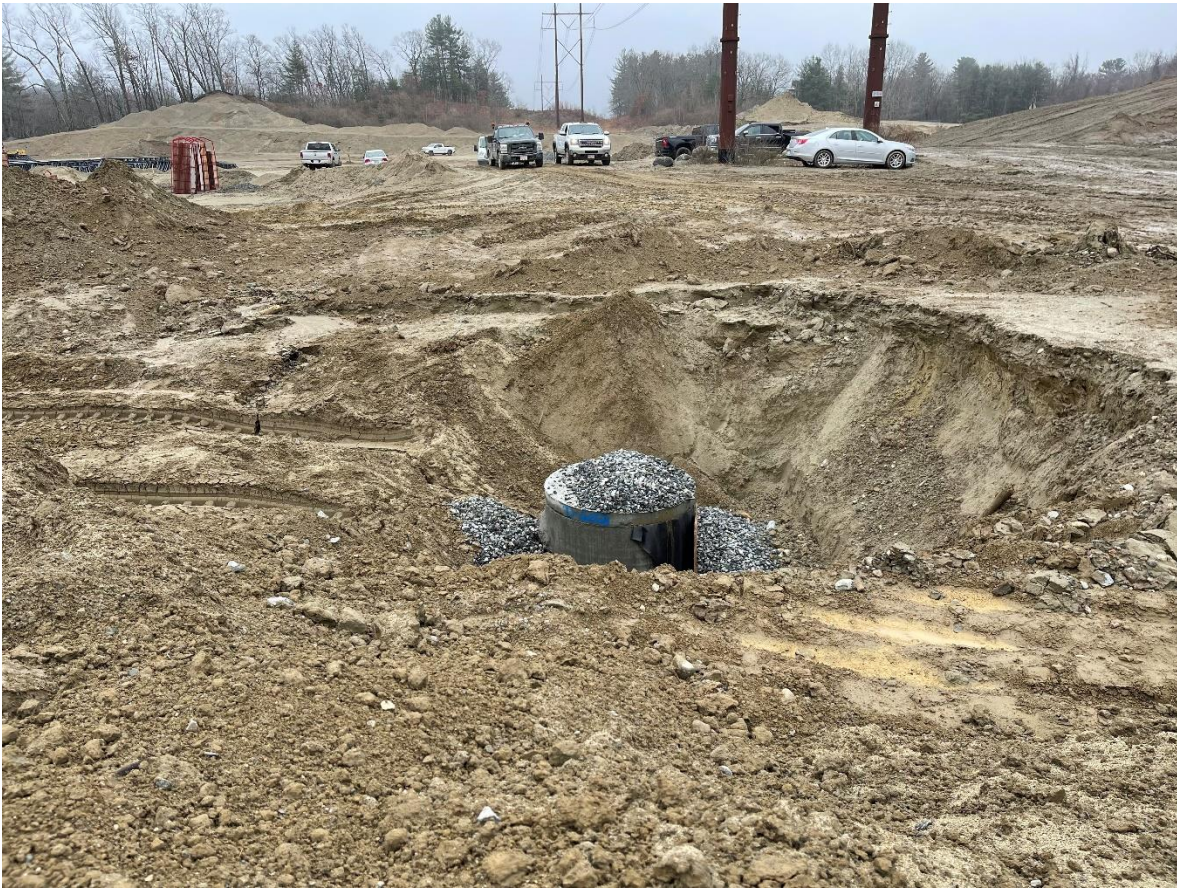
**Photo 1:** DMH 602 had been installed.

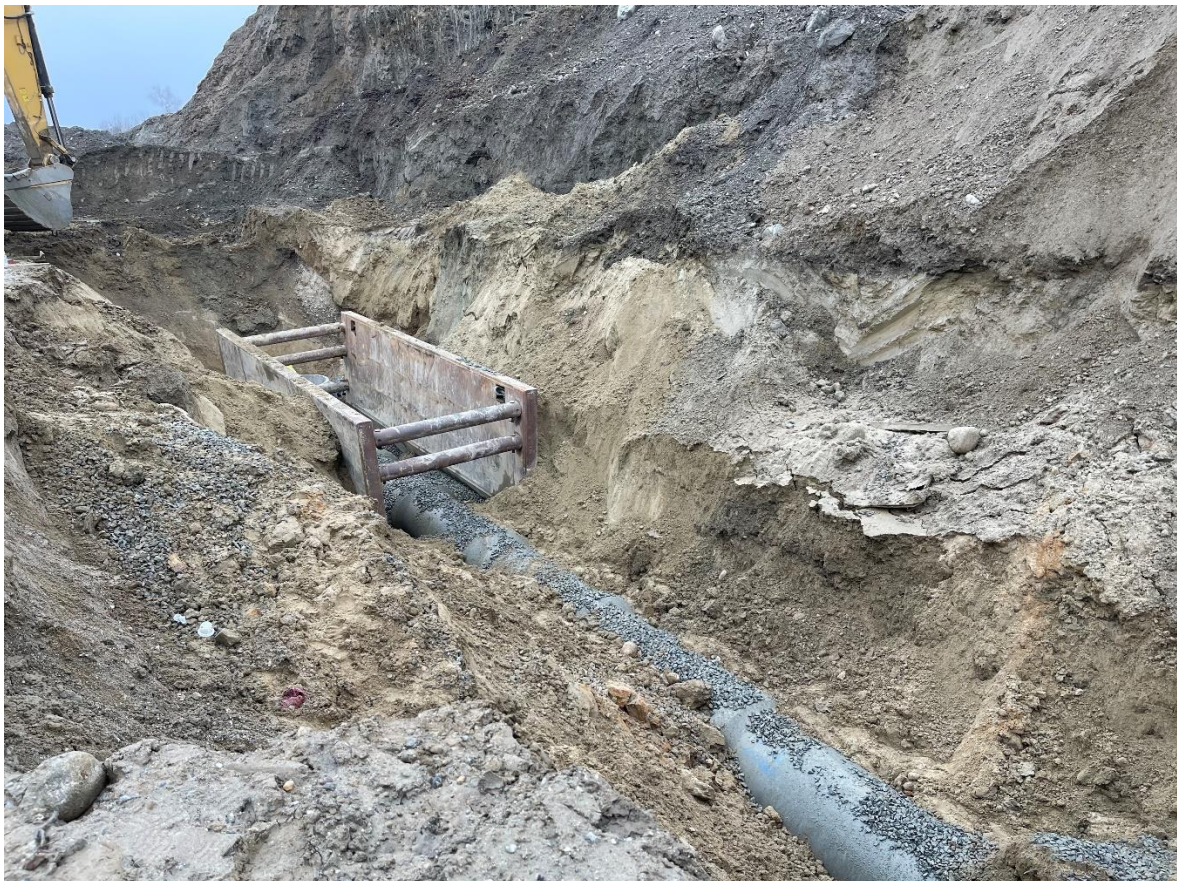
- The pipe between DMH 603 and DMH 601 was chinked with three-quarter-inch crushed stone, and backfill material placed along the sides of the pipe. The pipe between RD 600 and DMH 602 was completely backfilled.

**Photo 2:** Approximately 80 feet of 24-inch RCP was installed and chinked between DMH 603 and DMH 601.
