Site Visit Report

Date:	July 26, 2023	Prepared By:	Olivia Caton
Client:	Sutton Planning Board	Arrived on site:	11:45 AM
Project:	Unified Parkway Lots 2 and 3	Left site:	12:20 PM
Contractor:	Walsh Contracting Corp.	Site Conditions:	Dry/Slightly Damp
Contractor Contact:	John Walsh	Weather:	78°, Hazy

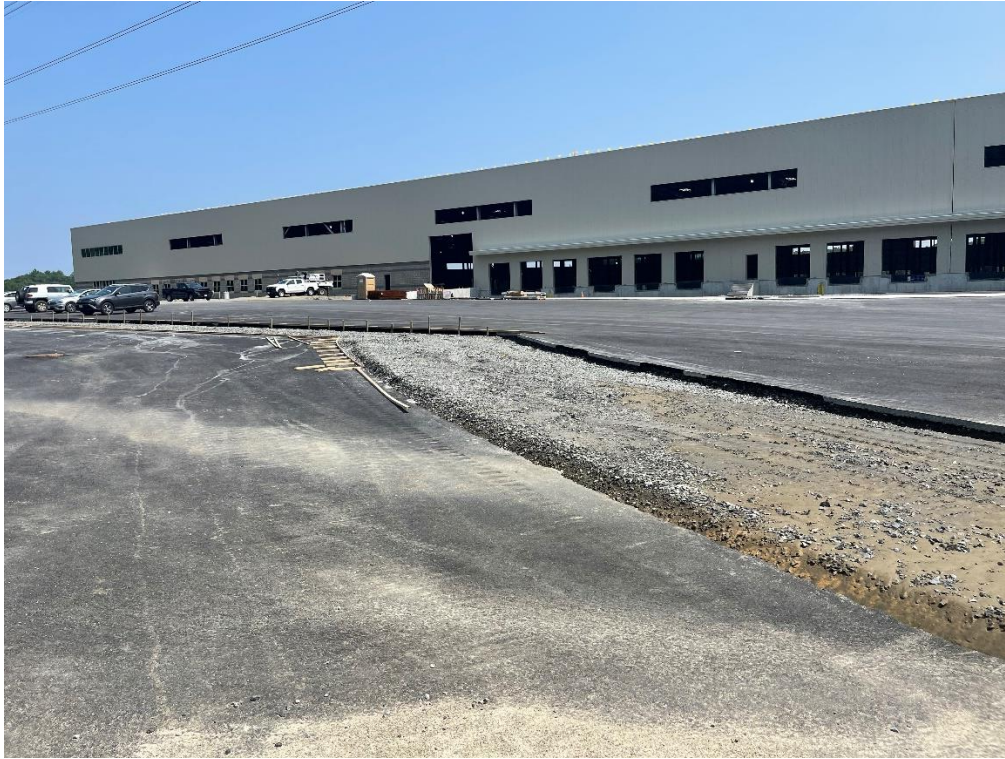
- The contractor continued work on Building 3.
- The concrete pads in the southern portion of the western parking lot had been installed. The areas for the pads in the northern portion of the parking lot had been prepared.

Photo 1: The areas for the concrete pads in the northern portion of the western lot had been prepared.

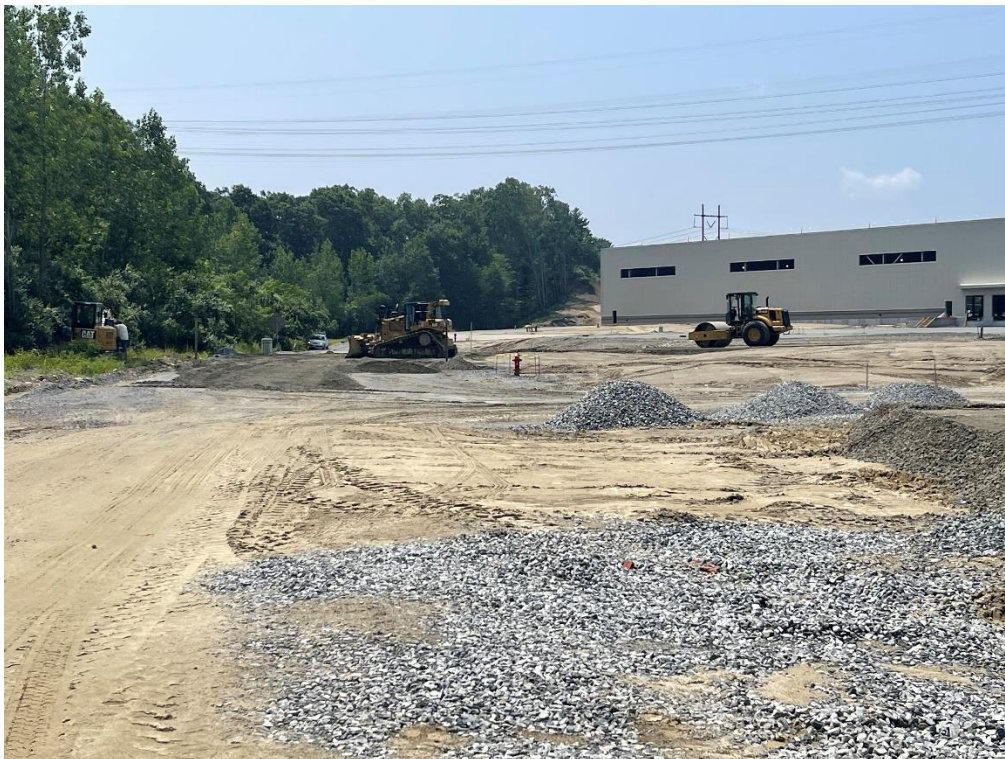
- The contractor was spreading and compacting dense-graded crushed stone along the roadways throughout the northeastern corner of Lot 3. The dense-graded crushed stone was compacted with a plate compacter, and larger areas compacted with a 10-ton roller.

Photo 2: The contractor placing and compacting dense-graded crushed stone.

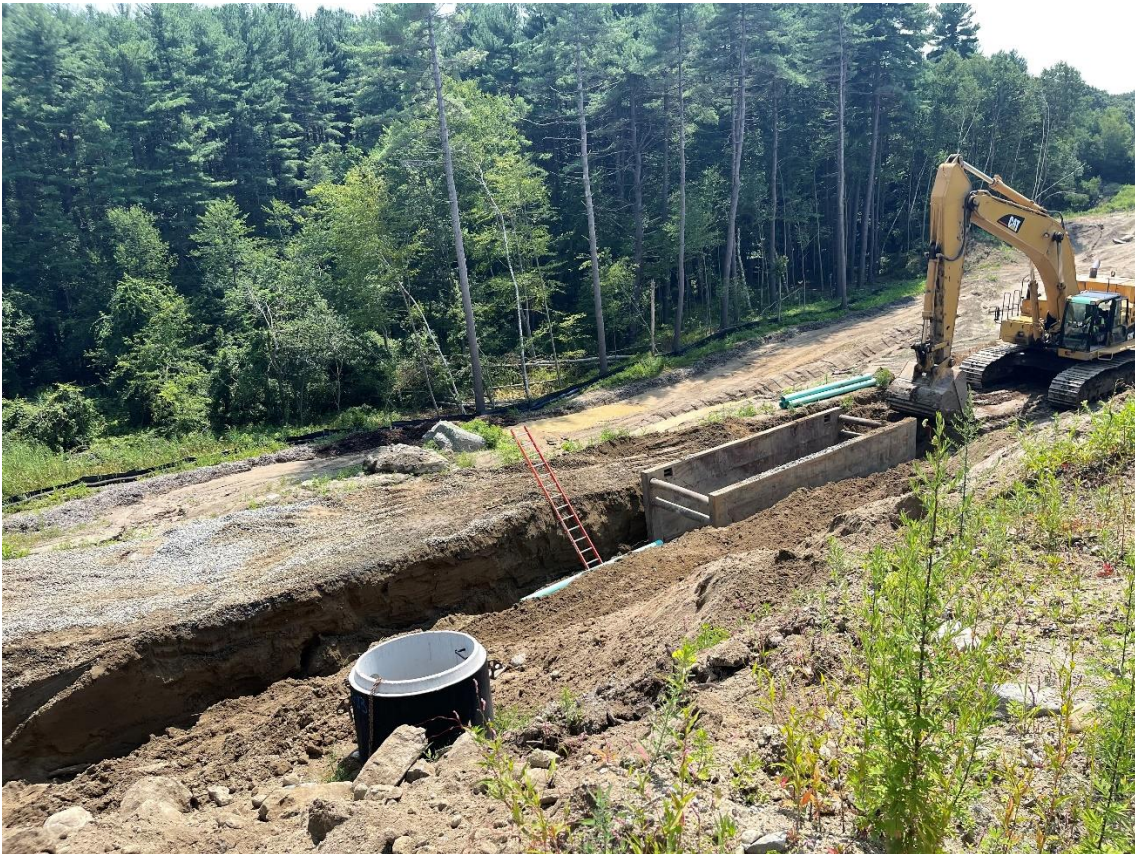
- Approximately 90 feet of 8-inch PVC pipe had been installed from Sewer Manhole (SMH) 107 towards SMH 108. The contractor was excavating the trench beyond the end of the pipe.

Photo 3: The contractor excavating the trench beyond the end of the pipe extending from SMH 107.

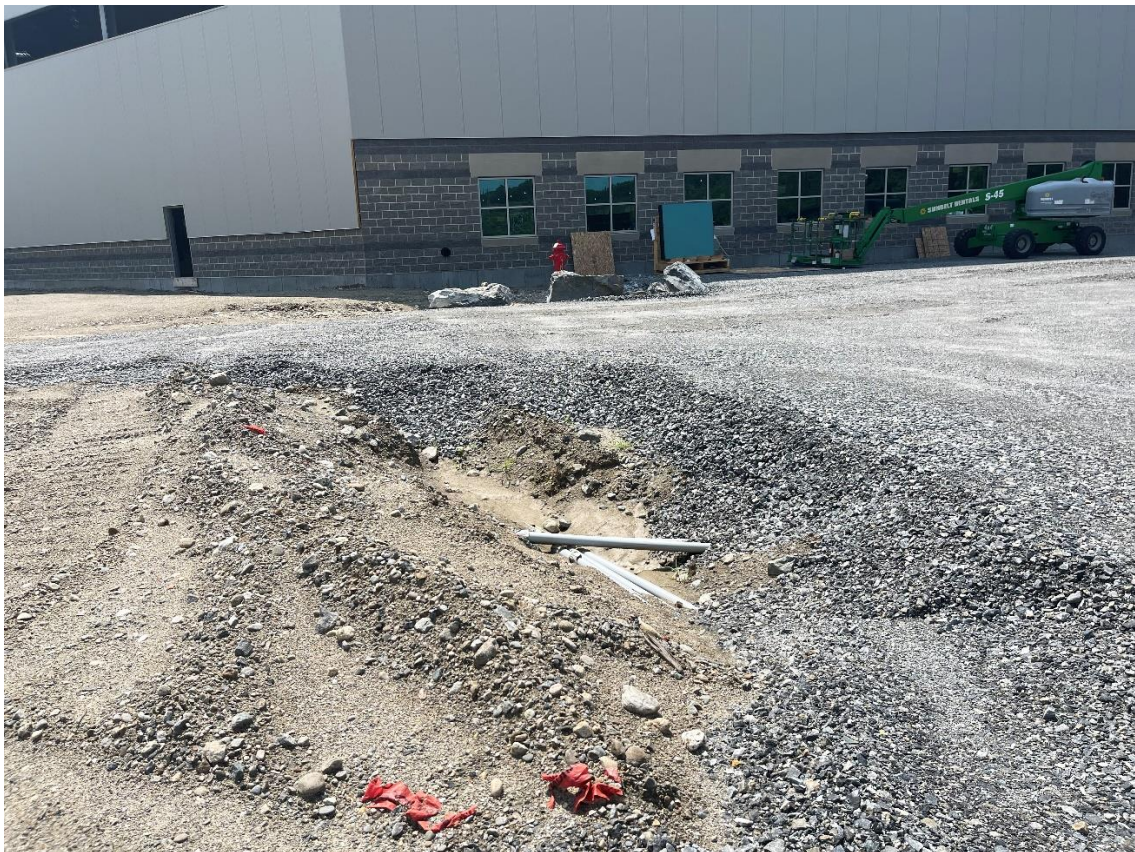
- The contractor was moving earth material along the southern side of the southern driveway on Lot 3.
- Near the northeastern corner of Building 3, a portion of utility pipes was uncovered. The uncovered pipes need to be marked to avoid damaging them and covered.

Photo 4: Near the northeastern corner of Building 3, utility pipes were uncovered.

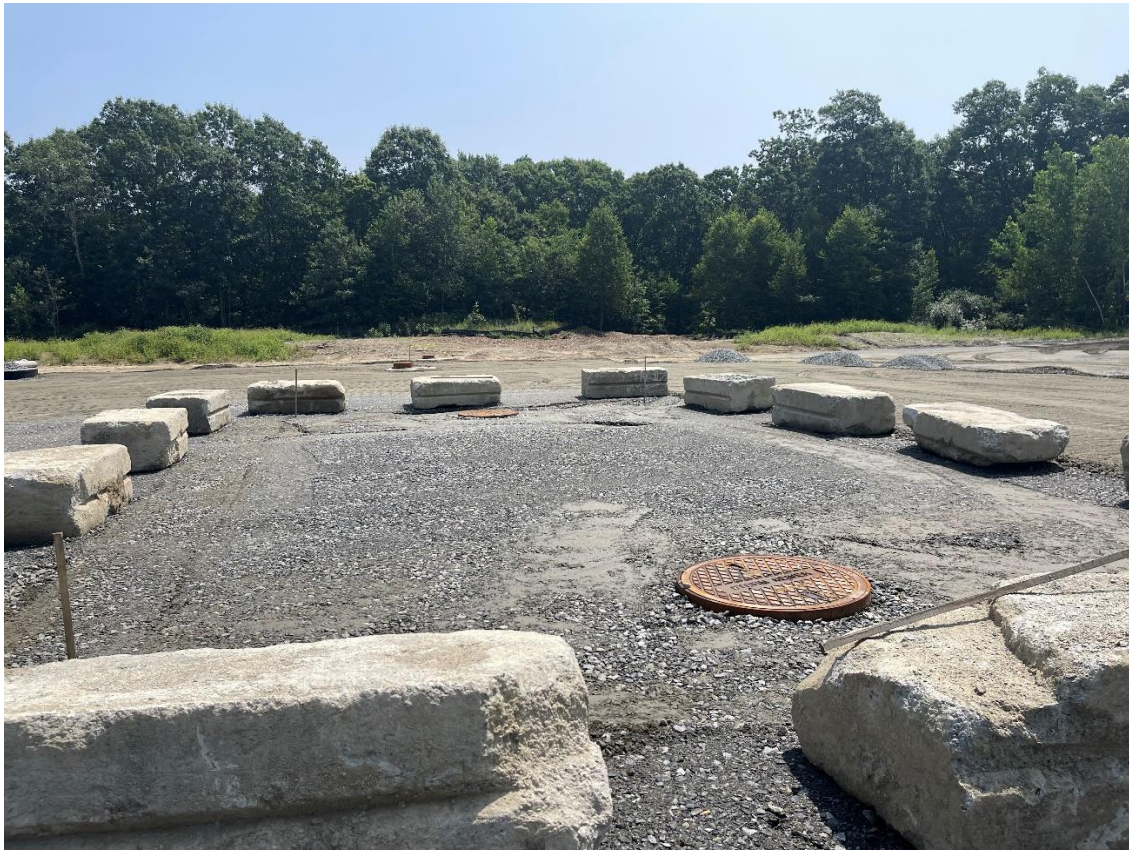
- The SWMA had been covered with compacted dense-graded crushed stone and was no longer visible.
- Two access manholes had been installed and backfilled until only their frames and covers were visible.
- Several large blocks were placed around where the subsurface vault is located.

Photo 5: SWMA UG2e was covered in compacted dense-graded crushed stone. Two access manholes had been installed.
