Site Visit Report

Date: October 27, 2022
Client: Sutton Planning Board
Project: Unified Parkway
Contractor: Walsh Contracting Corp.
Contractor Contact: John Walsh

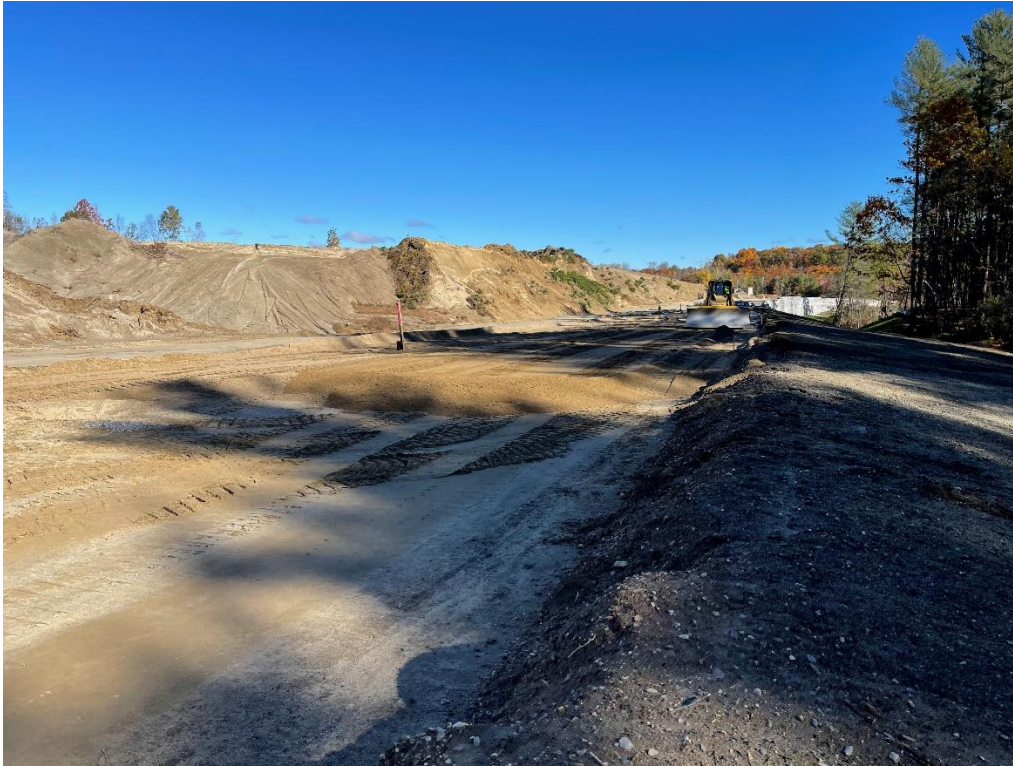
Photo 1: Between stations 8+00 and 8+50 the contractor was spreading a one-foot lift of backfill material across the right-of-way.

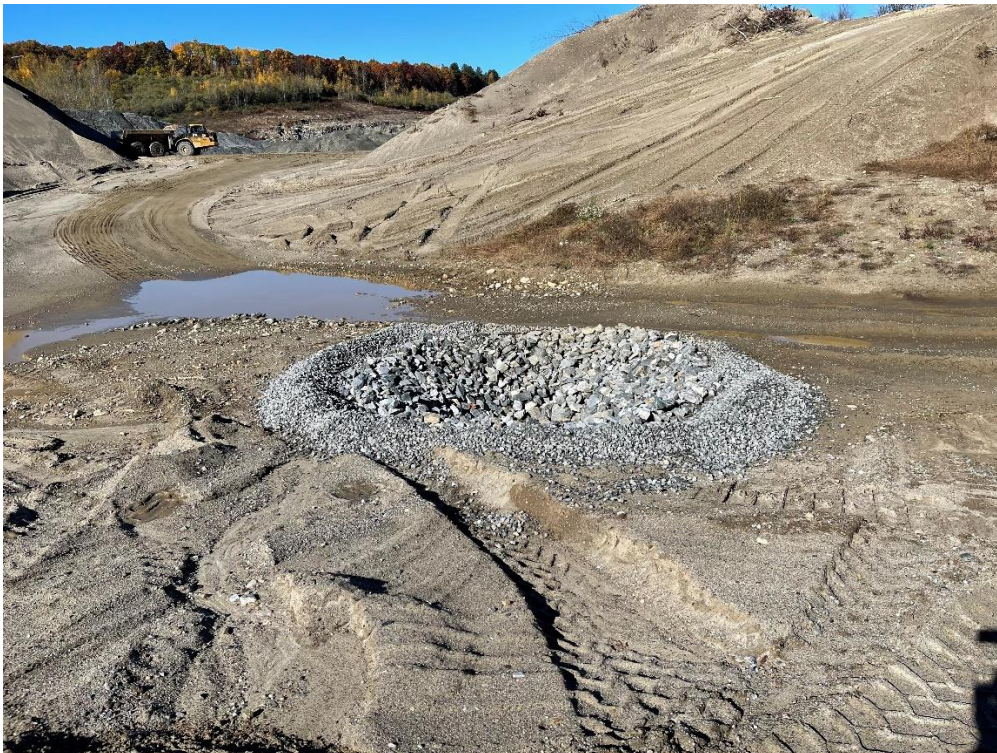
- The riprap around Flared End Section (FES) 3A had been installed.

Photo 2: The riprap at FES 3A had been installed.

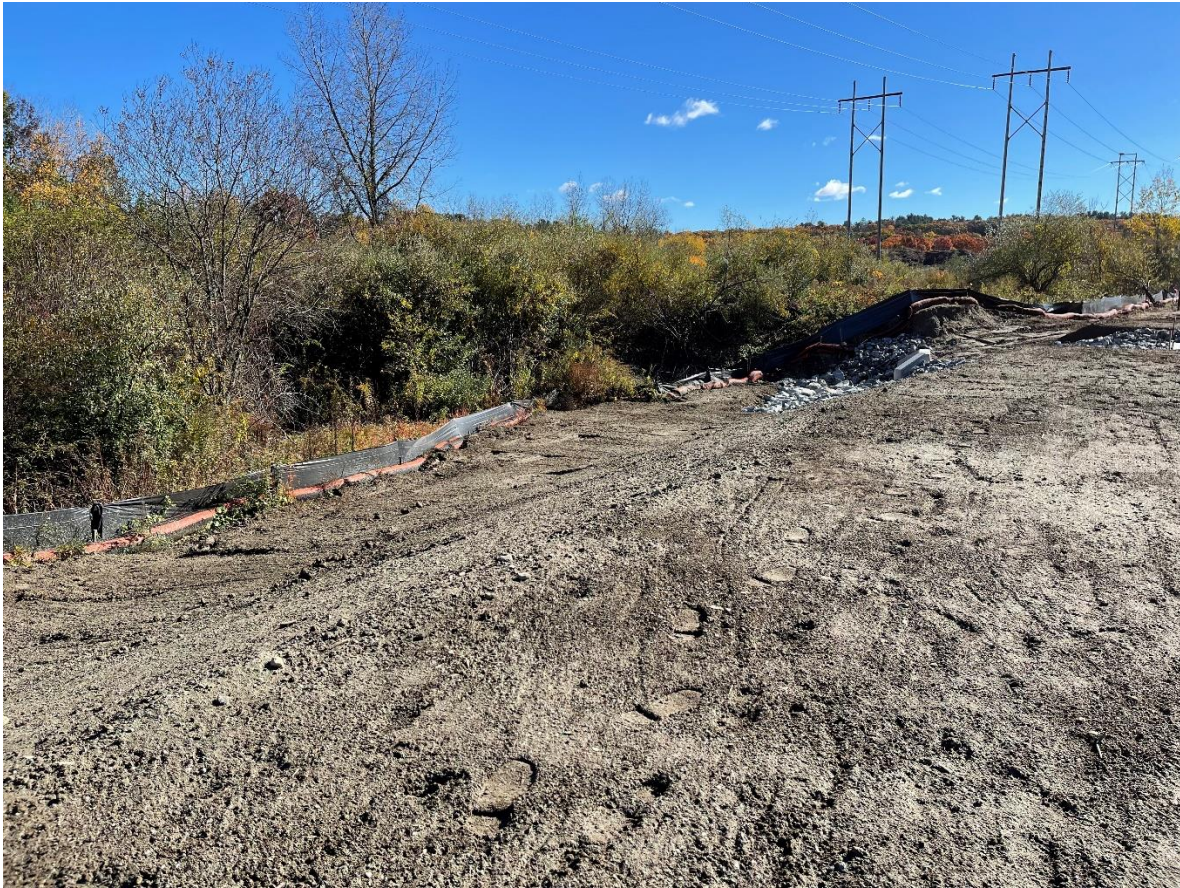
- Stormwater Management Area (SWMA) #1 was beginning to experience grass growth.
- In SWMA #2, erosion rills were beginning to form along the slope around the emergency spillway and outlet control structure.
- SWMA #3 was experiencing moderate grass growth, except near the emergency spillway where the topsoil had recently been replaced.
- At SWMA #3, near the outer slope of the emergency spillway, the topsoil had been replaced to prevent water pooling in this area.

Photo 3: At SWMA #3, the topsoil at the outer slope near the emergency spillway had been repalced to avoid water pooling.
