# Site Visit Report

<b>Date:</b>	November 4, 2022	<b>Prepared By:</b>	Olivia Caton
<b>Client:</b>	Sutton Planning Board	<b>Arrived on site:</b>	2:50 PM
<b>Project:</b>	Unified Parkway	<b>Left site:</b>	3:50 PM
<b>Contractor:</b>	Walsh Contracting Corp.	<b>Site Conditions:</b>	Dry
<b>Contractor Contact:</b>	John Walsh	<b>Weather:</b>	65°, Clear

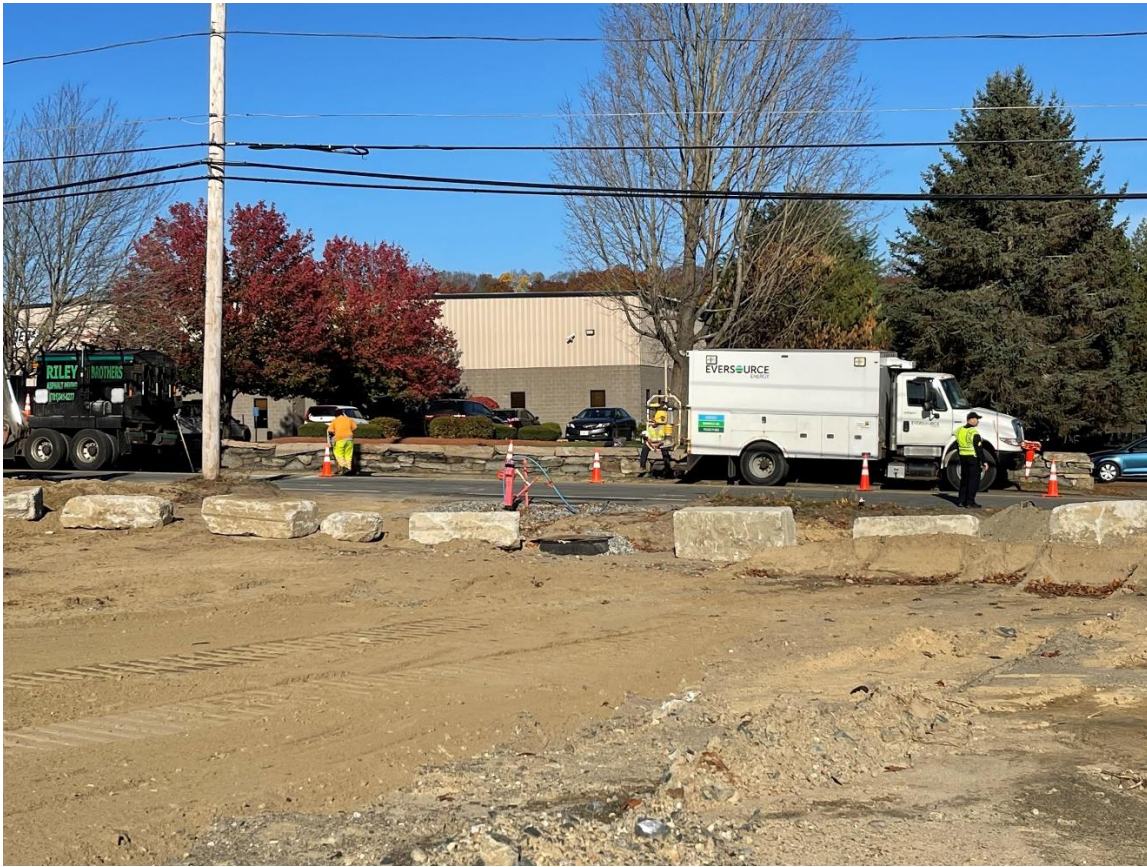
**Photo 1:** The contractor was performing utility work in Providence Road.

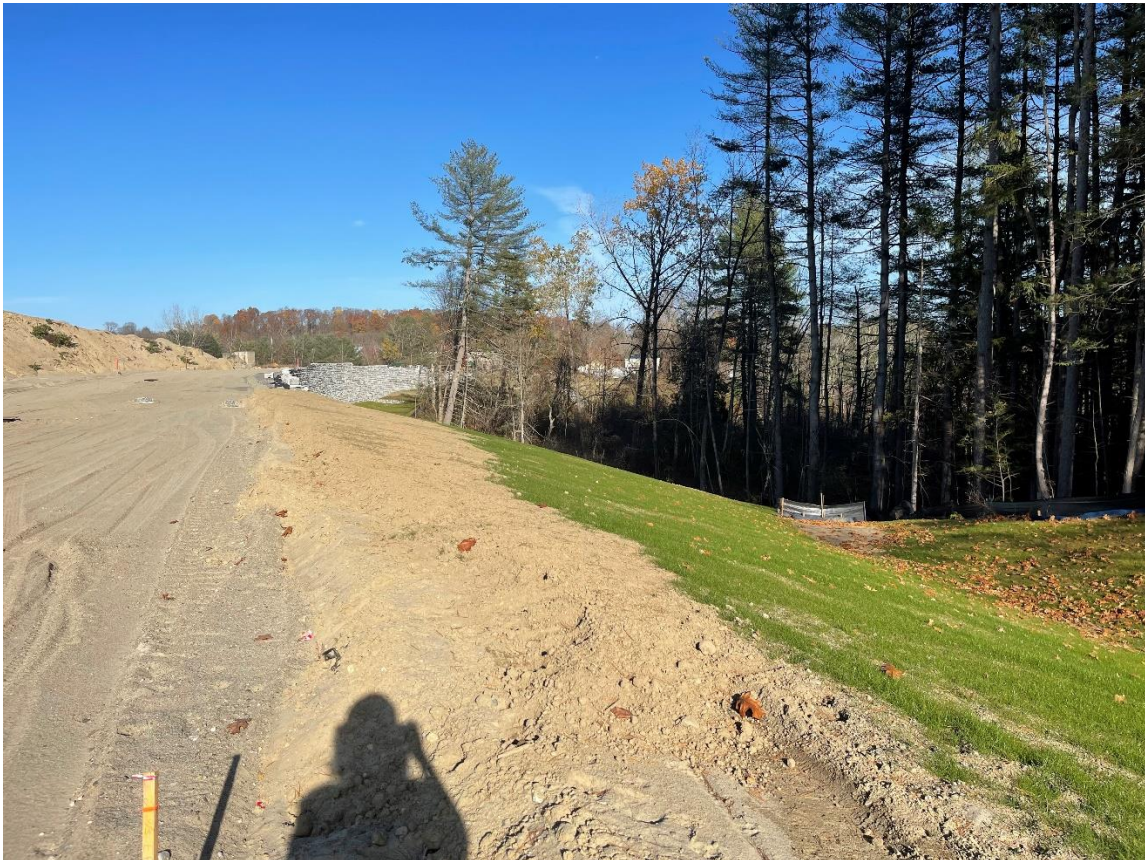
**Photo 2:** The uppermost portion of the slope between stations 8+00 and 9+00 needs to be reseeded.

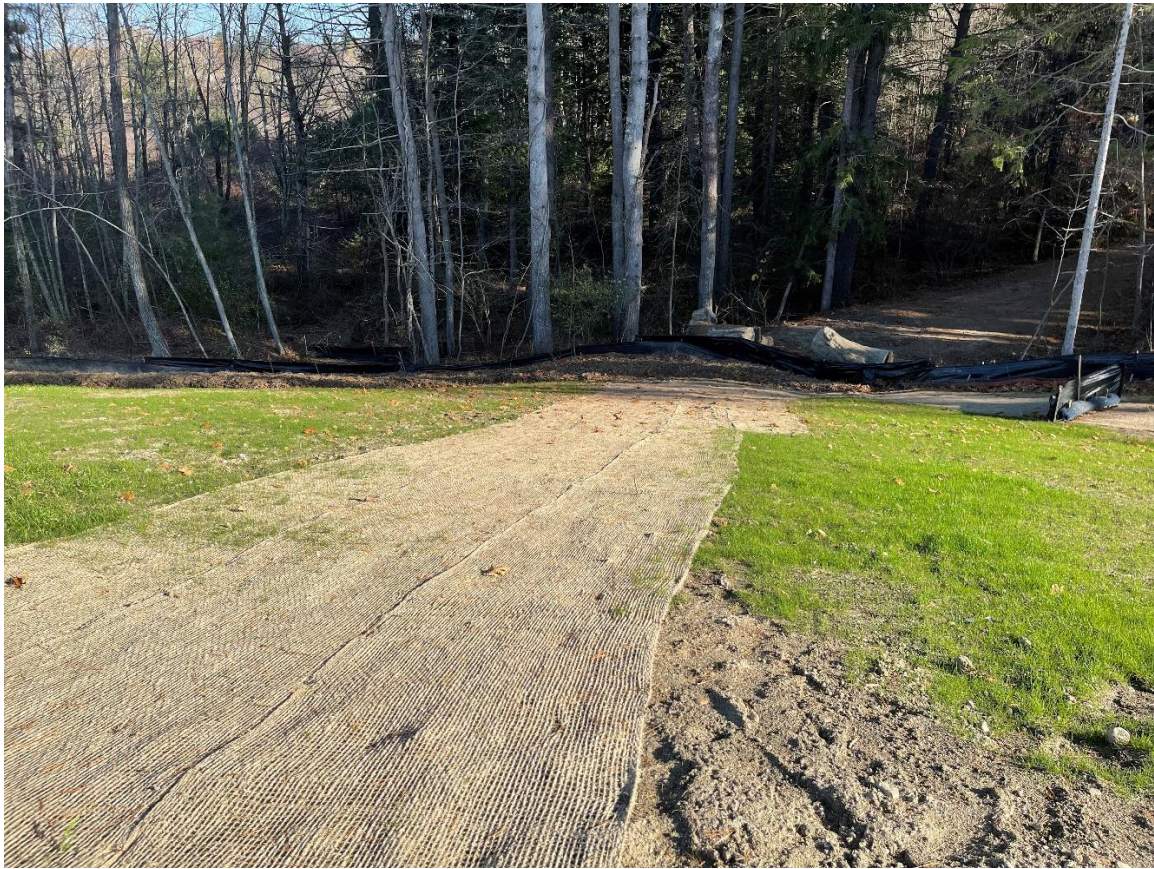
**Photo 3:** The area with jute matting between stations 8+00 and 9+00 was beginning to experience grass growth.
