# Site Visit Report

**Date:** January 24, 2023  
**Client:** Sutton Planning Board  
**Project:** Unified Parkway  
**Contractor:** Walsh Contracting Corp.  
**Contractor Contact:** John Walsh

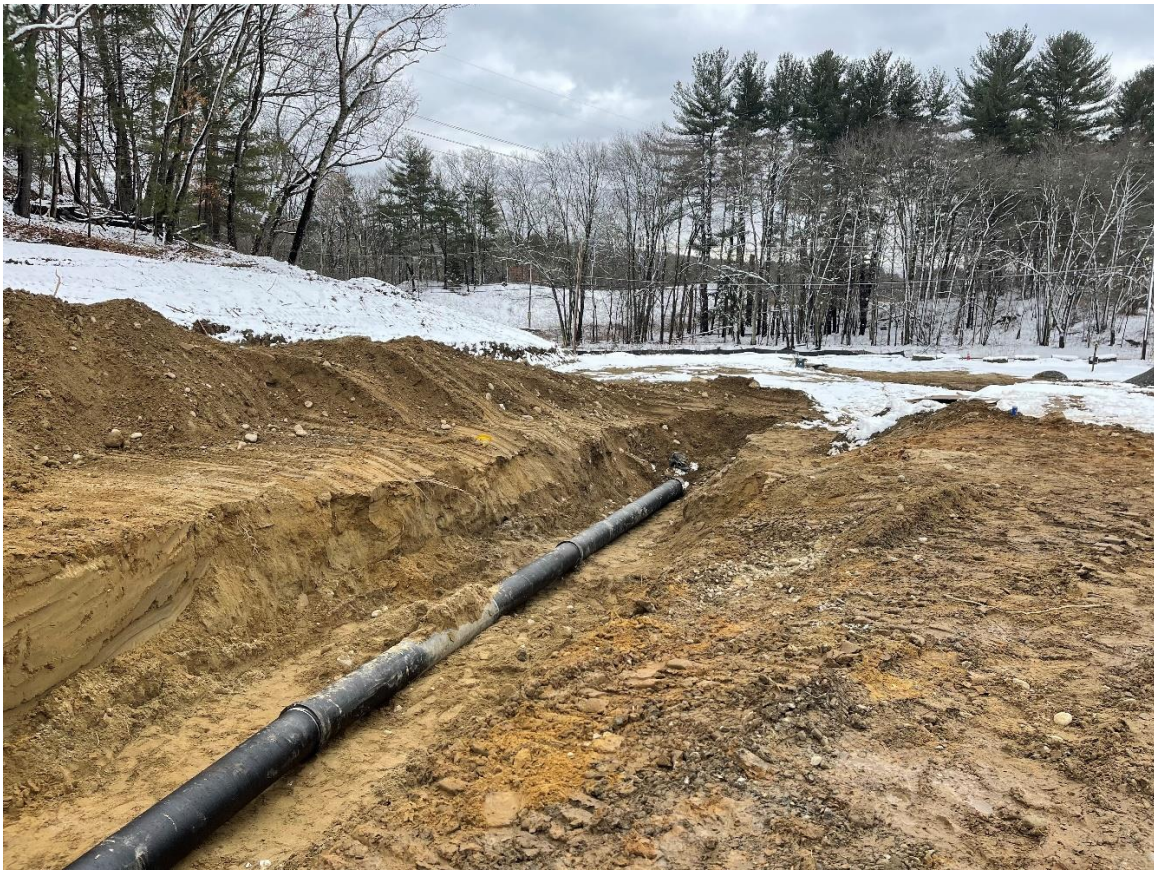
- At approximately station 53+50, the contractor was installing ductile iron pipe for the water main utility. Where the water pipe crossed over the drainage pipe, there was approximately one foot of compacted backfill material between the pipes.

**Photo 1:** Where the water pipe crossed over the drainage pipe (not visible), there was approximately one foot of compacted backfill material between the pipes.

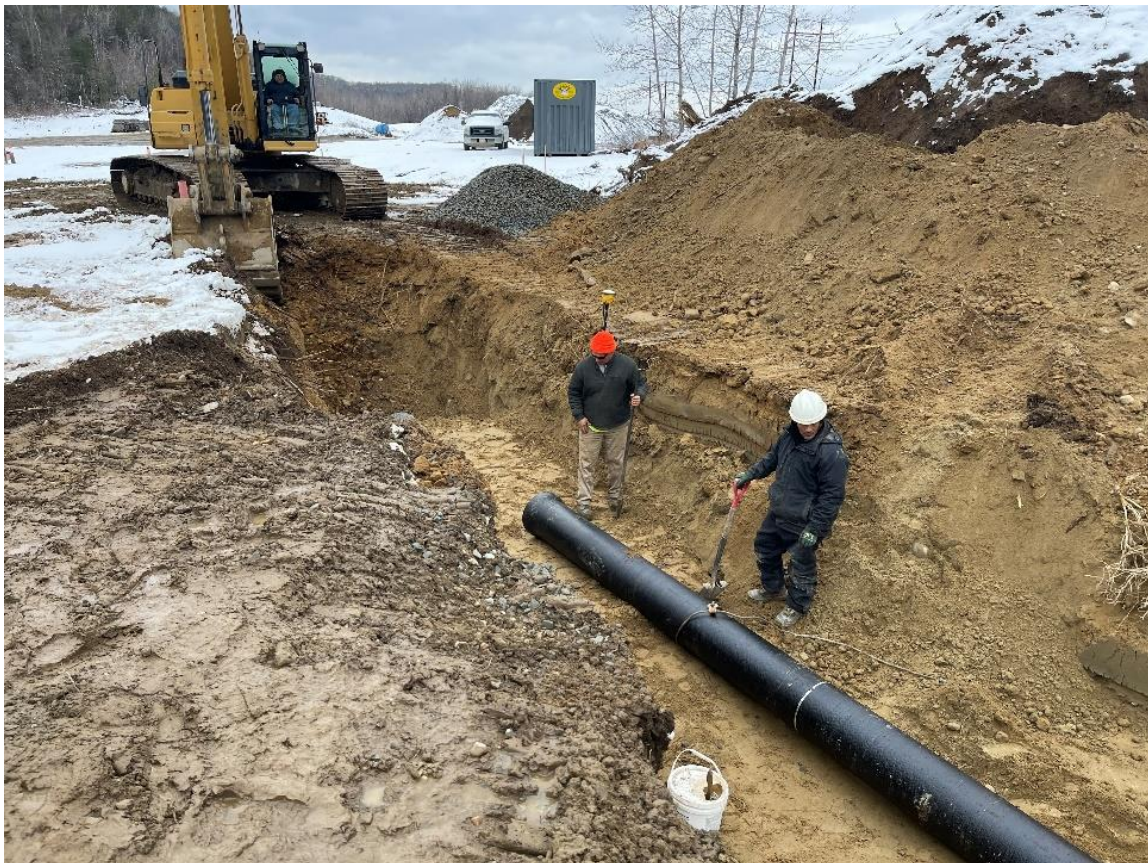
- Approximately 180 feet of 12-inch reinforced concrete pipe (RCP) had been installed from Drain Manhole (DMH) 403 towards DMH 400. The 78 feet of this pipe closest to DMH 403 was completely backfilled, and the remaining portion of pipe was partially backfilled.
- The contractor excavating the trench past the end of the pipe.

**Photo 2:** The contractor was excavating the pipe trench beyond the ends of the pipes.
