Site Visit Report

Dranarad Dv. Date: November 11, 2022 Client: Sutton Planning Board Project: **Unified Parkway Contractor:** Walsh Contracting Corp.

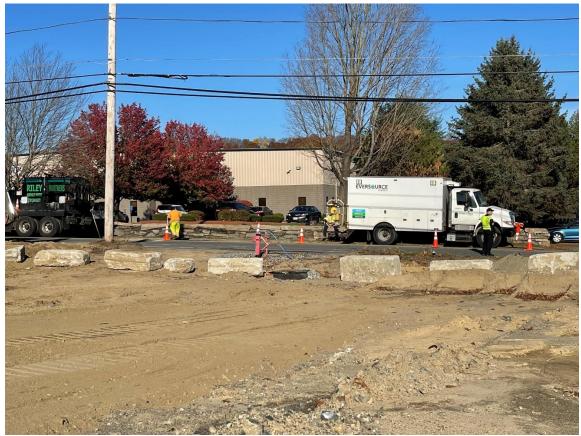
Photo 1: The contractor was performing utility work in Providence Road.

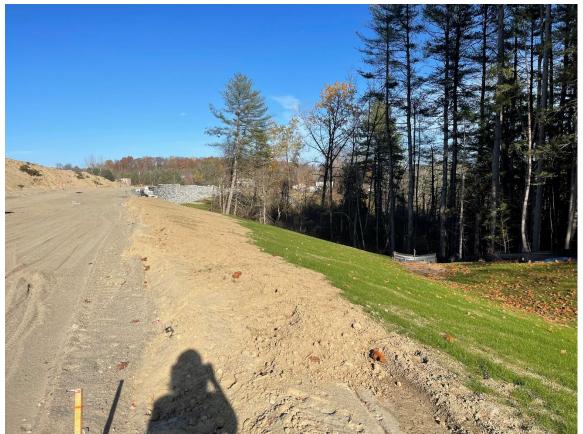
Photo 2: The uppermost portion of the slope between stations 8+00 and 9+00 needs to be reseeded.

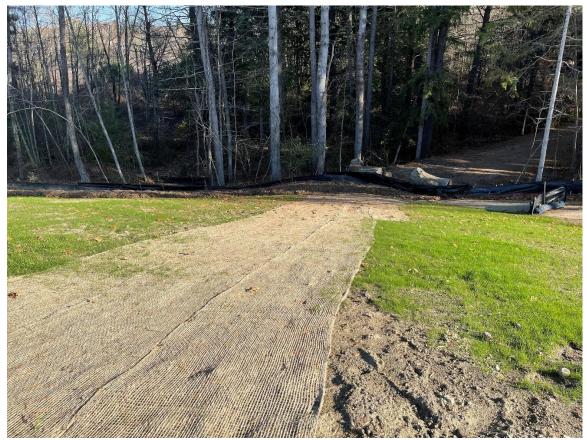
Photo 3: The area with jute matting between stations 8+00 and 9+00 was beginning to experience grass growth.
