# Site Visit Report

Date:November 15, 2022Client:Sutton Planning BoardProject:Unified ParkwayContractor:Walsh Contracting Corp.

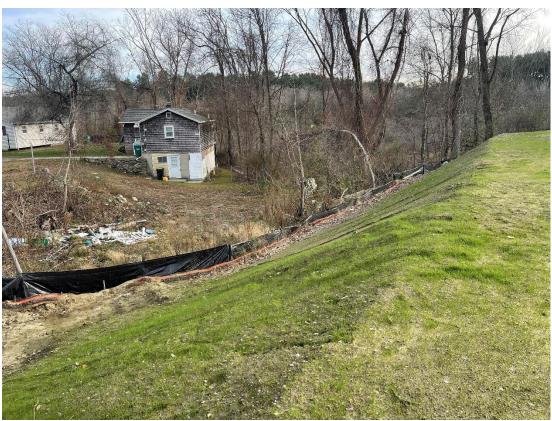
- Stormwater Management Area (SWMA) #1, the eastern slope of SWMA #2, and the area near the emergency spillway of SWMA #3 will need to be reseeded in the spring.
- The silt fence between SWMA #1 and N/F Vaillancourt will need to be cleaned out.
- The slope near the emergency spillway in SWMA #2 was beginning to experience grass growth.

Photo 1: The silt fence between SWMA #1 and N/F Vaillancourt will need to be cleaned out.

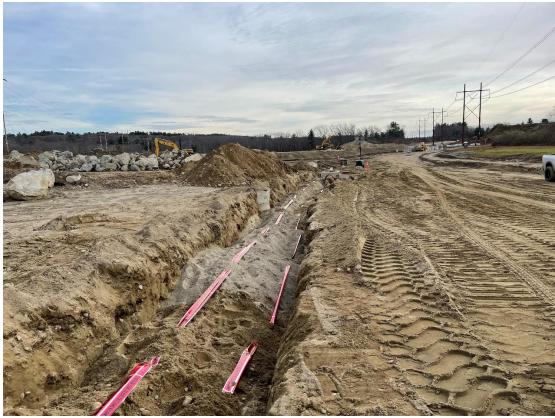
**Photo 2:** Electrical conduit installed between stations 31+00 and 34+00.

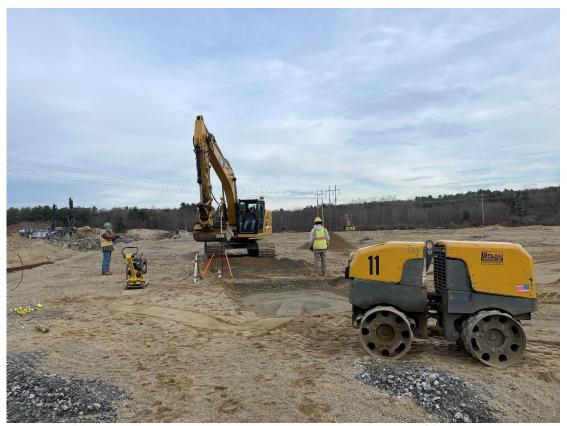
Photo 2: The contractor continued working at the location of Building 3.
