Site Visit Report

Date:	May 20, 2022	Prepared By:	Olivia Caton
Client:	Sutton Planning Board	Arrived on site:	9:00 AM
Project:	Unified Parkway	Left site:	9:50 AM
Contractor:	Walsh Contracting Corp.	Site Conditions:	Dry/Damp
Contractor Contact:	John Walsh	Weather:	59°, Partly Cloudy

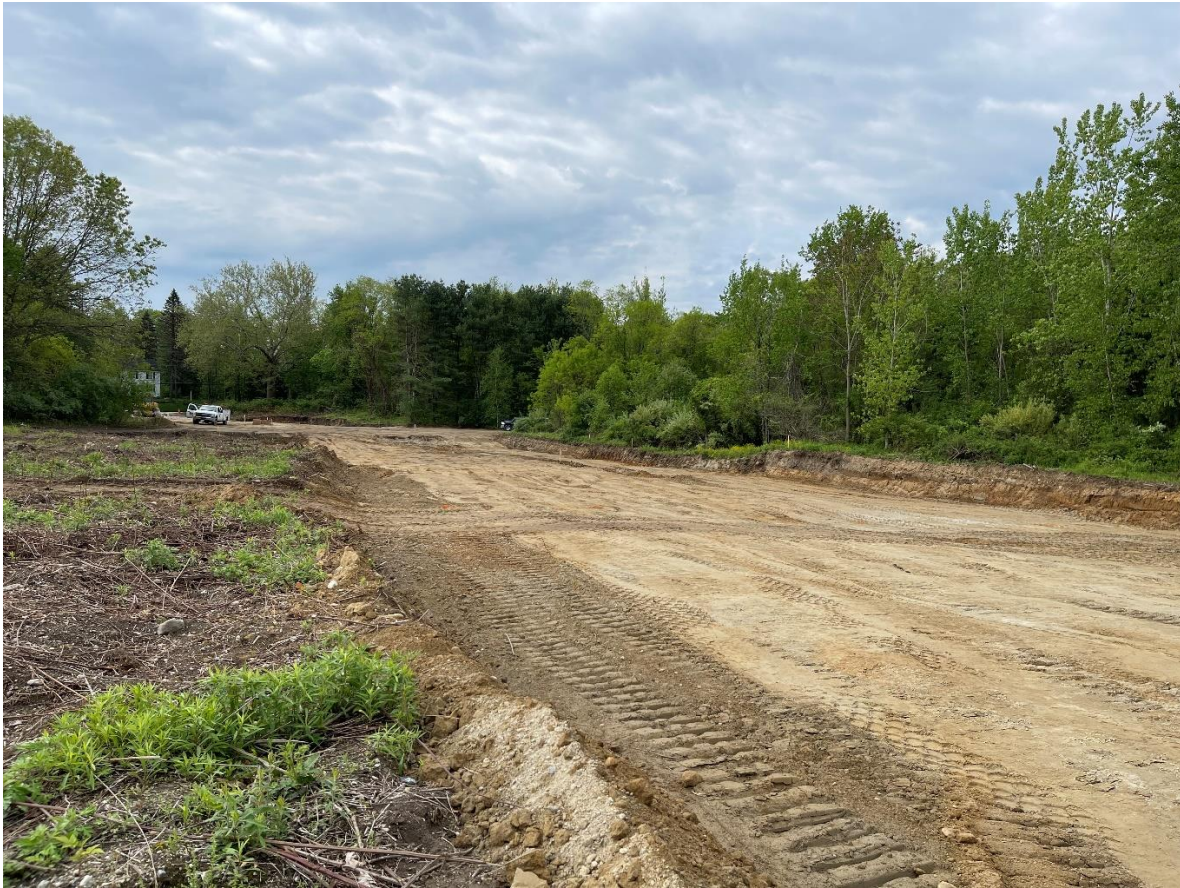
Photo 1: General site conditions between stations 49+00 and 56+00.

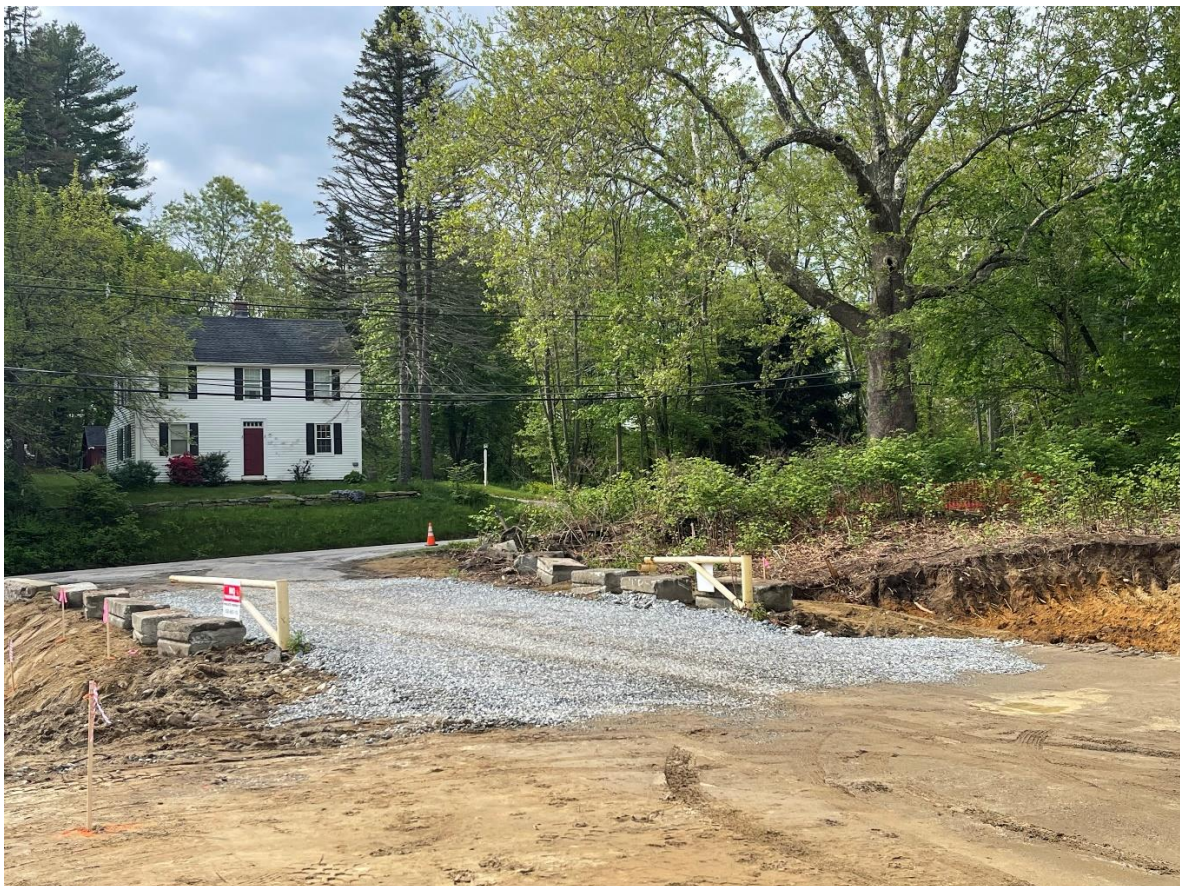
Photo 2: The construction entrance at Boston Road and large tree at station 56+00 that was left untouched.

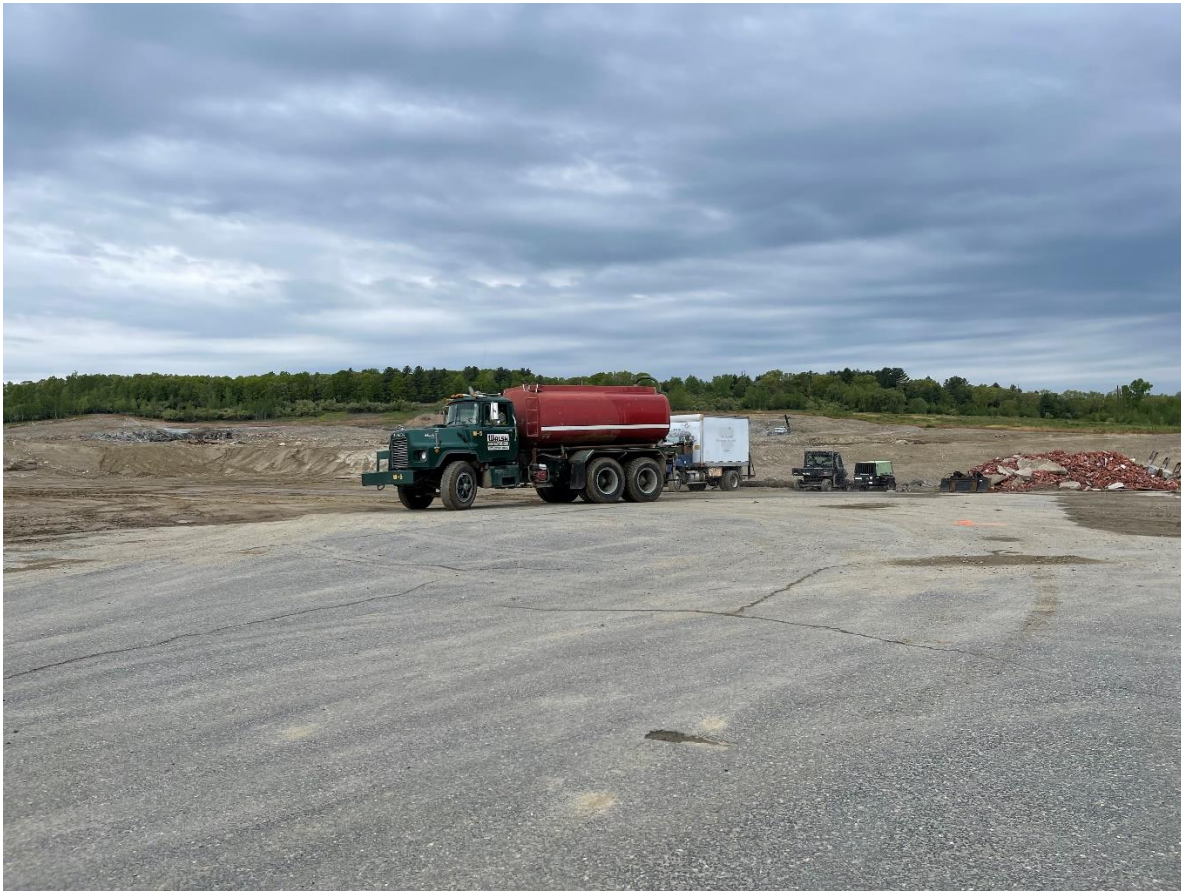
Photo 3: A water truck was watering the access roads.
