# Site Visit Report

**Date:** October 6, 2022  
**Client:** Sutton Planning Board  
**Project:** Unified Parkway  
**Contractor:** Walsh Contracting Corp.  
**Contractor Contact:** John Walsh

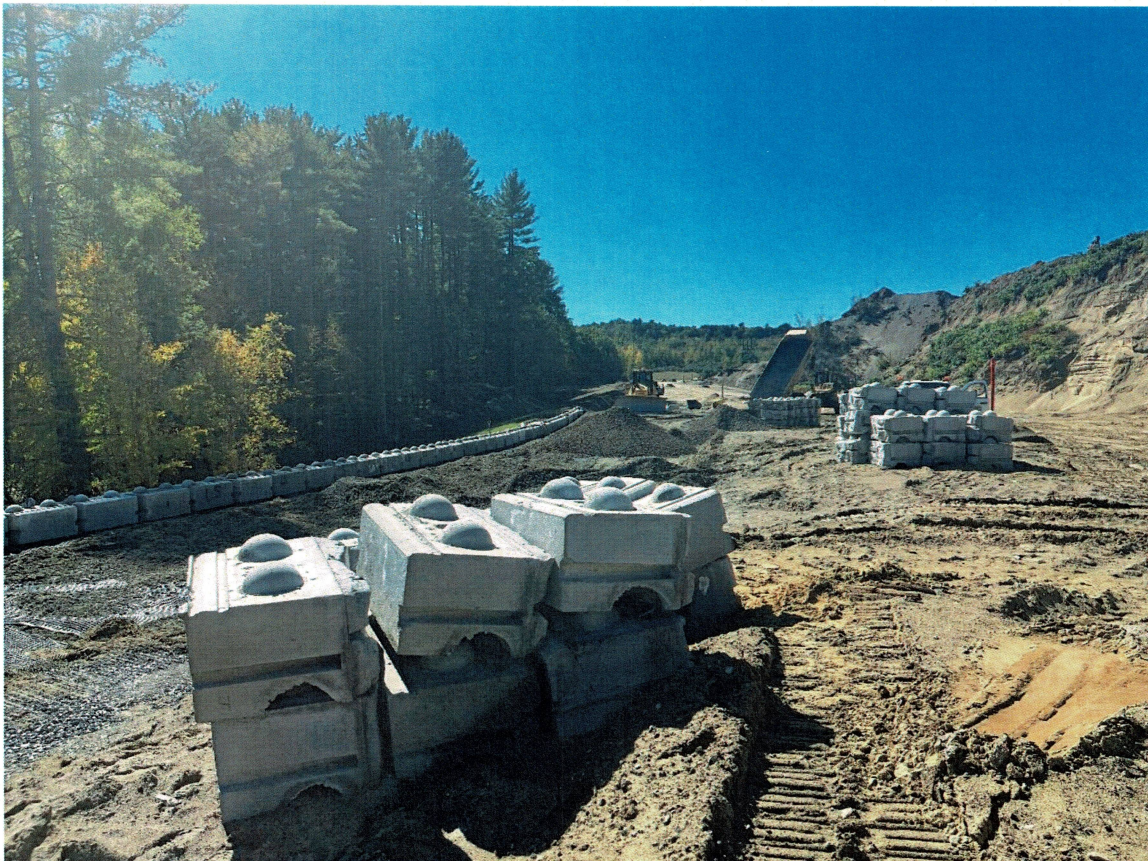
- The retaining wall between stations 3+25 and 7+50 had been constructed to approximately the seventh row. The contractor was placing bedding material consisting of three-quarter-inch crushed stone behind the wall. Geotextile fabric was pulled tightly before the bedding material was placed.
- The contractor was backfilling a water utility trench near station 39+00.
- The contractor was performing work on the lots between stations 32+00 and 42+00.

**Photo 1:** The contractor placing bedding material behind the retaining wall near station 7+50.

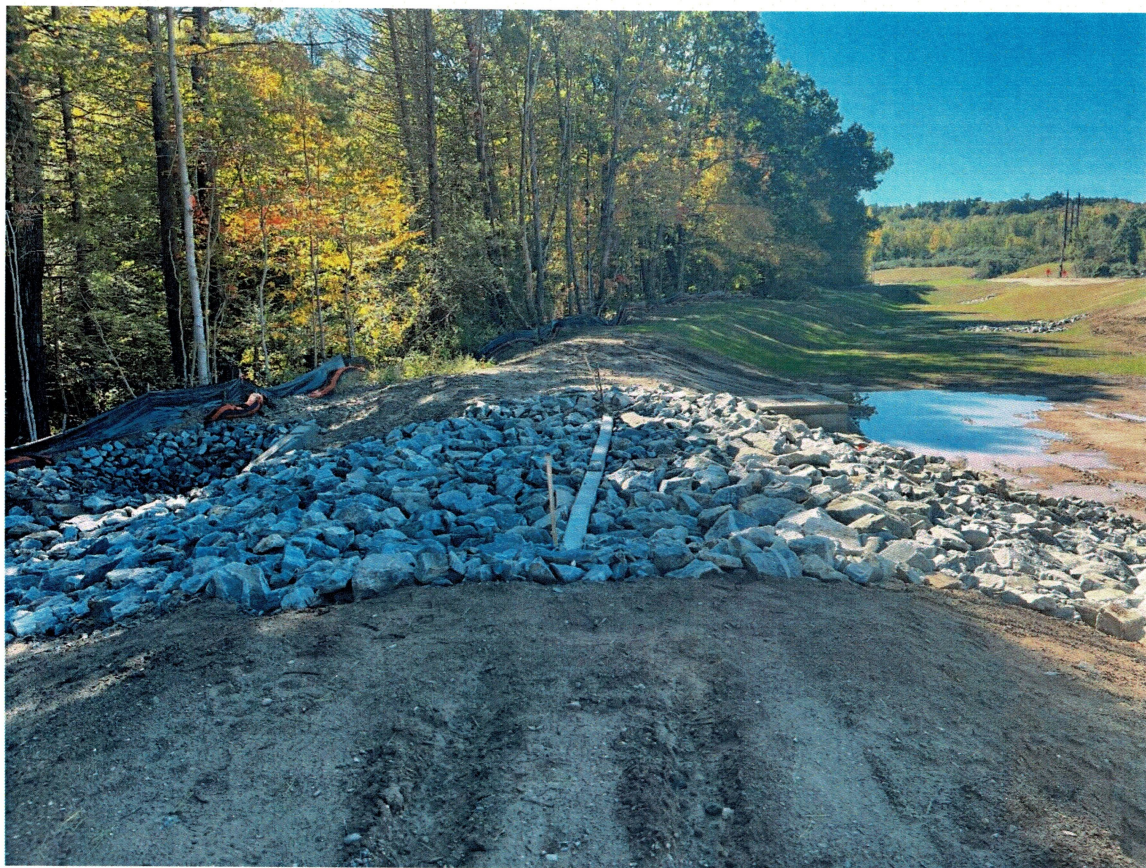
**Photo 2:** Approximately 30 feet of 12-inch RCP was installed and backfilled between OCS 200 and HW 202.

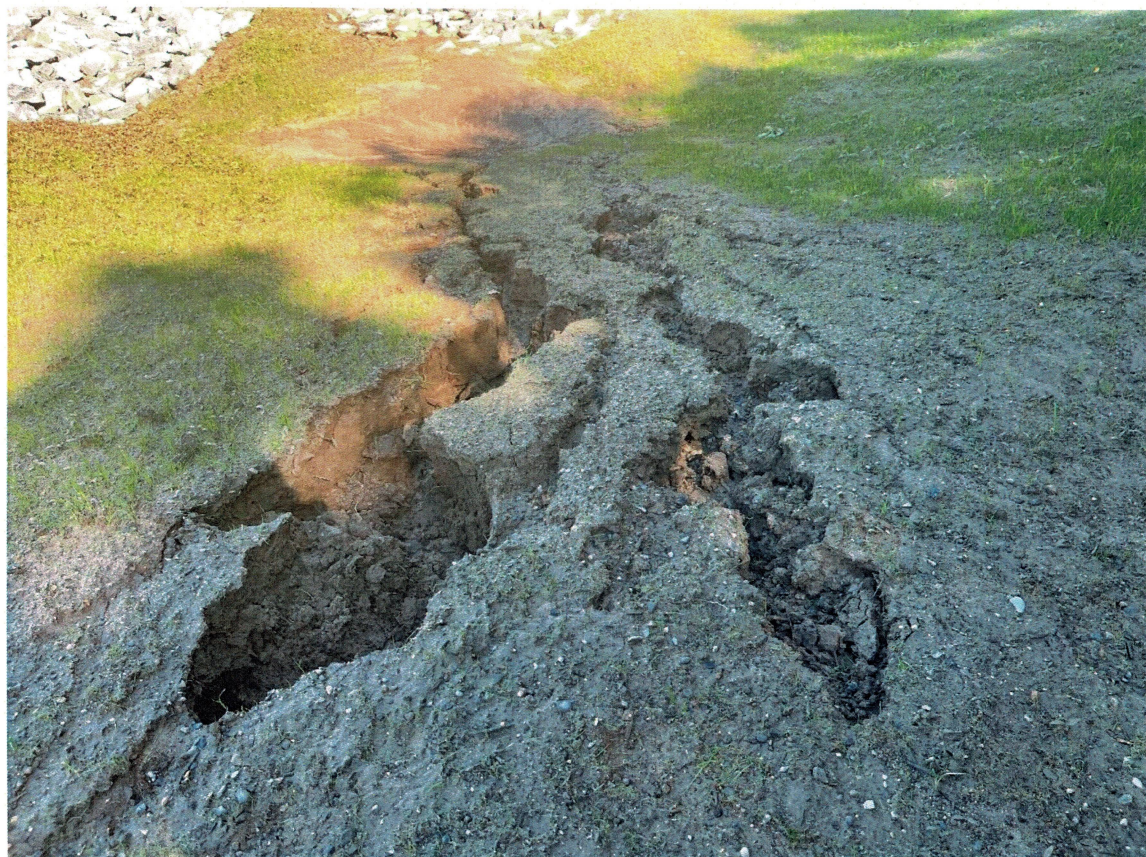
- Near Forebay 2B in SWMA #2, the erosion rills had deepened to approximately one foot, and will need to be repaired.
- In SWMA #2, the portion of the emergency spillway along the top of the berm had been installed, as well as the riprap for HW 202.
- The northern portion of SWMA #2 will need to be reseeded.
- In SWMA #3, the portion of the emergency spillway along the top of the berm had been installed, as well as the riprap for HW 402.

**Photo 3:** The erosion rills near Forebay 2B had deepened to approximately one foot.
