# Site Visit Report

**Date:** September 13, 2022  
**Client:** Sutton Planning Board  
**Project:** Unified Parkway  
**Contractor:** Walsh Contracting Corp.  
**Contractor Contact:** John Walsh

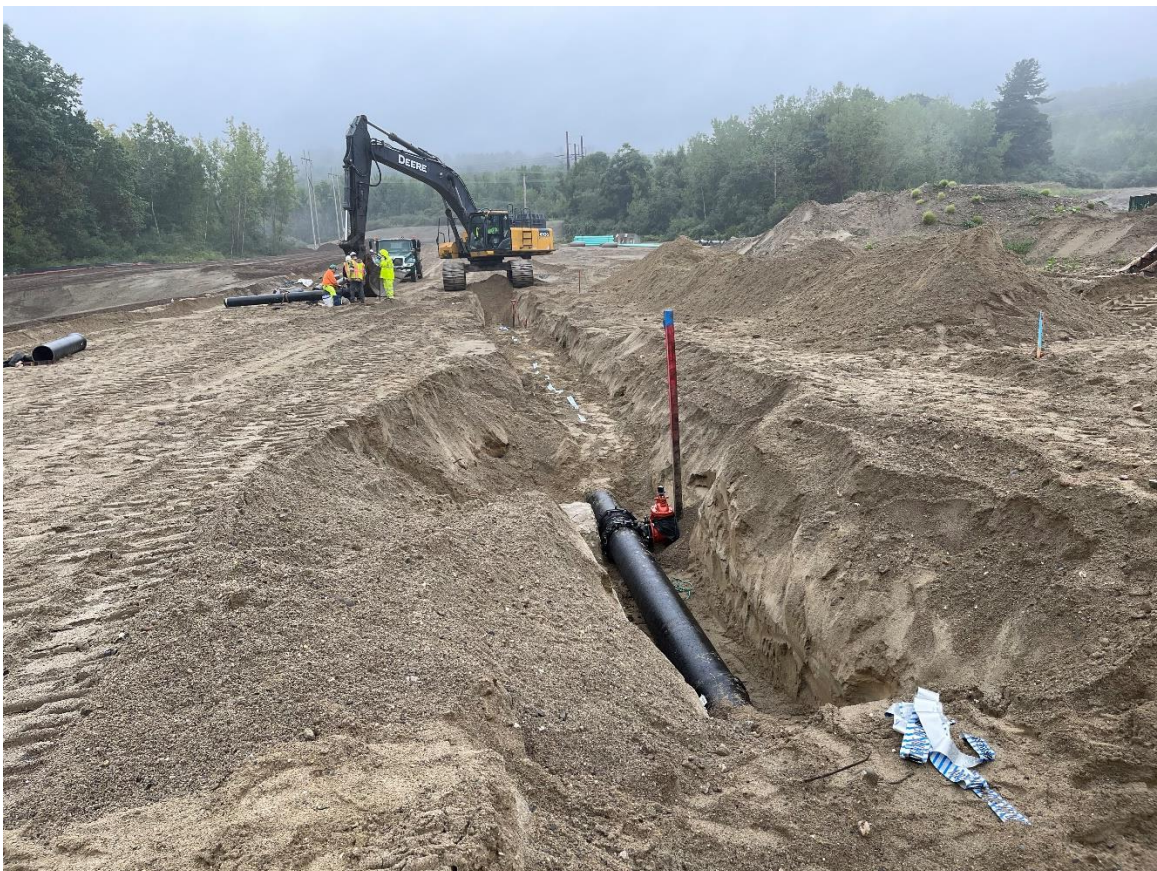
**Photo 1:** The contractor installing ductile iron pipe for the water main between stations 15+50 and 17+00.

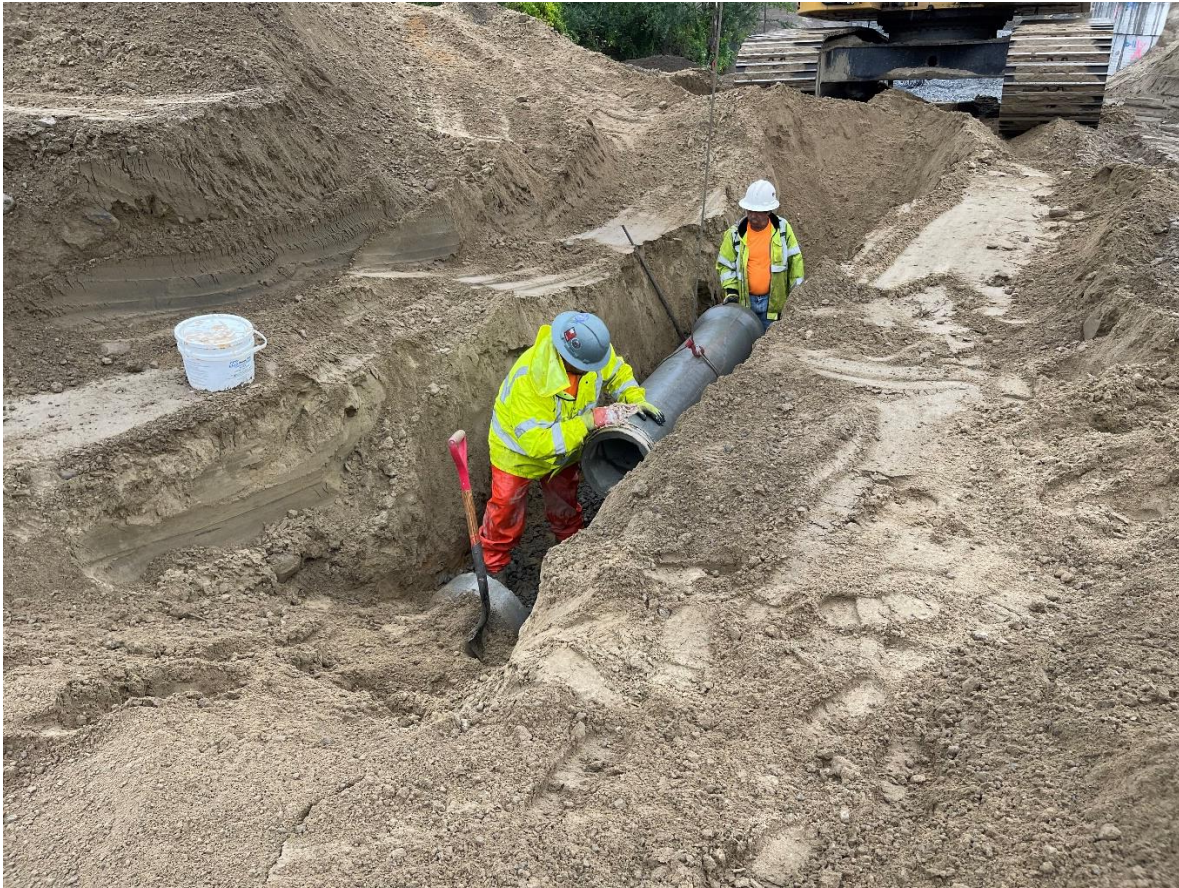
- Drain Manhole (DMH) 104 and the riser and cover sections of DMH 103 had been installed.
- Catch Basin (CB) 104 had been installed.
- From DMH 102 towards DMH 103, approximately 80 feet of 12-inch reinforced concrete pipe (RCP) had been installed. The first 72 feet of the pipe was backfilled prior to my visit. The contractor backfilled the last 8 feet of the pipe, then compacted the backfill material with a plate compactor. The trench past the end of the pipe was excavated approximately 15 feet, and bedding material consisting of three-quarter-inch crushed stone was placed along the bottom of the trench. An additional 8 feet of pipe was installed in a satisfactory manner.

**Photo 2:** The contractor installing 8 feet of 12-inch RCP pipe between DMH 102 and DMH 103.

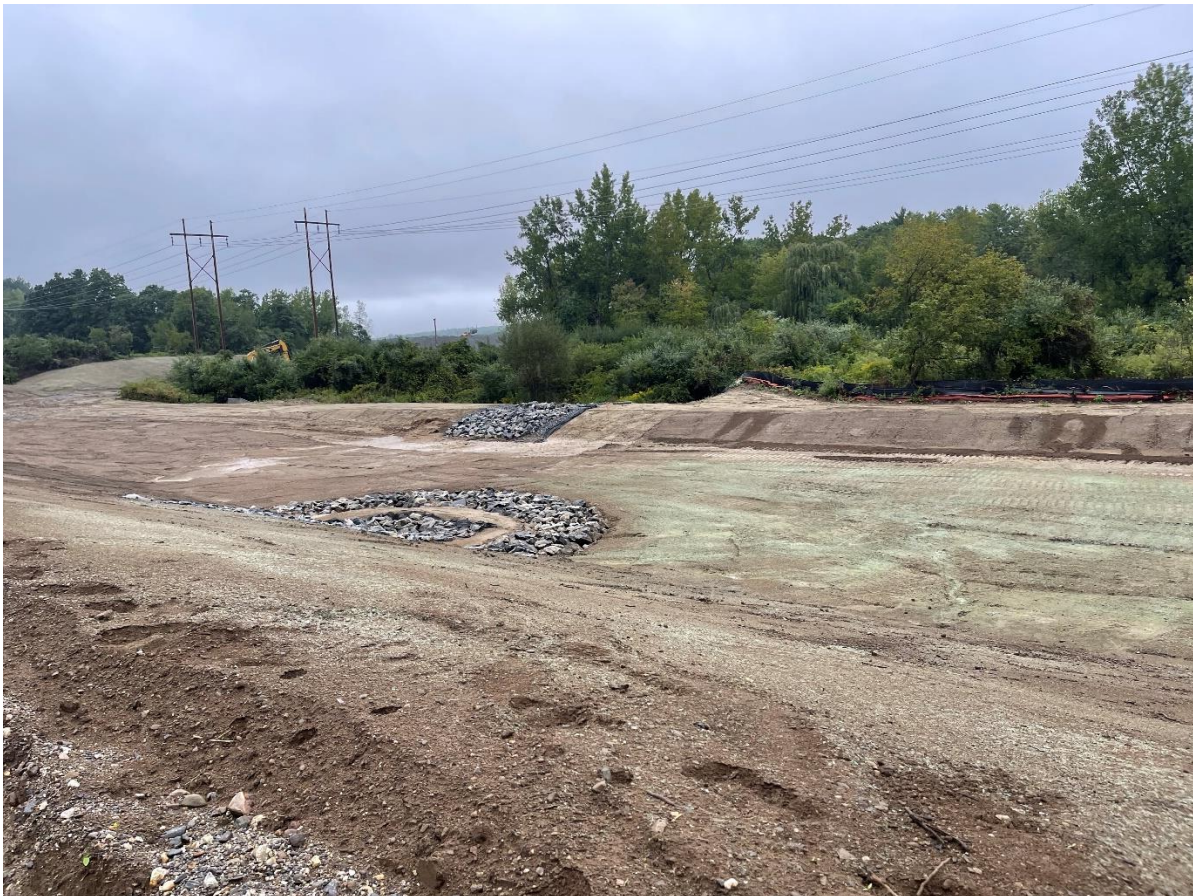
- Stormwater Management Areas (SWMAs) #2 and #3 had been hydroseeded except for the portion of SWMA #3 northwest of Forebay 3A.

**Photo 3:** SWMA #3 had been hydroseeded except for the portion northwest of Forebay 3A.
