# Site Visit Report

**Date:** December 28, 2022  
**Client:** Sutton Planning Board  
**Project:** Unified Parkway  
**Contractor:** Walsh Contracting Corp.  
**Contractor Contact:** John Walsh

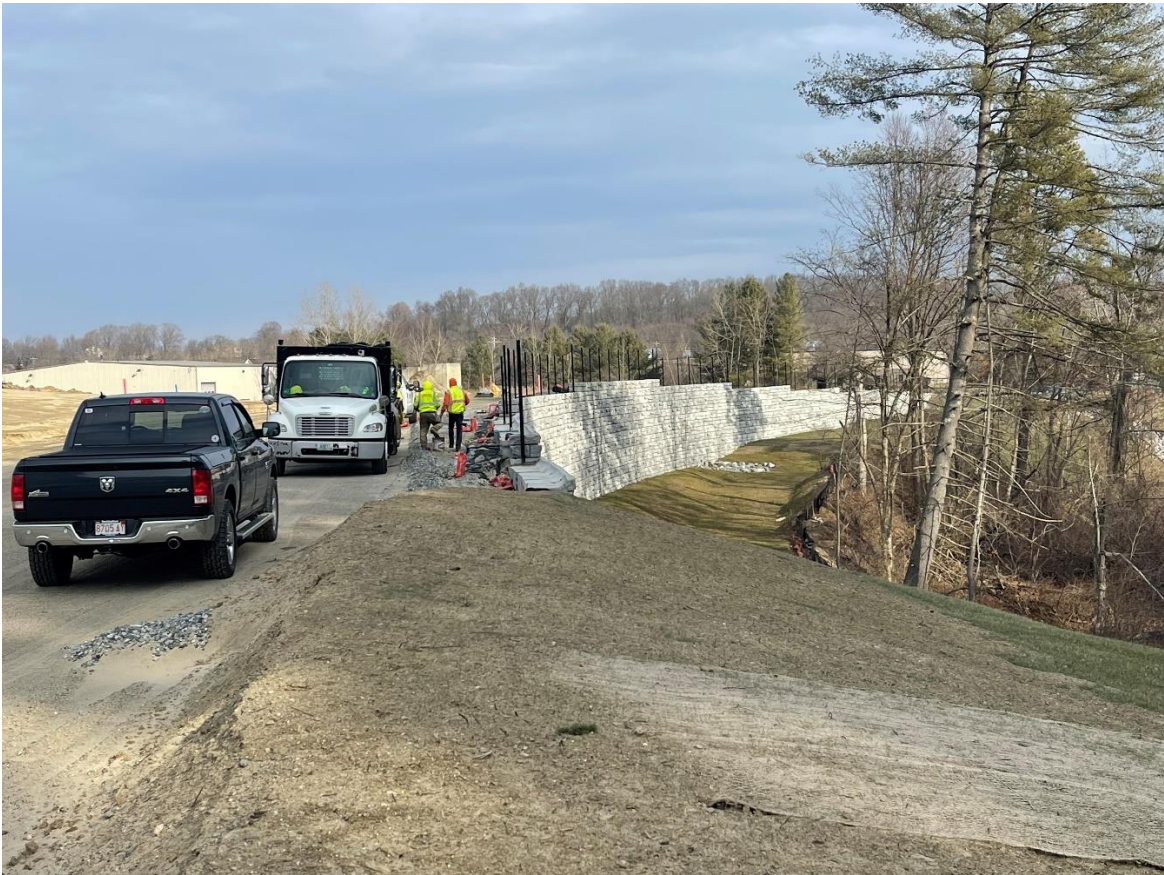
**Photo 1:** The contractor was installing the posts of the chain link fence along the retaining wall.

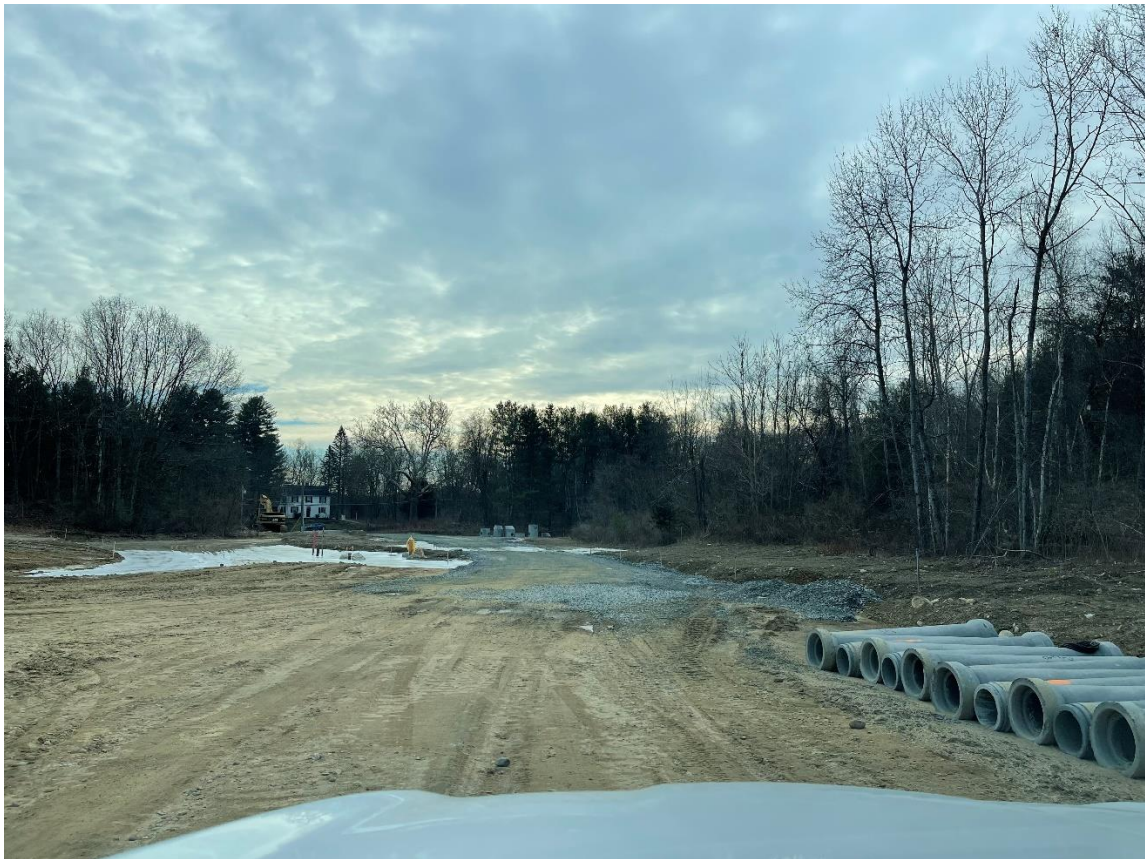
**Photo 2:** Three-quarter-inch crushed stone had been placed along the roadway between stations 52+00 and 56+00.

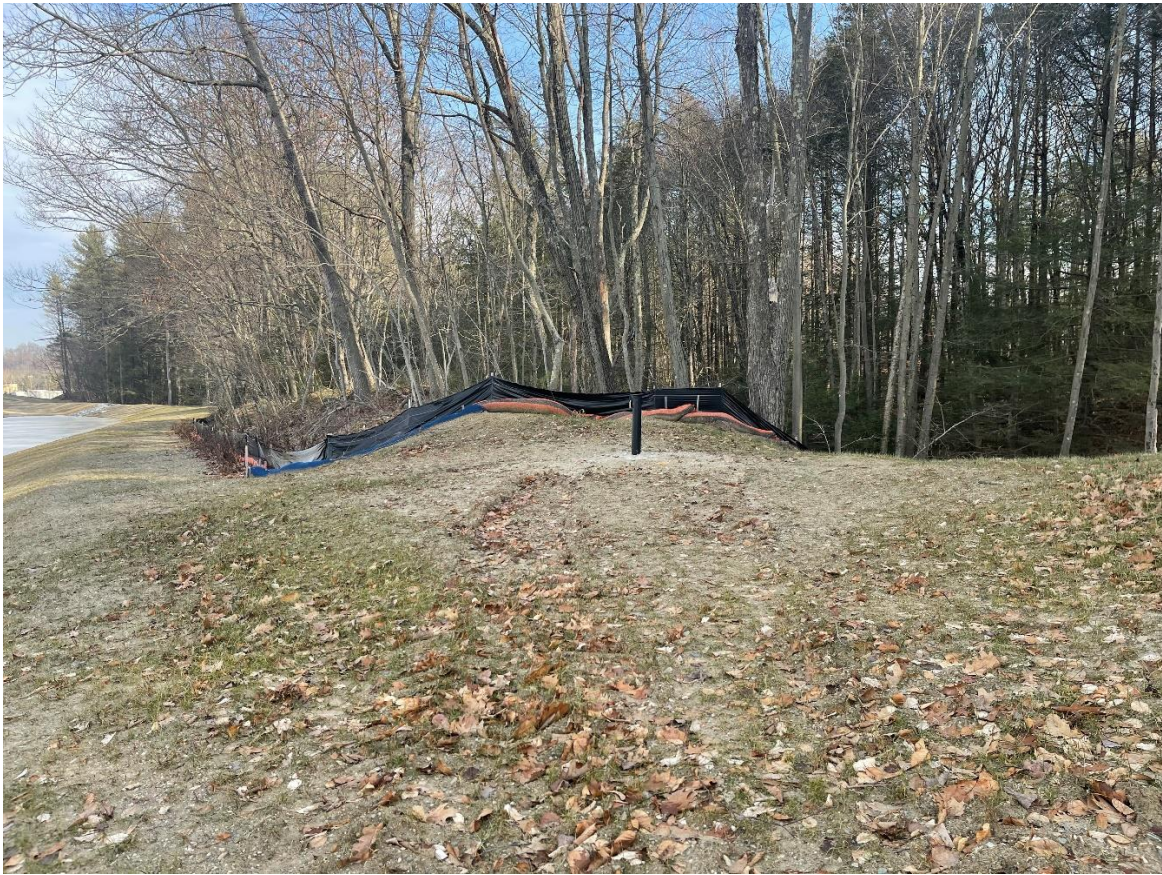
**Photo 3:** A monitoring well was installed at SWMA #2.
