Site Visit Report

Date: January 4, 2023
Client: Sutton Planning Board
Project: Unified Parkway
Contractor: Walsh Contracting Corp.
Contractor Contact: John Walsh

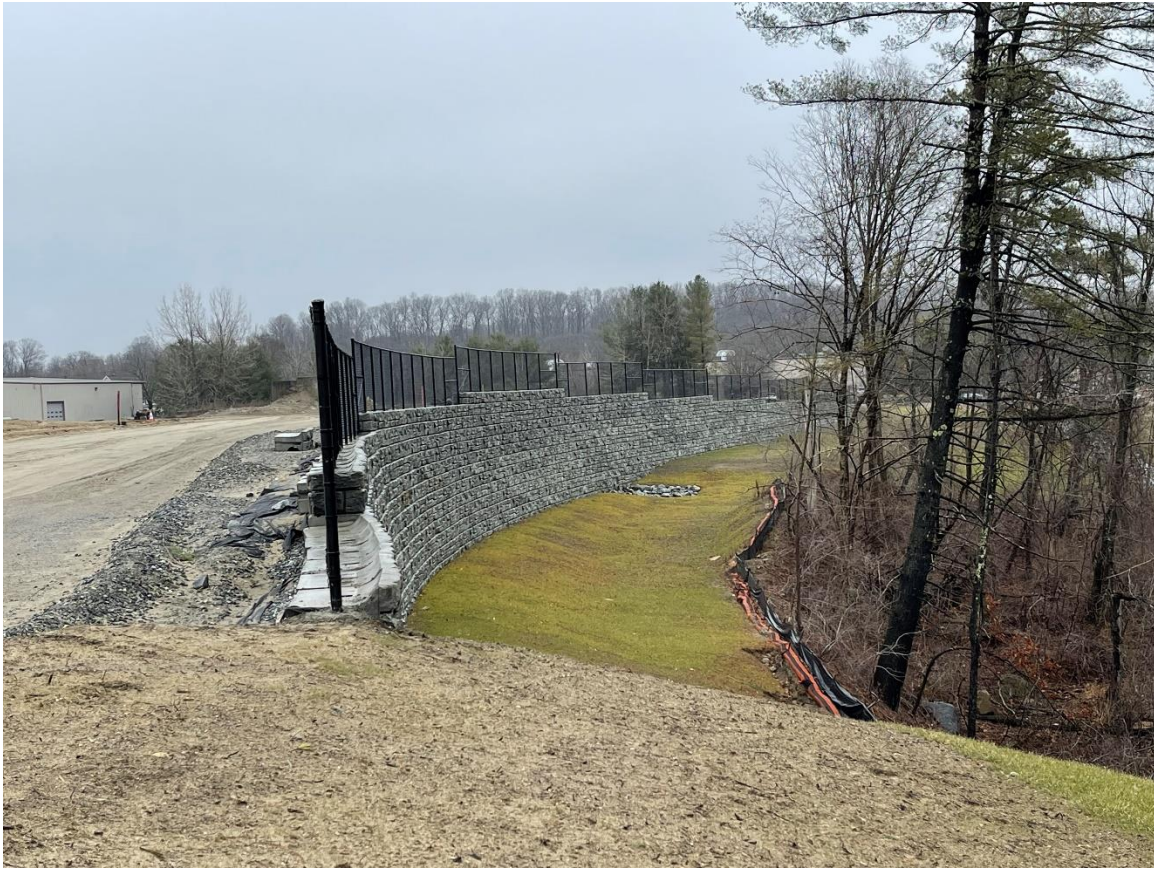
Photo 1: The posts and fence for the fence along the retaining wall had been installed.

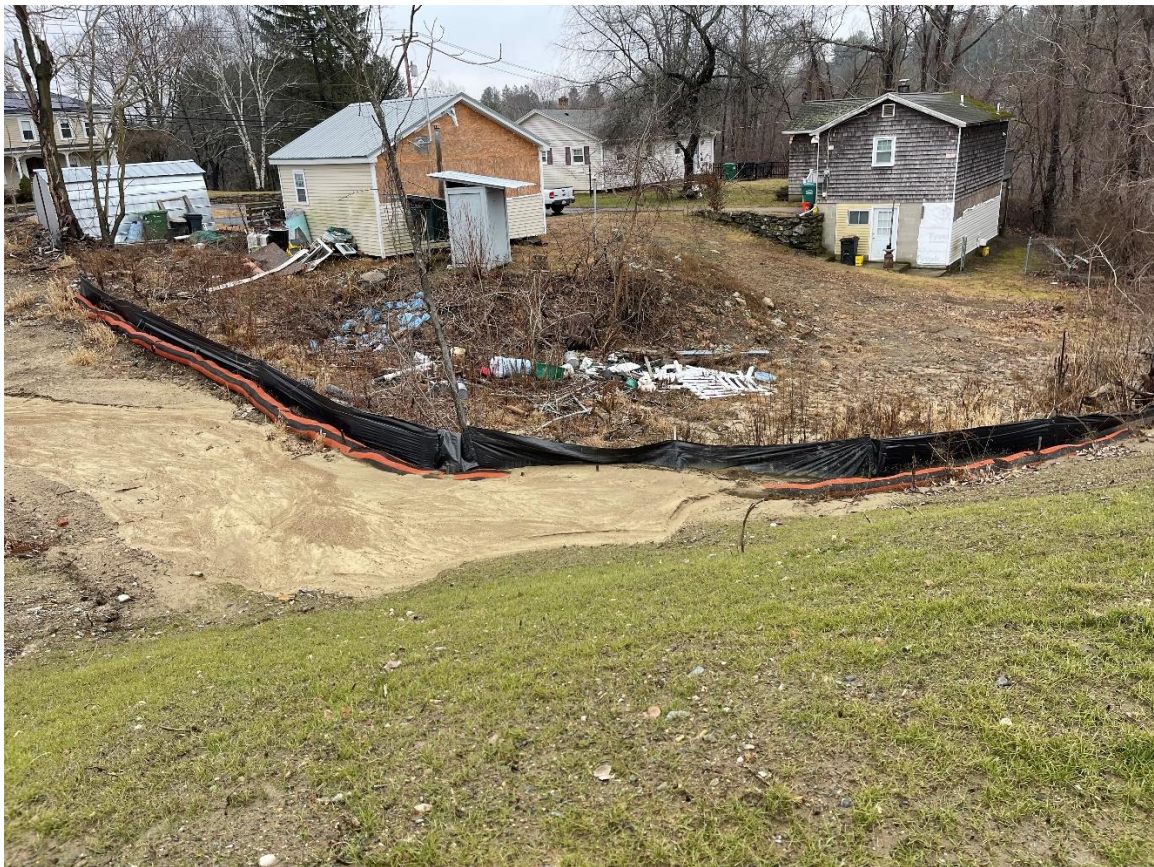
Photo 2: A significant amount of sediment had accumulated in the silt fence between the eastern corner of SWMA #1 and the property line.

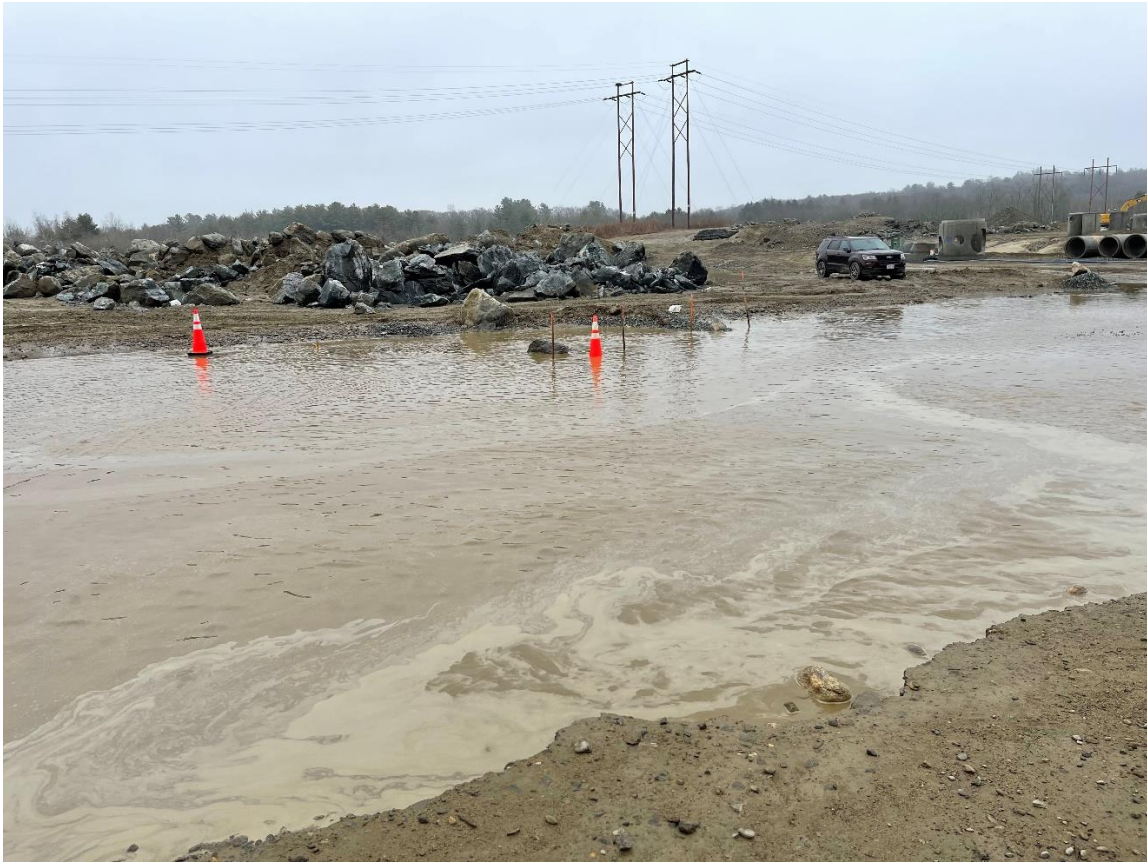
Photo 3: A significant amount of runoff had pooled at approximately station 38+00, at the intersection of the subdivision road and the driveway leading to Lots 2 and 3.
