Site Visit Report

Date:	April 13, 2023	Prepared By:	Olivia Caton
Client:	Sutton Planning Board	Arrived on site:	10:30 AM
Project:	Unified Parkway	Left site:	11:00 AM
Contractor:	Walsh Contracting Corp.	Site Conditions:	Dry
Contractor Contact:	John Walsh	Weather:	77°, Clear

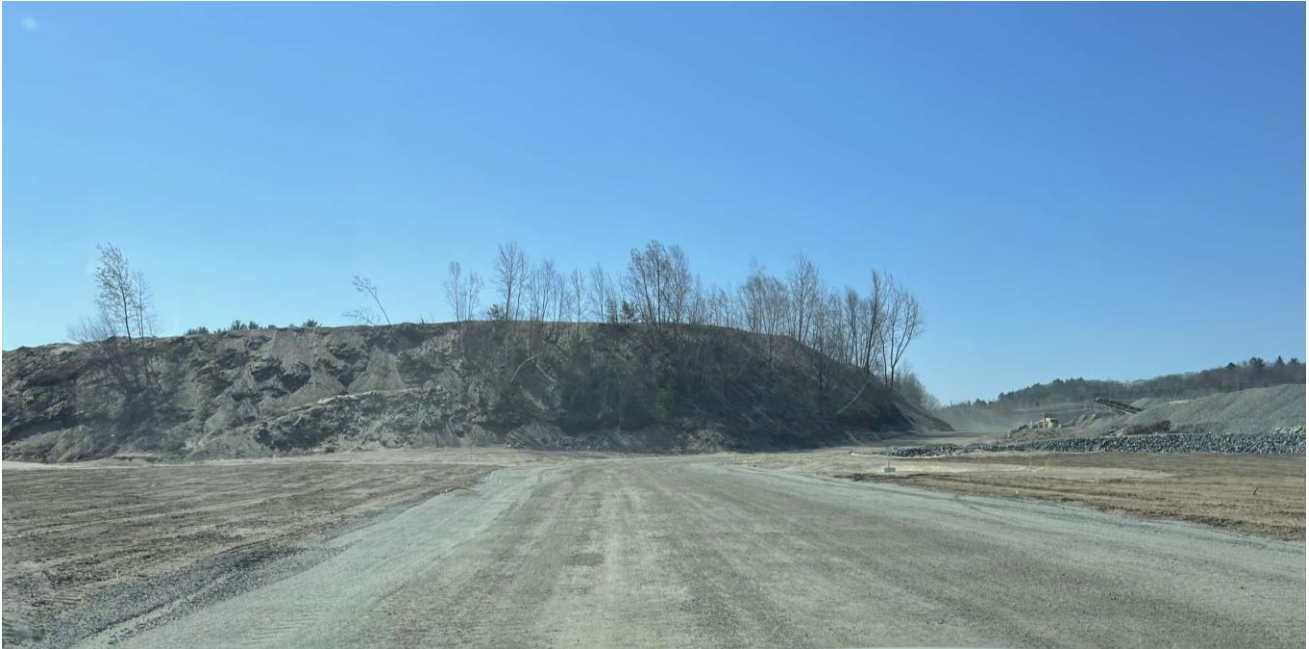
Photo 1: Gravel was placed along the construction road between the trailers and subdivision road (photo taken through tinted window).

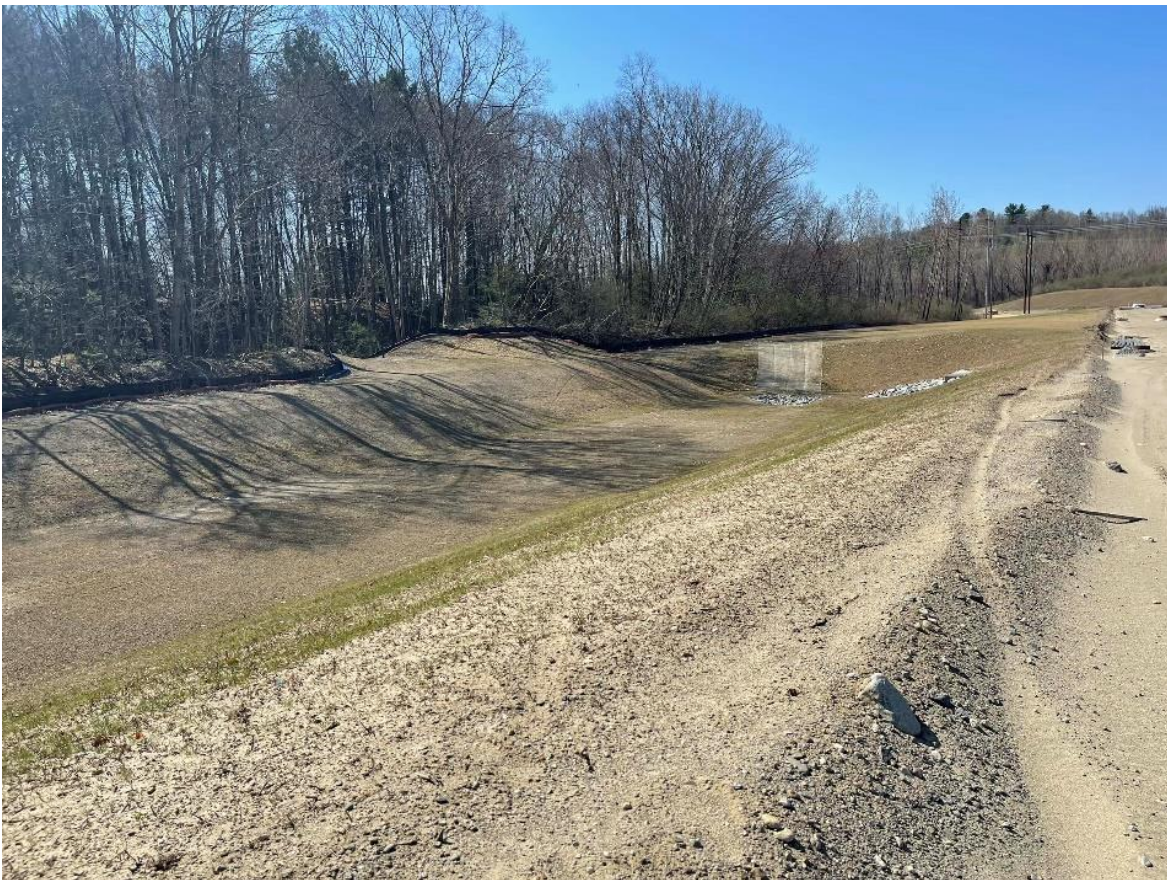
Photo 2: SWMA #2 was experiencing sparse grass growth, and the jute matting in the northern corner was in good condition.

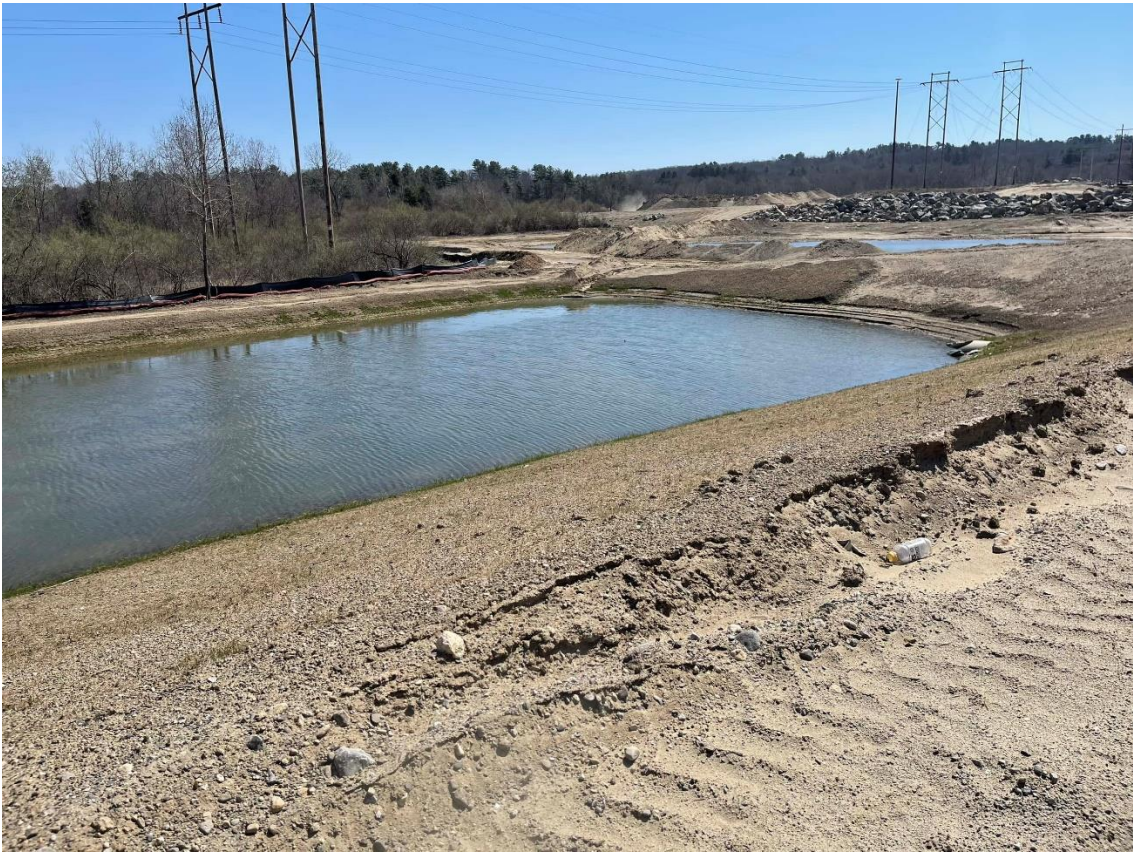
Photo 3: SWMA #3 was filled with over 2 feet of water.
