Site Visit Report

Date: October 5, 2023
Client: Sutton Planning Board
Project: Unified Parkway
Contractor: Walsh Contracting Corp.
Contractor Contact: John Walsh

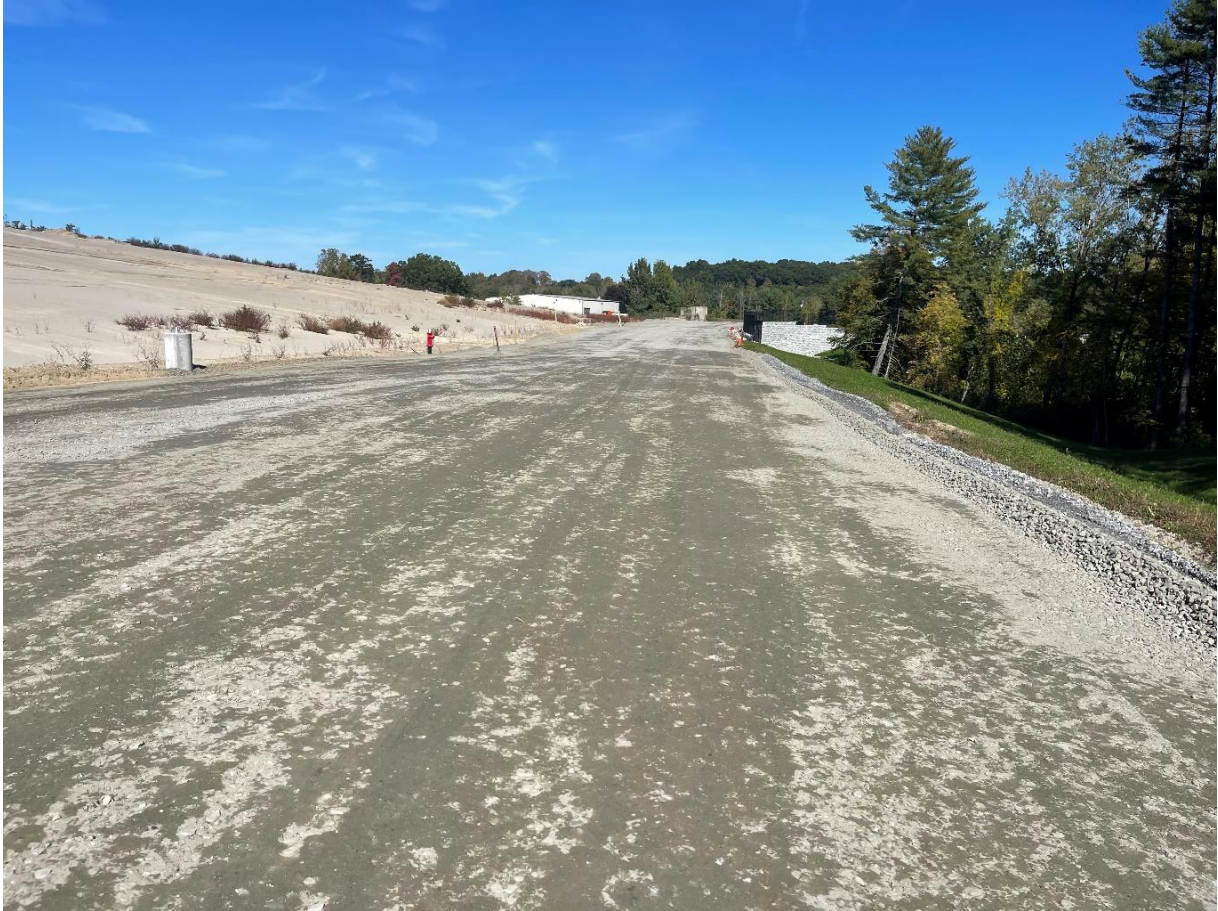
- Dense graded crushed stone had been placed and compacted along the roadway between stations 0+00 and 35+50 in a satisfactory manner. The dense graded crushed stone had been placed to a width of approximately 54 feet, except between stations 25+00 and 27+00 which had a width of approximately 32 feet. It appeared this area excluded the landscaped portion of the right-of-way.

Photo 1: General conditions of the dense graded crushed stone at approximately station 19+00 facing towards 0+00.

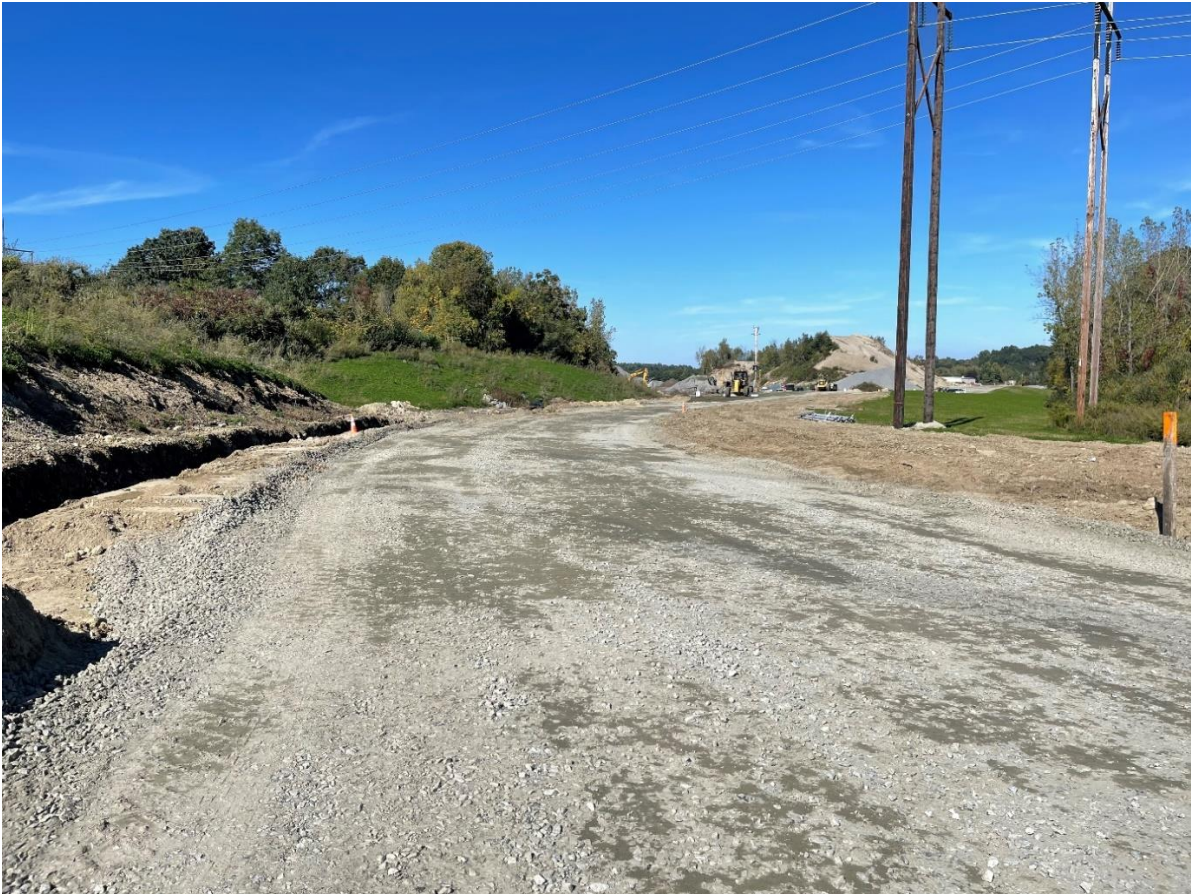
Photo 2: General conditions of the dense grade crushed stone at approximately station 26+00 facing towards 0+00.

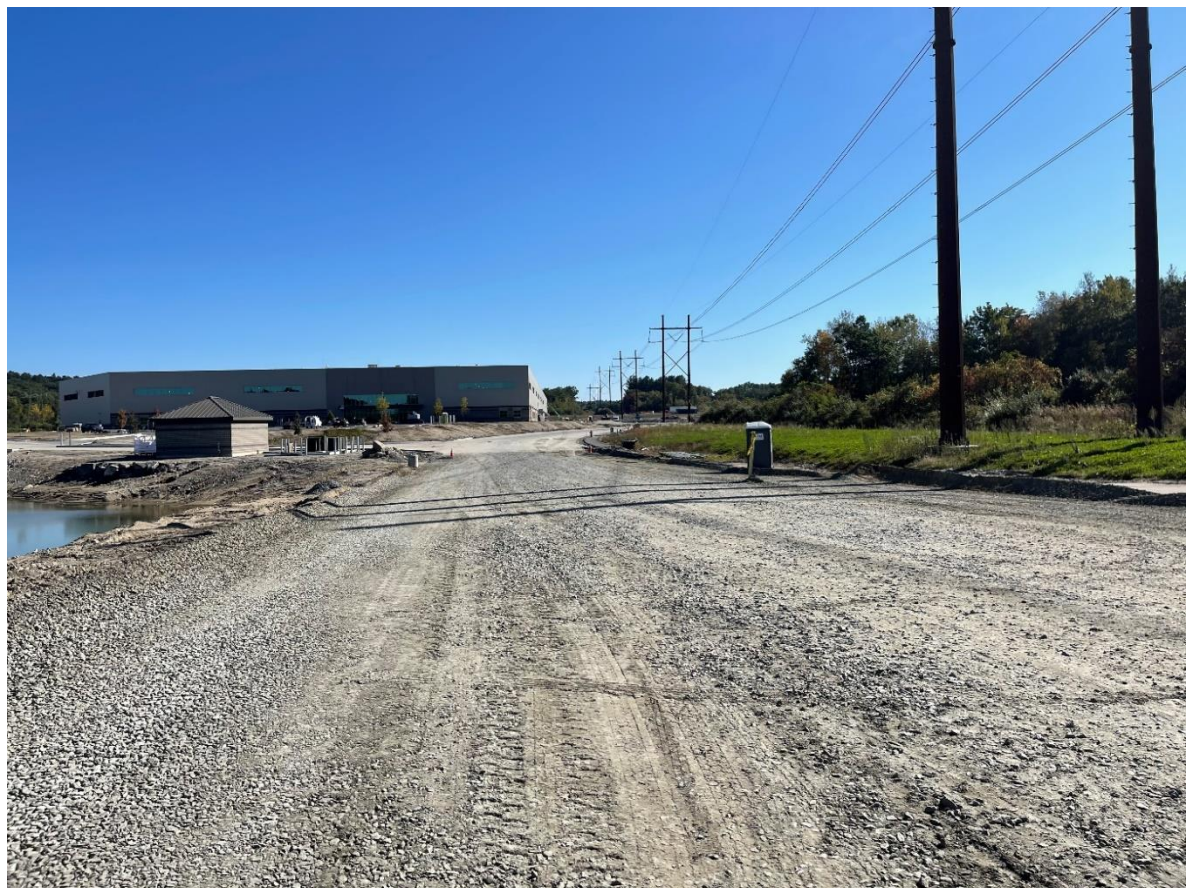
Photo 3: General conditions of the dense graded crushed stone at approximately station 32+00 facing towards 56+00.

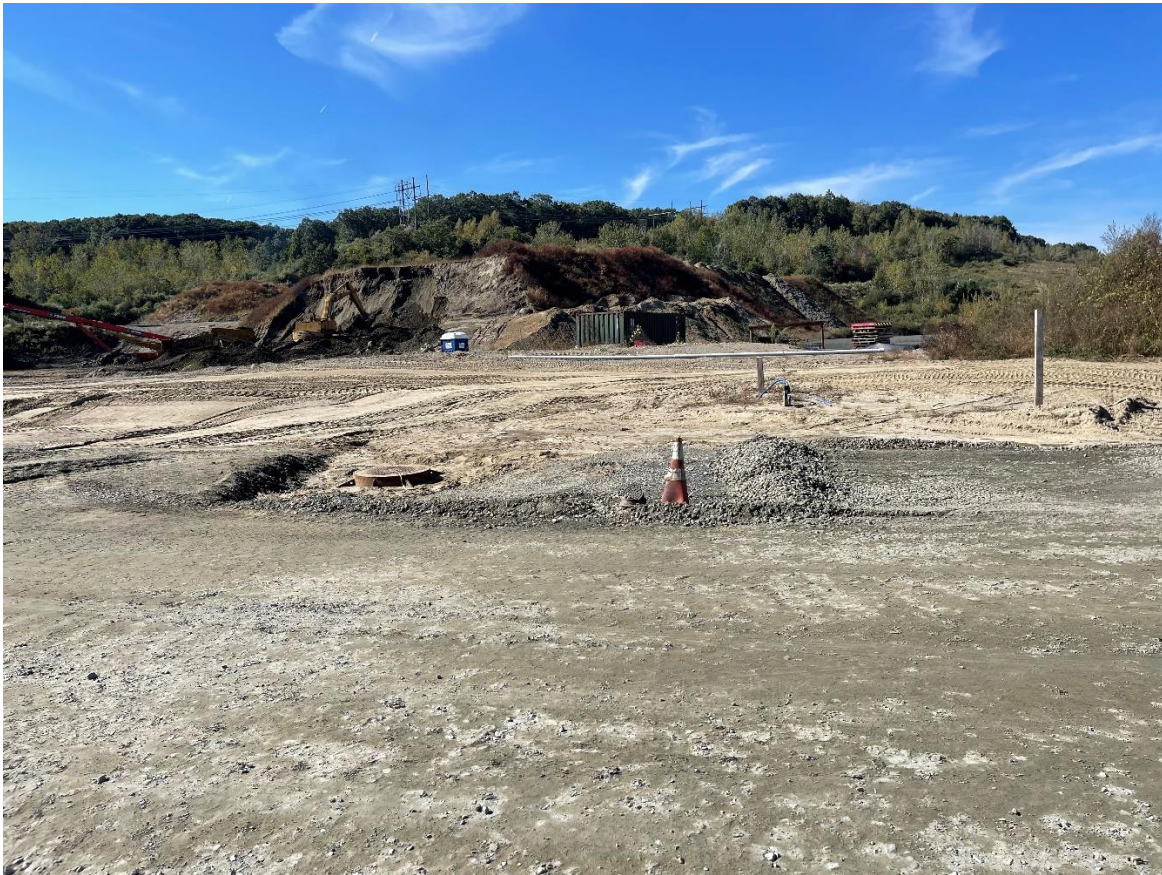
- The contractor was fine grading the roadway at approximately station 22+00. They informed me the remaining portion of the road had been fine graded prior to my arrival. The area immediately surrounding the electrical manhole near station 17+00 did not have dense graded crushed stone.

Photo 4: The area immediately surrounding the electrical manhole did not have dense graded crushed stone.

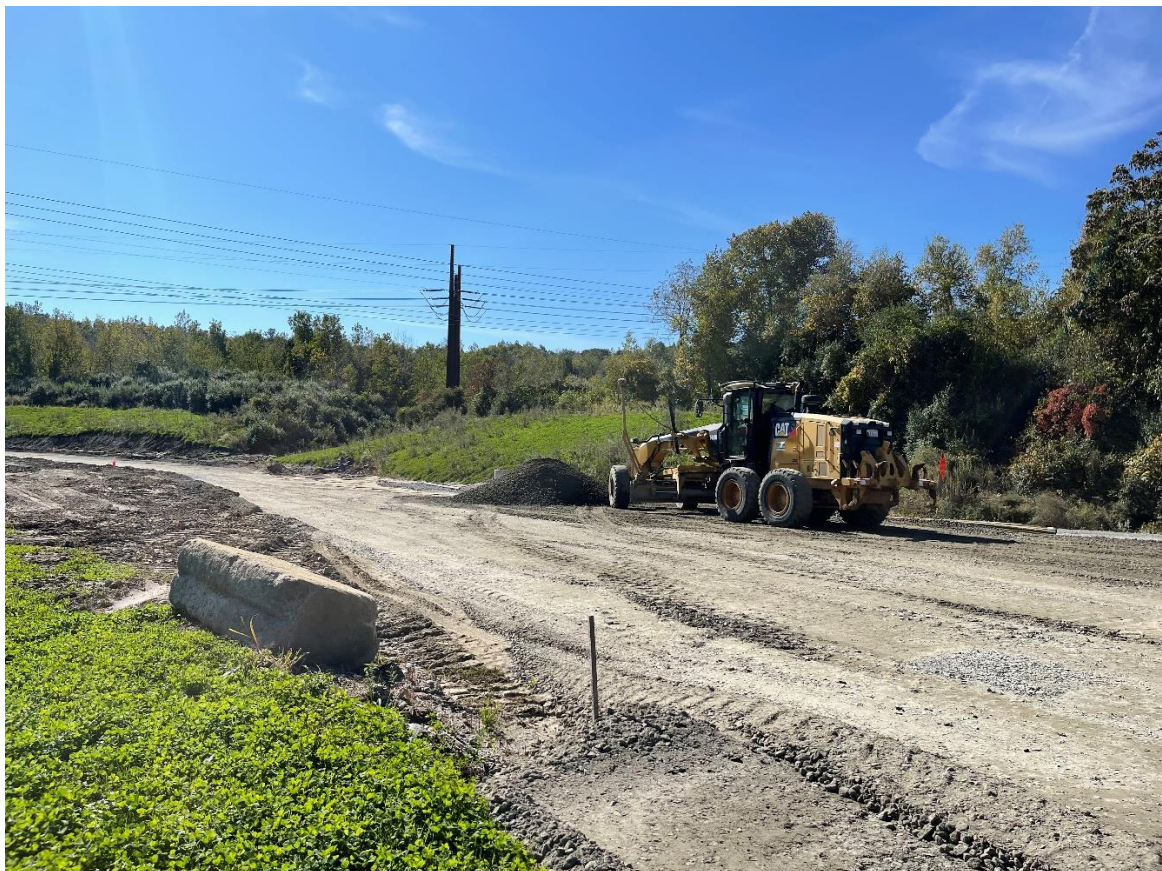
Photo 5: The contractor was fine grading at station 22+00.

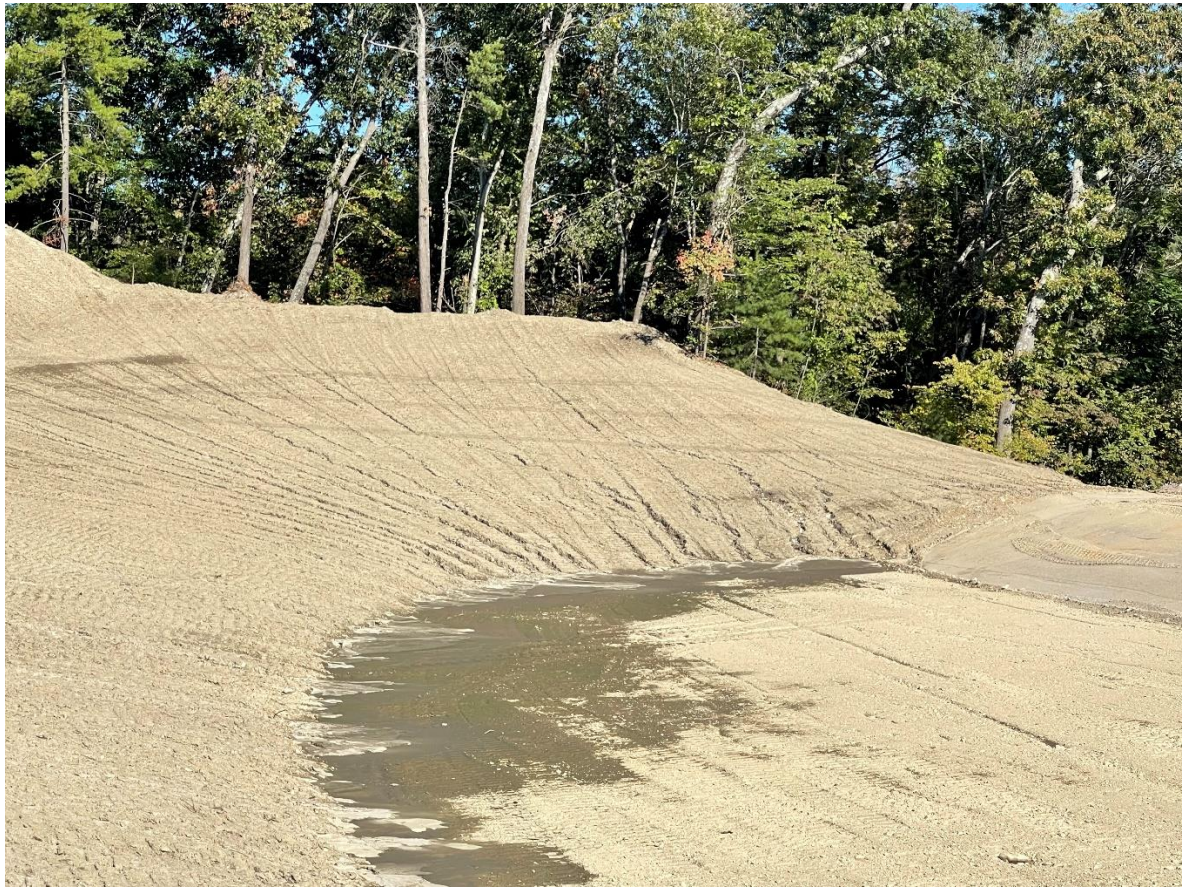
- Stormwater Management Area (SWMA) #1 was dry, approximately six inches of water had pooled in SWMA #2, and over two feet of water had pooled in SWMA #3.
- Erosion rills had formed along the eastern slope of SWMA #4.

Photo 6: Erosion rills had formed along the eastern slope of SWMA #4.

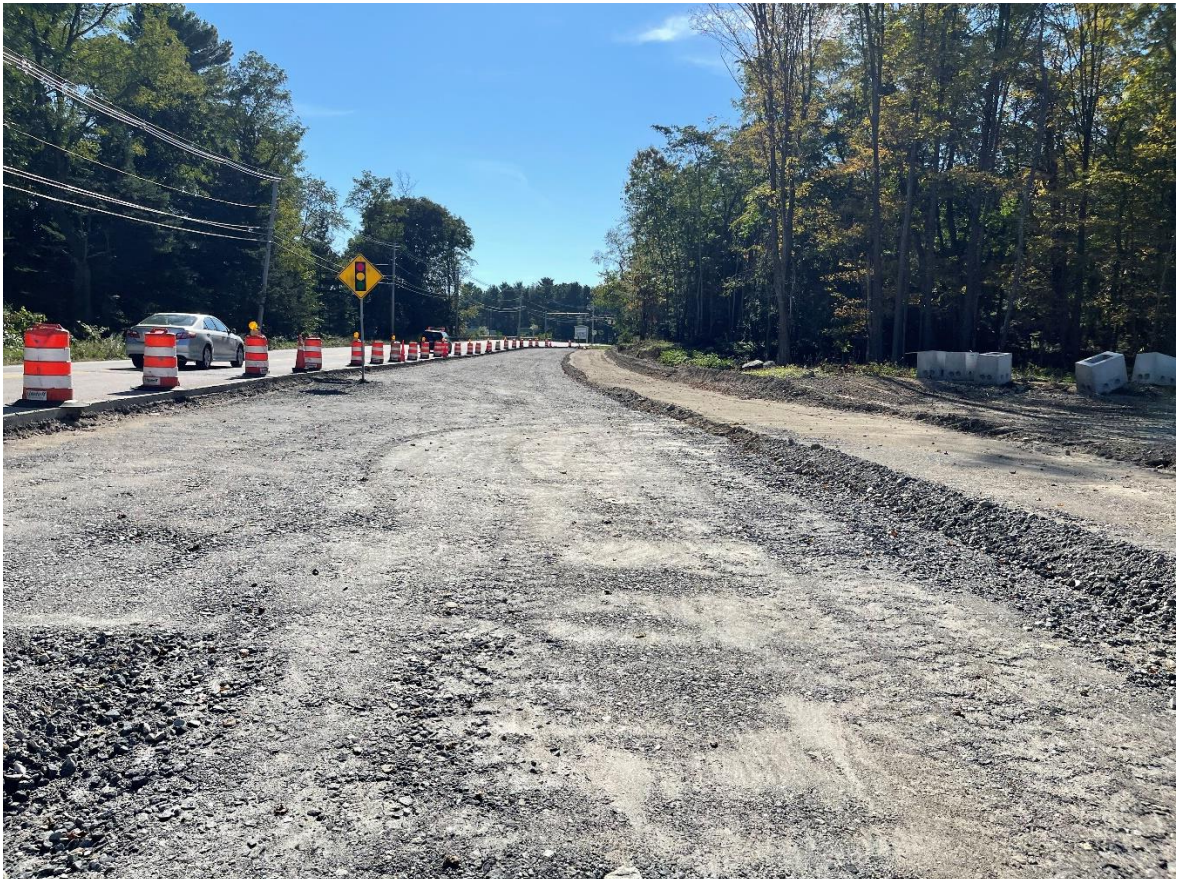
- The dense graded crushed stone in the road modification areas had been fine graded in a satisfactory manner.
- The slope and cross slope of the modification areas were checked intermittently. The slope was found to be between 0.5% and 3.55%. The cross slope was found to be between 0.6% and 5.15%.

Photo 7: The dense graded crushed stone in the Boston Road modification areas had been fine graded.
