Site Visit Report

Date: September 28, 2023
Client: Sutton Planning Board
Project: Unified Parkway
Contractor: Walsh Contracting Corp.
Contractor Contact: John Walsh

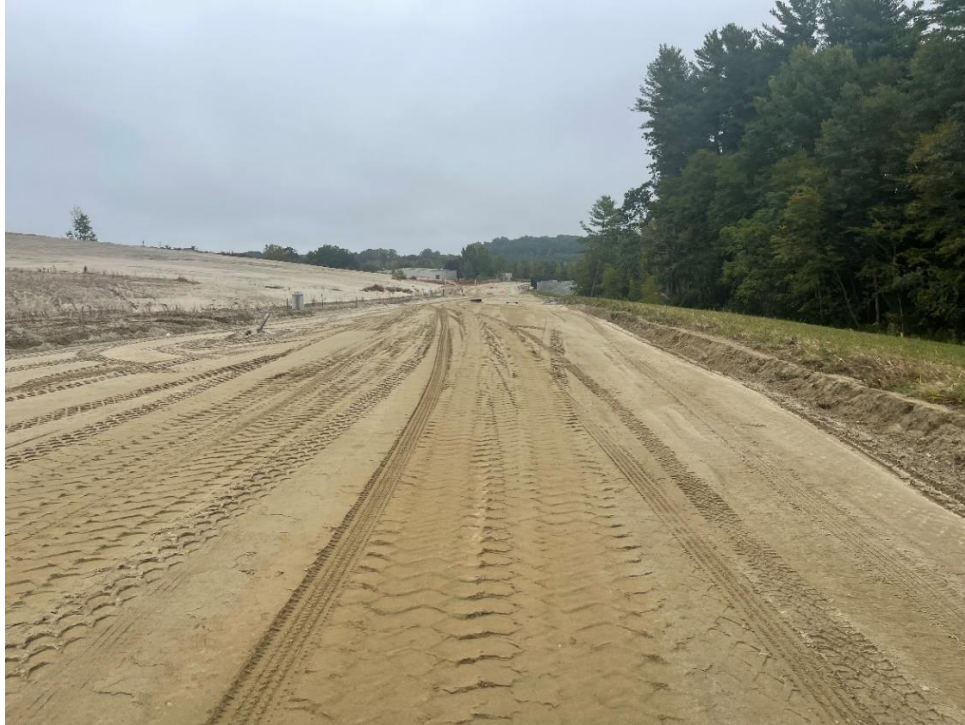
- The contractor was moving earth material throughout the site.
- The road subbase between stations 0+00 and 35+50 was free of organics. The right-of-way had been cleared and compacted to a width of approximately 48 feet, except between approximately stations 25+00 and 27+00 which has a width of approximately 30 feet. It appeared this area excluded the landscaped portion of the right-of-way.

Photo 1: General condition of the subbase at approximately station 15+00, facing towards 0+00.

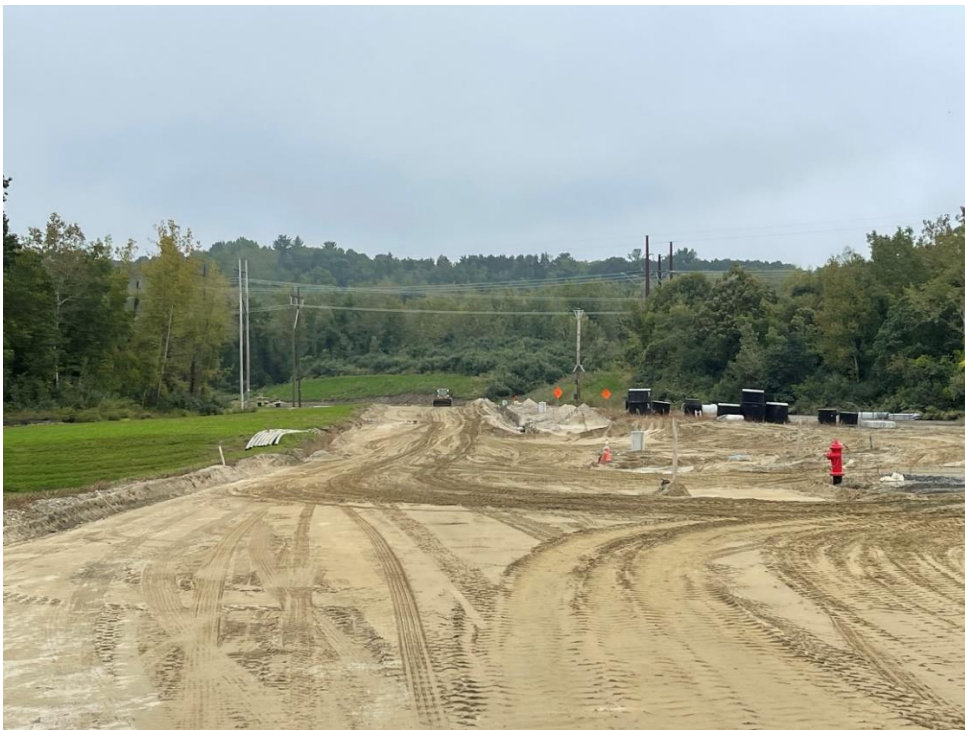
Photo 2: General condition of the subbase at approximately station 19+00, facing towards 56+00.

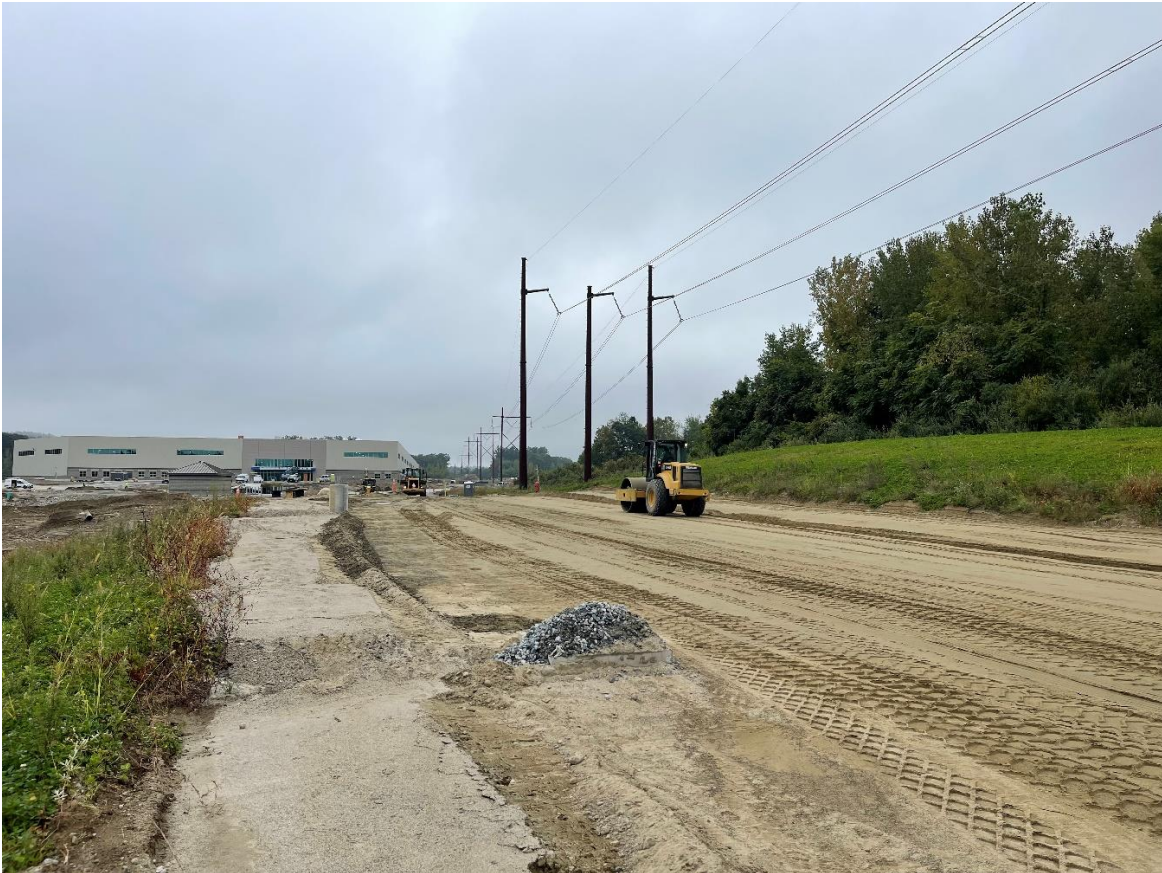
- The contractor was placing dense grade crushed stone along the right-of-way between stations 0+00 and 0+90 in approximately one-foot lifts.
- The contractor was compacting the roadway between stations 30+00 and 32+00 with a 10-ton roller.

Photo 3: The contractor compacting the roadway between stations 30+00 and 32+00.

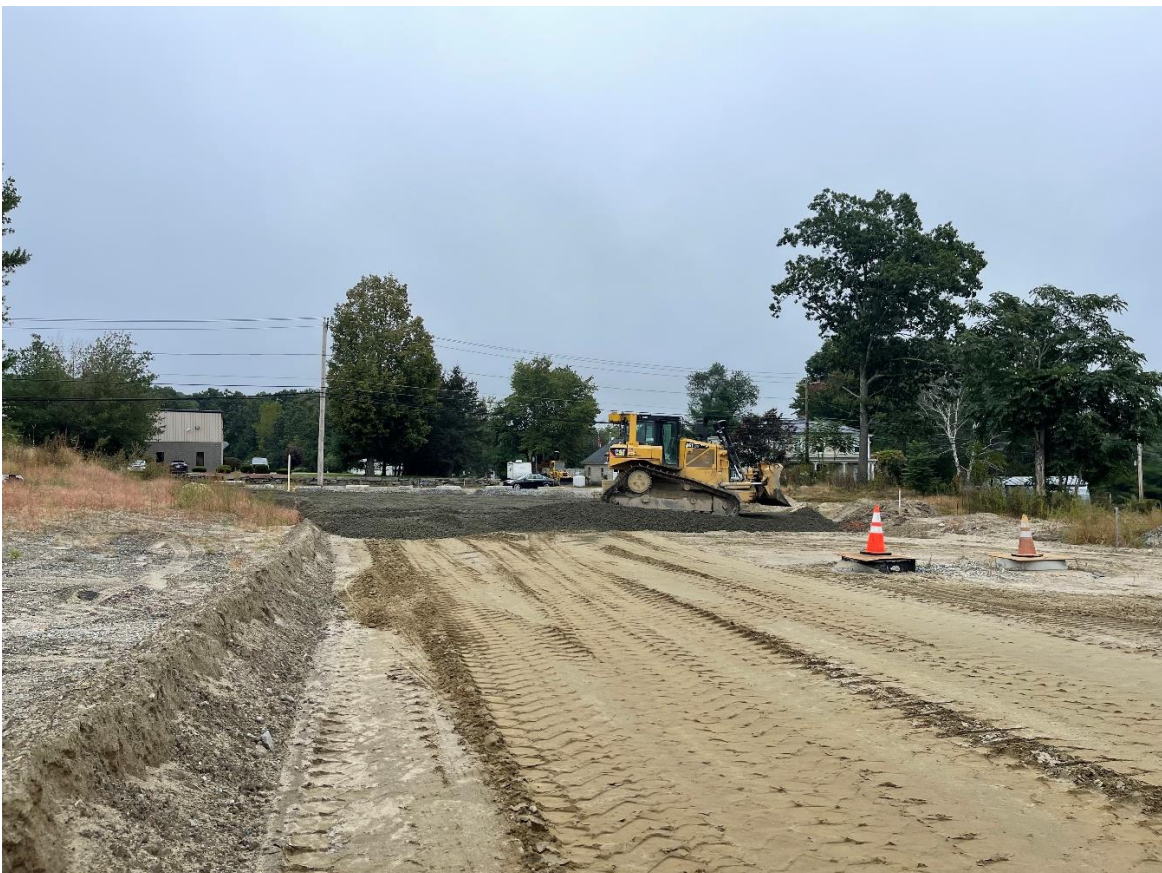
Photo 4: The contractor placing dense grade crushed stone at station 0+90.

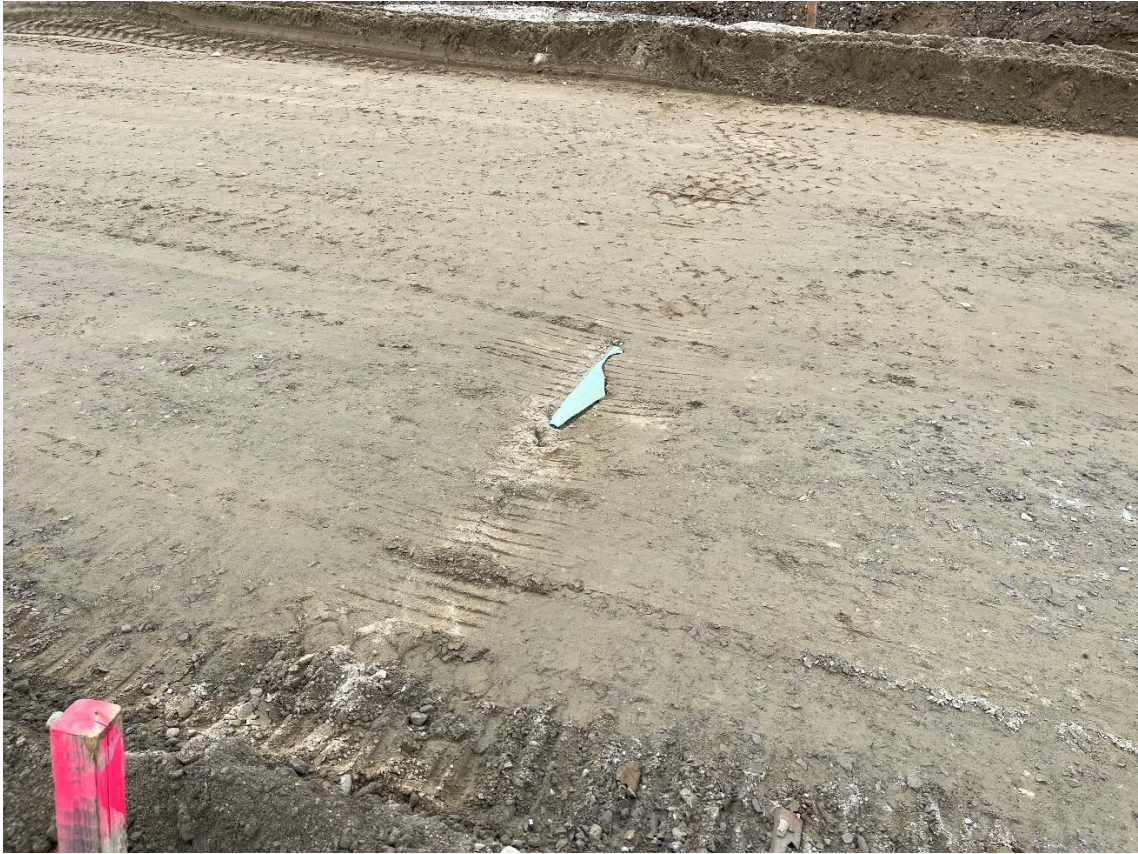
- At approximately station 27+00, approximately two feet of an SDR pipe running across the roadway was exposed. The exposed portion of the pipe had broken. This pipe does not appear on the plans.

Photo 5: The exposed portion of the SDR pipe at station 27+00 was broken.
