Site Visit Report

Olivia Caton Date: March 13, 2023 Prepared By: Arrived on site: Client: Sutton Planning Board 3:45 PM Project: **Unified Parkway** Left site: 4:15 PM **Contractor:** Walsh Contracting Corp. **Site Conditions:** Slightly Damp **Contractor Contact:** John Walsh Weather: 43°, Raining

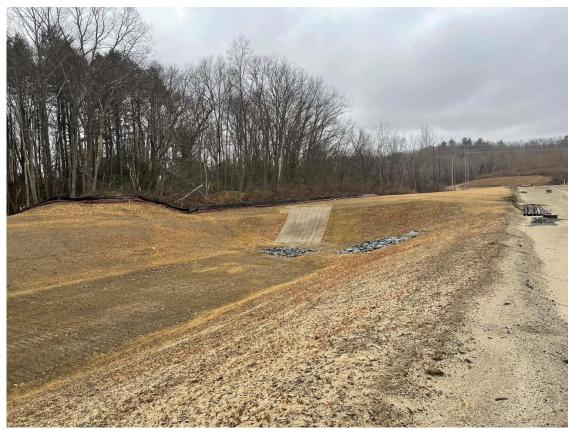
Photo 1: The silt fence and stump grindings between the eastern corner of Stormwater Management Area (SWMA) #1 and the property line were well-maintained.

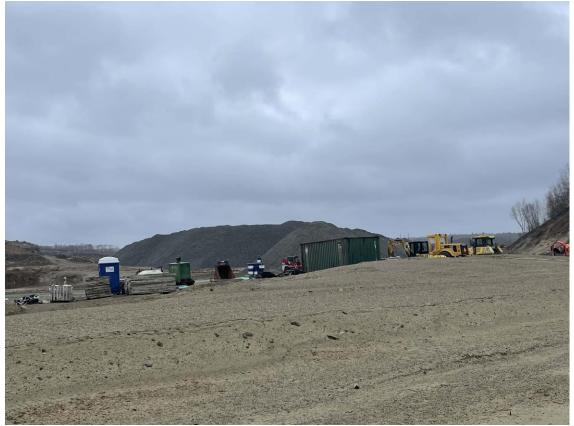
Photo 2: Three-quarter-inch crushed stone was stockpiled in the storage area and outside the right-of-way.
