# Site Visit Report

**Date:** April 27, 2023  
**Client:** Sutton Planning Board  
**Project:** Unified Parkway  
**Contractor:** Walsh Contracting Corp.  
**Contractor Contact:** John Walsh

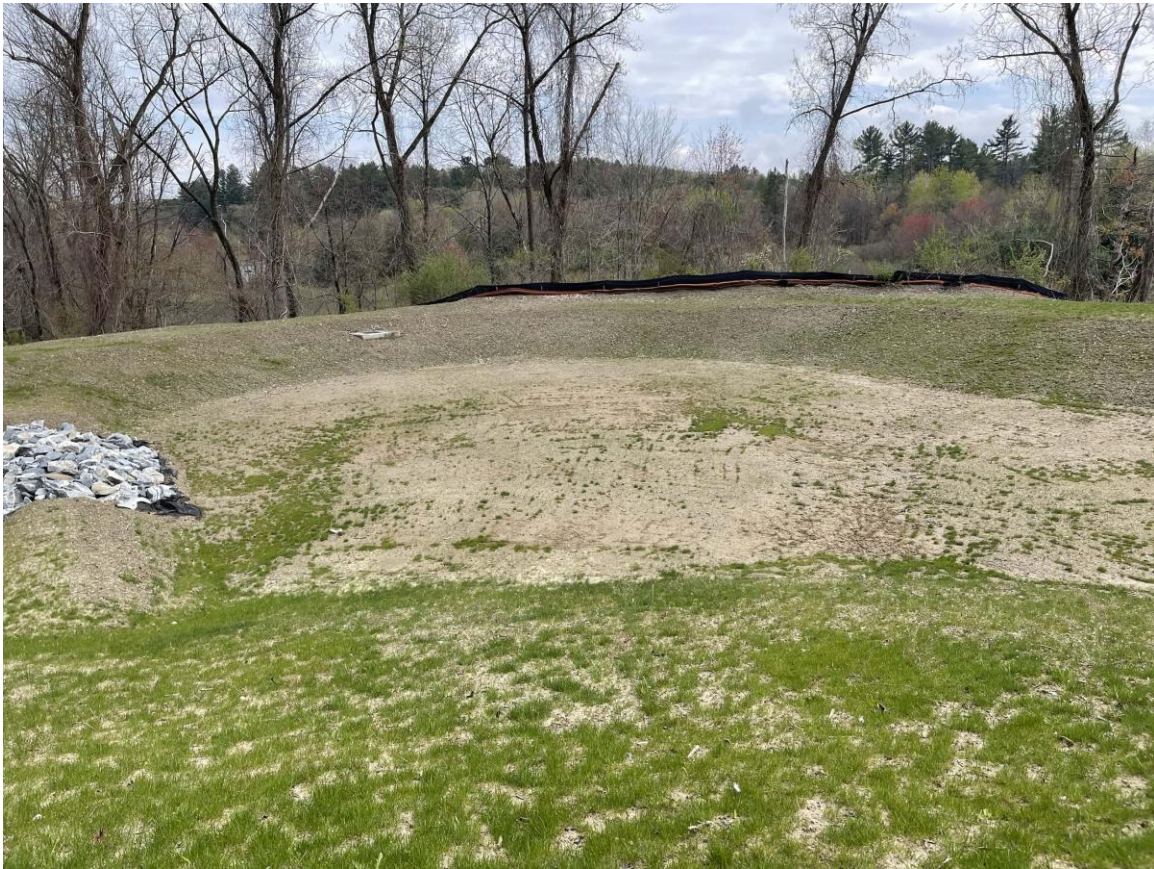
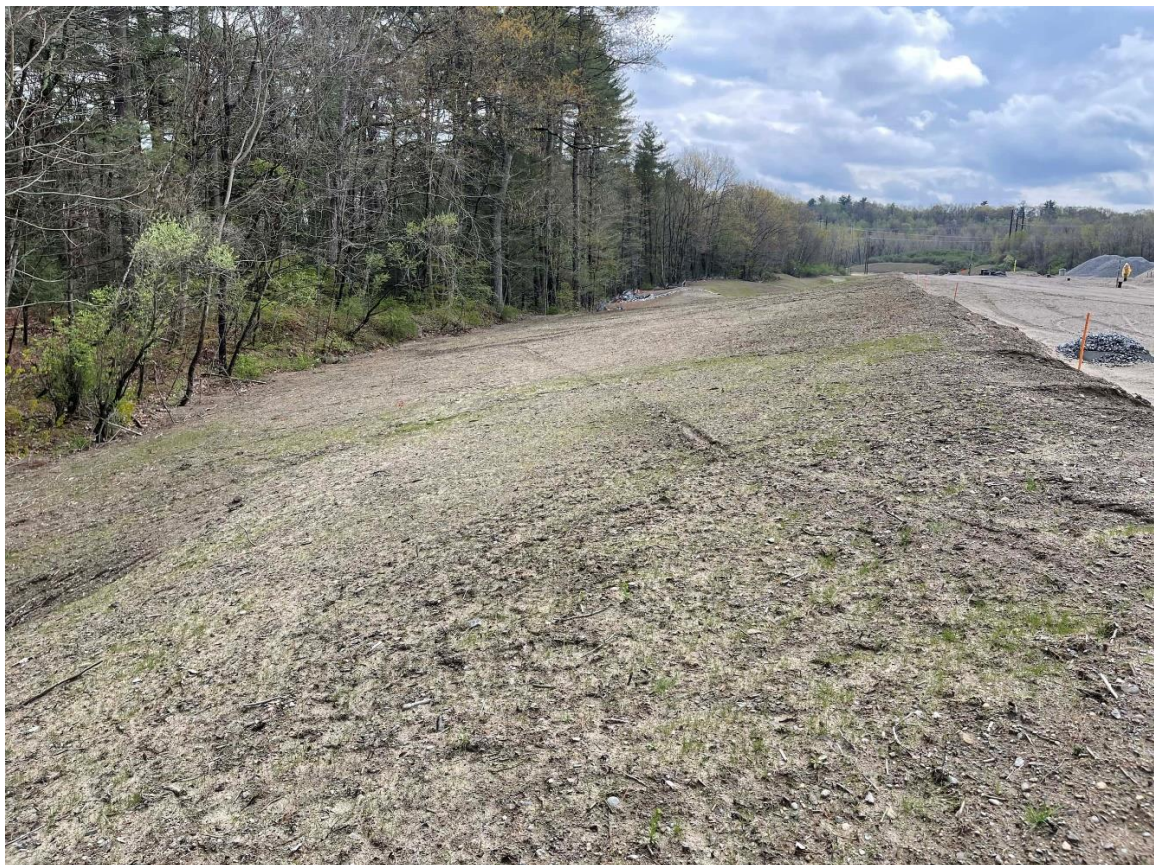
- SWMAs #1 and #2 were dry. SWMA #3 contained approximately 6 inches of water.
- Areas throughout the site experiencing less than 70% grass coverage (e.g., SWMAs #1 and #2, the slope along the retaining wall between stations 2+50 and 8+00, the slope between the retaining wall and SWMA #2) may have to be reseeded to encourage additional grass growth.

**Photos 1 and 2:** Areas experiencing less than 70% grass coverage (SWMA #1 and the slope between the retaining wall and SWMA #2 shown) may have to be reseeded to encourage additional grass growth.

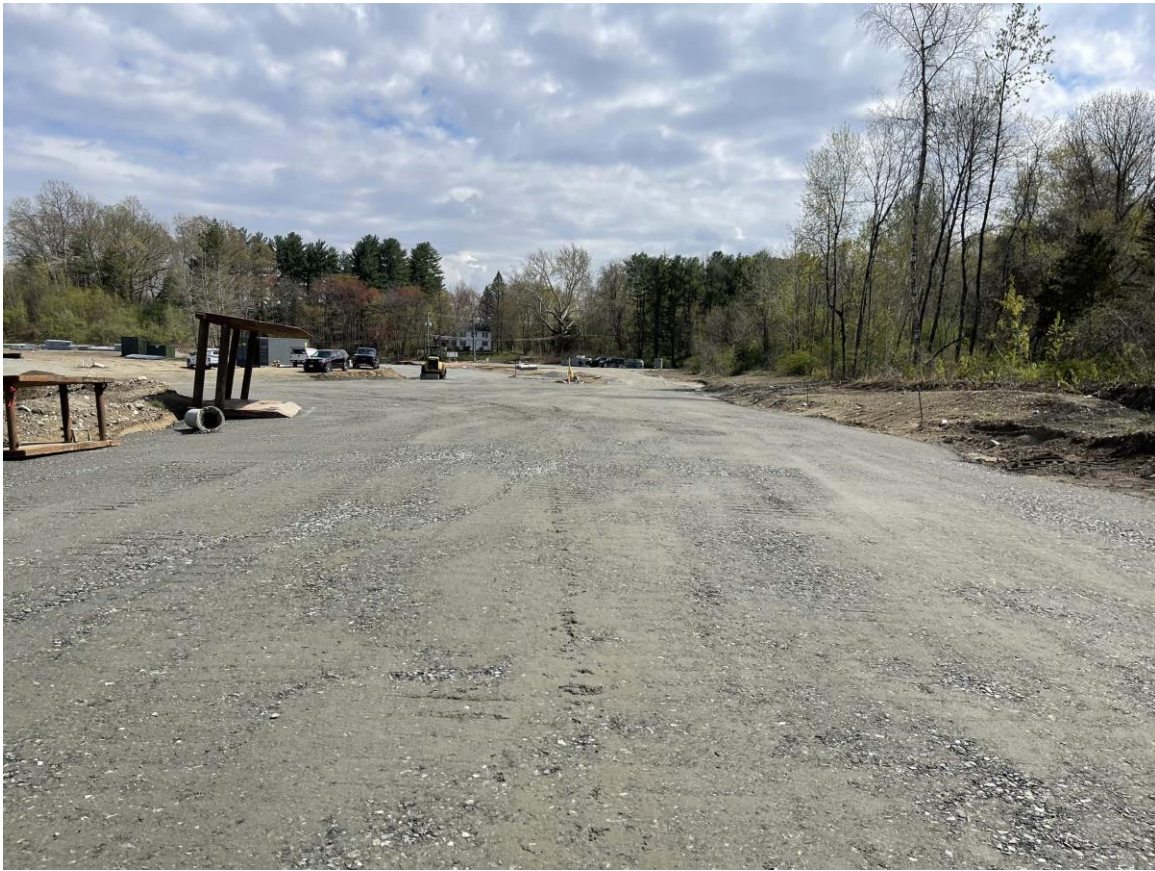
- The erosion rills along the right-of-way slope at station 44+00 should be repaired.
- Between approximately stations 39+99 and 56+00, dense-grade crushed stone had been placed and compacted along the right-of-way to a width of approximately 50 feet, avoiding utilities. At approximately station 39+00, the contractor was placing a one-foot lift of dense-grade crushed stone.

**Photo 3:** Dense-graded crushed stone had been placed and compacted along the right-of-way between stations 50+00 and 56+00 to a width of 50 feet.

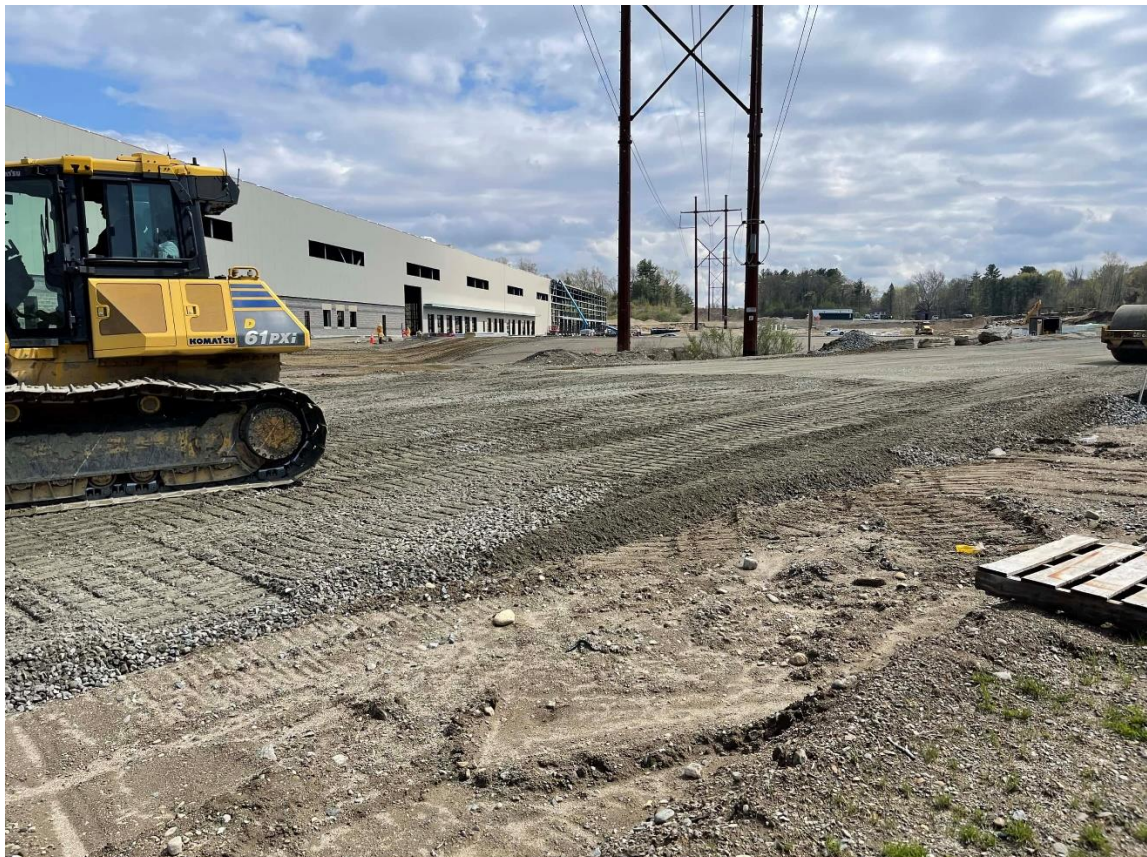
**Photo 4:** The contractor placing a one-foot lift of dense-graded crushed stone at approximately station 39+00.
