Site Visit Report

Date: July 26, 2023
Client: Sutton Planning Board
Project: Unified Parkway
Contractor: Walsh Contracting Corp.
Contractor Contact: John Walsh

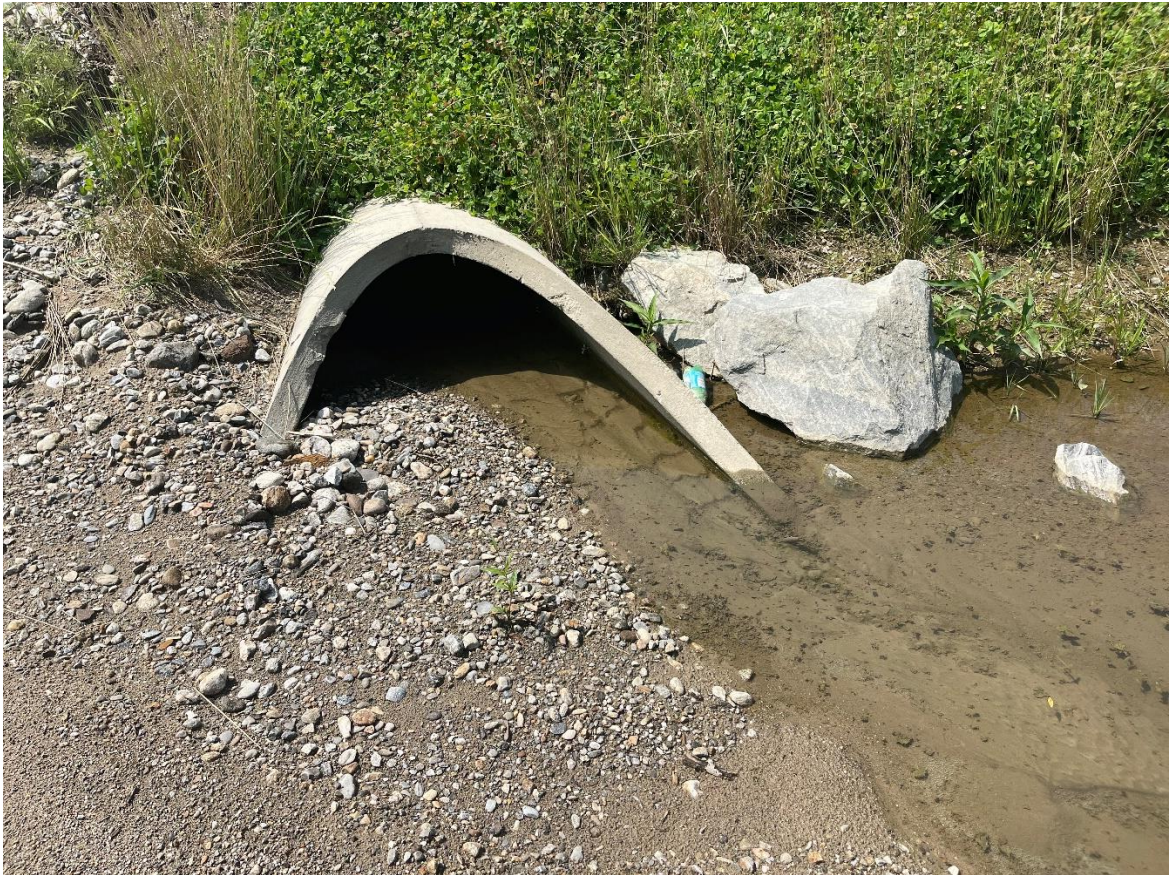
- Sediment had accumulated in Flared End Section (FES) 301. An erosion rill had caused additional sediment buildup in this portion of SWMA #3. The erosion rill needs to be repaired and the sediment cleaned out.

Photo 1: Sediment had accumulated in FES-301 and needs to be cleaned out.

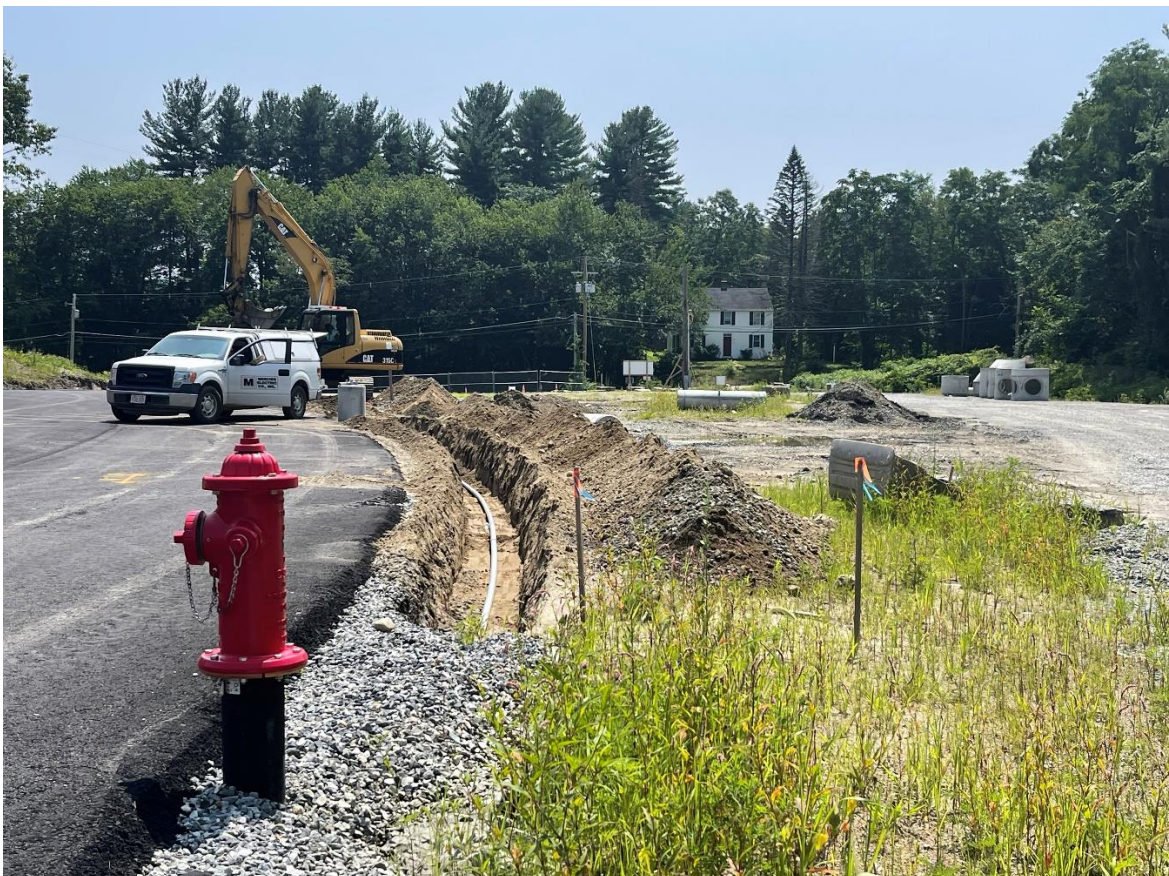
- SWMAs #1 and #2 were dry. Water had pooled in SWMA #3 to approximately one foot deep.
- The contractor was installing electrical conduit pipe at approximately station 52+50.

Photo 3: The contractor installing electrical conduit pipe at approximately station 52+50.
