ROAD SAFETY AUDIT

Worcester - Providence Turnpike (Route 146)
at Boston Road
Town of Sutton
October 25, 2022

Prepared For:
MassDOT

Prepared By:
VHB
120 Front Street
Worcester, MA 01608

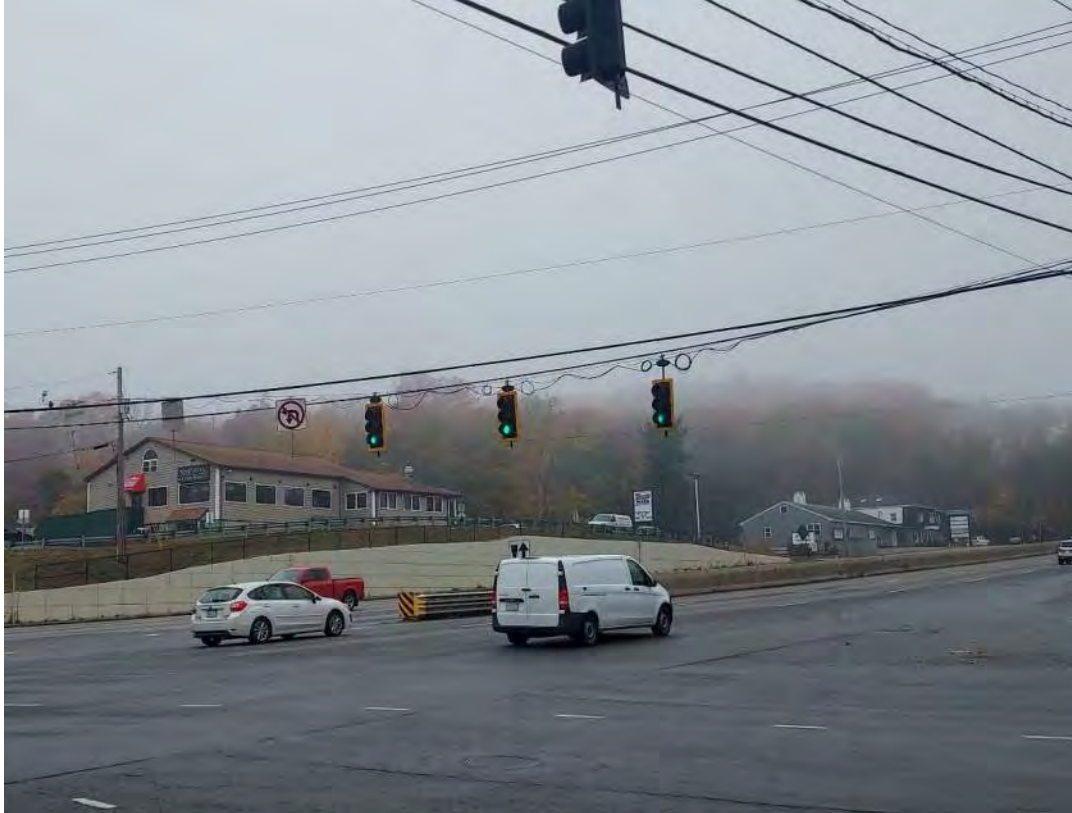
Image 1: Route 146 NB Approach - Green Ball Indications

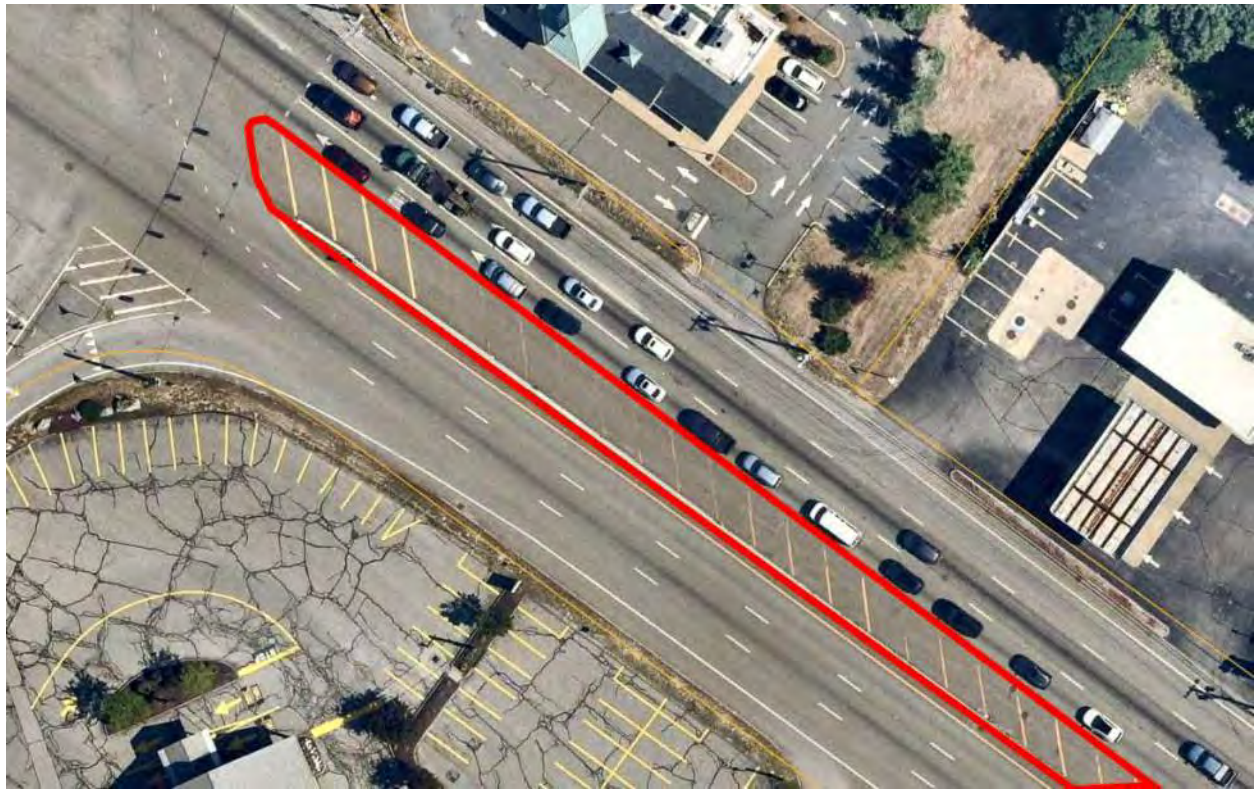
Image 2: Painted Median on Route 146 NB

- Consider installing additional broken lane lines to delineate the edge of the inner lane for the Route 146 southbound left turns and Boston Road westbound left turns to enhance vehicle turning movement tracking through the intersection.

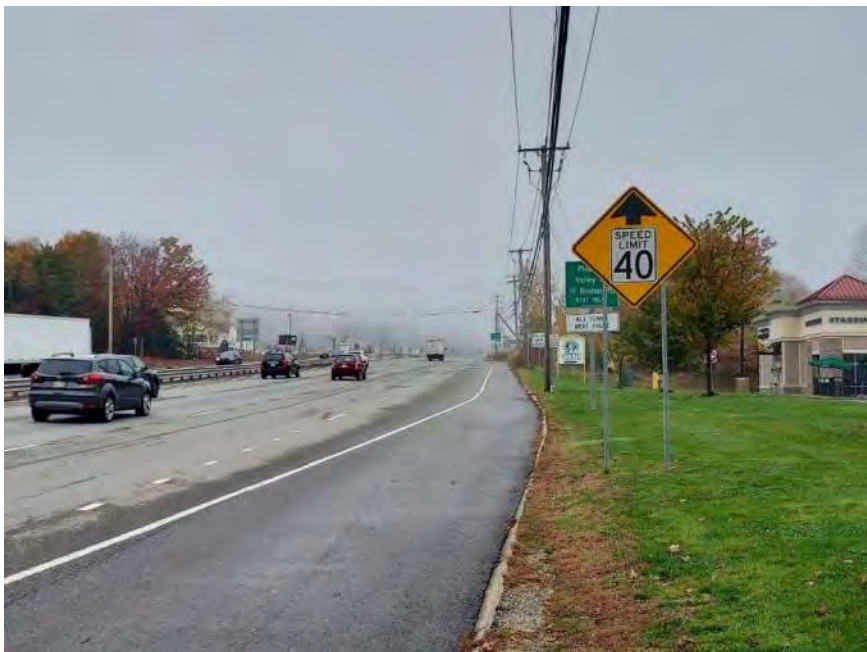
A set of guide signs is provided along the Route 146 northbound approach to the intersection to notify motorists that they must exit onto Pleasant Valley Road to access Boston Road. However, these signs are not located well in advance of Pleasant Valley Road. Additionally, the first of the guide signs is obscured by a speed limit ahead warning sign. The second of these signs is located slightly north of Pleasant Valley Road within the small traffic island beyond where vehicles turn and may be in a location where motorists do not have sufficient time to see it and maneuver into the right-turn lane. These signs are located on the right-side of the roadway and may be difficult for motorists traveling in the center or left lanes to see and maneuver, especially during congested traffic conditions.

Image 3: Route 146 NB Guide Sign Obscured By Speed Limit Warning Sign
