## *Listening Meeting General Outline*

**General Scope:** Planning Study for the Mumford River / Dark Brook watershed and river corridor with particular focus on flooding issues within the Manchaug Village area.

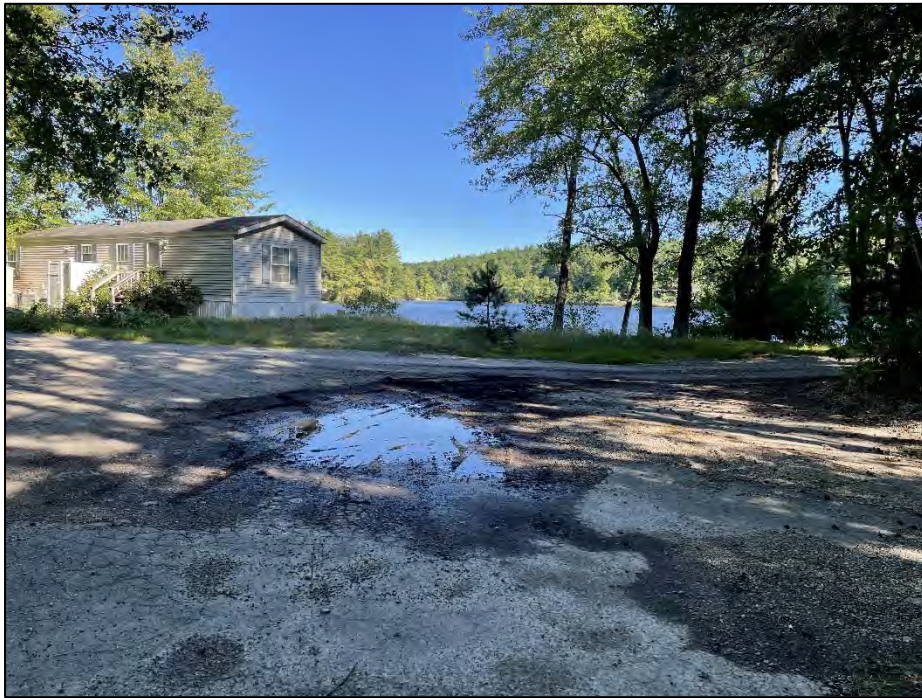
Photo No. 3.: Upper Tucker Pond South Dam low area at right end of dam that serves as informal auxiliary spillway (a.2)

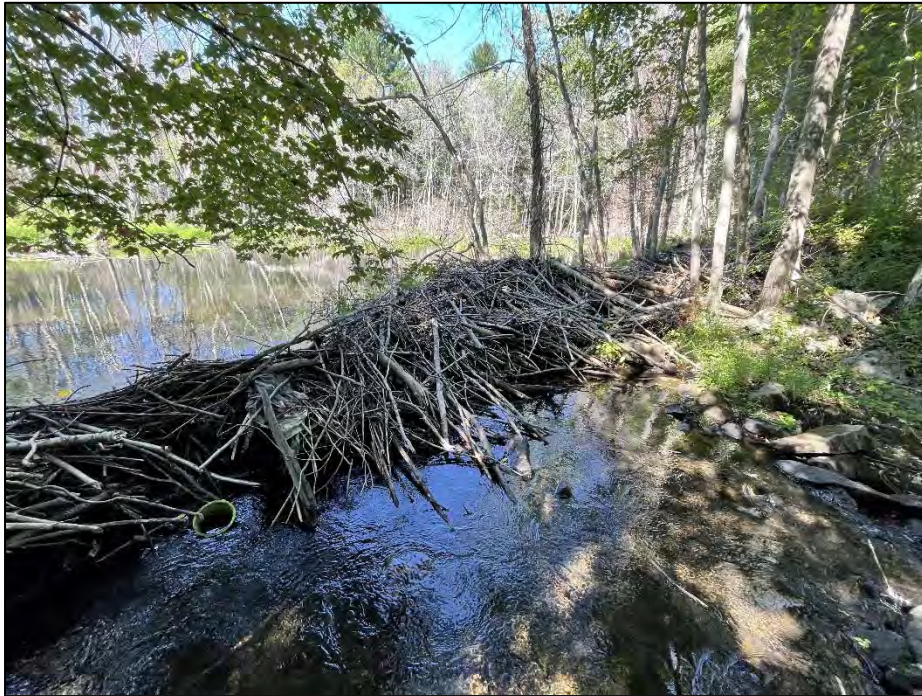
Photo No. 31.: 3-foot high beaver dam (A1) that has formed within breached section of the former dam embankment at Mill Site #1 (B1).

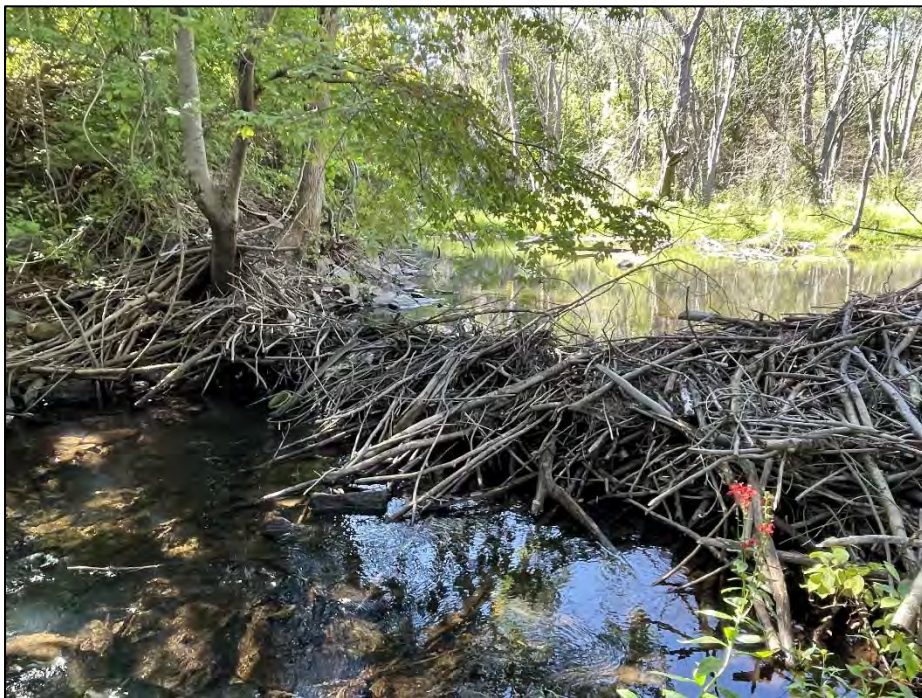
Photo No. 32.: Another view of the 3-foot high beaver dam (A1) that has formed within breached section of the former dam embankment at Mill Site #1 (B1).

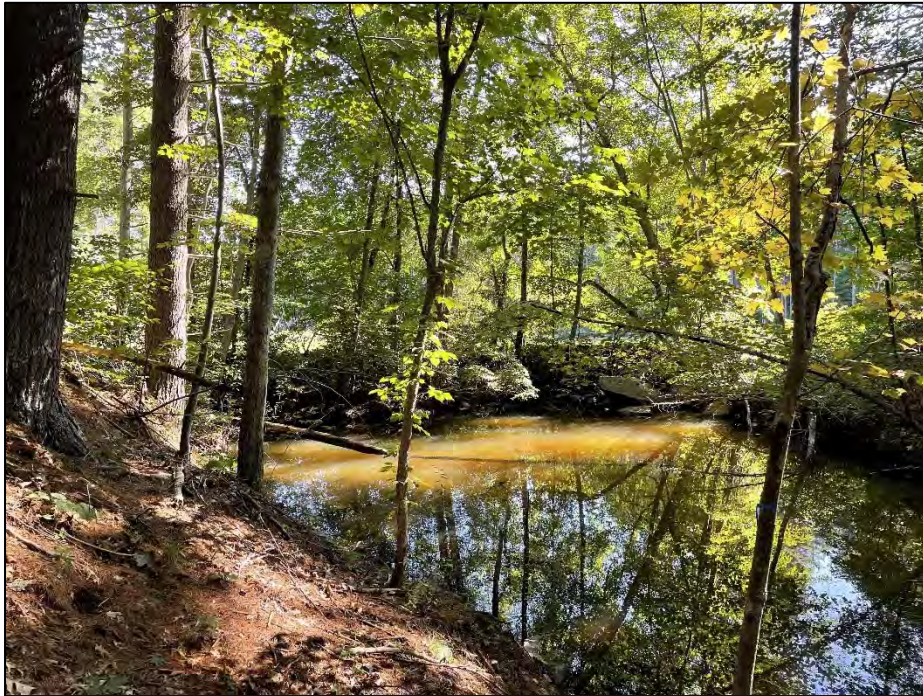
Photo No. 33.: View of the 6-foot high beaver dam (A2) that has formed within the breached section of a former dam embankment (B2).

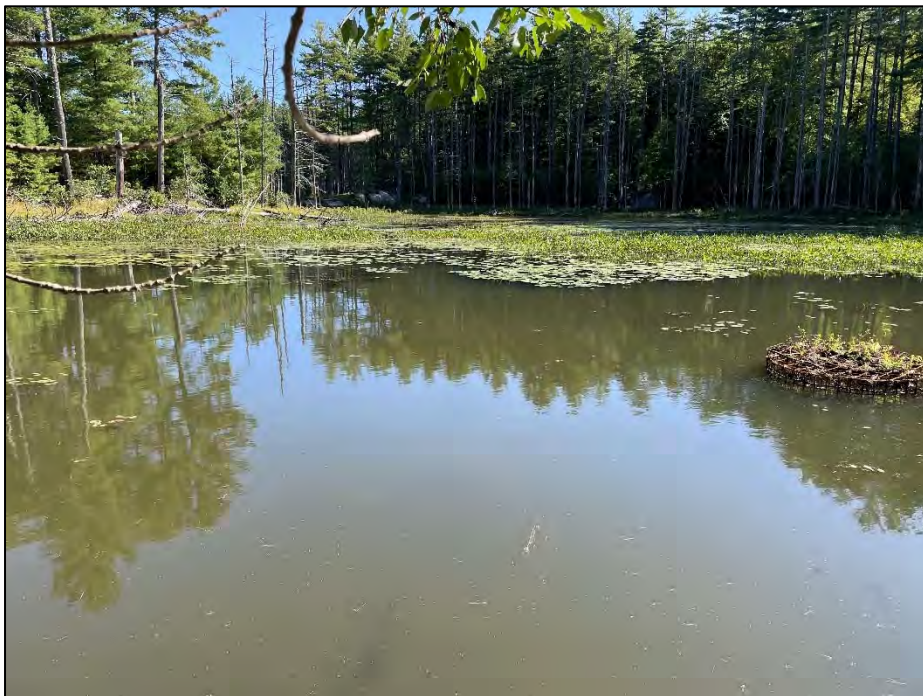
Photo No. 34.: View of the impoundment created by this beaver dam; note the beaver deceiver inlet cage photo right (A2 / B2)
