# Prioritization Planning for Culvert Replacement

An Interactive Qualifying Project Proposal  
Submitted to the Faculty of  
WORCESTER POLYTECHNIC INSTITUTE  
In partial fulfillment of the requirements for the degree of Bachelor of Science.

Water Resource Outreach Center  
Massachusetts

Date:  
May 2, 2023

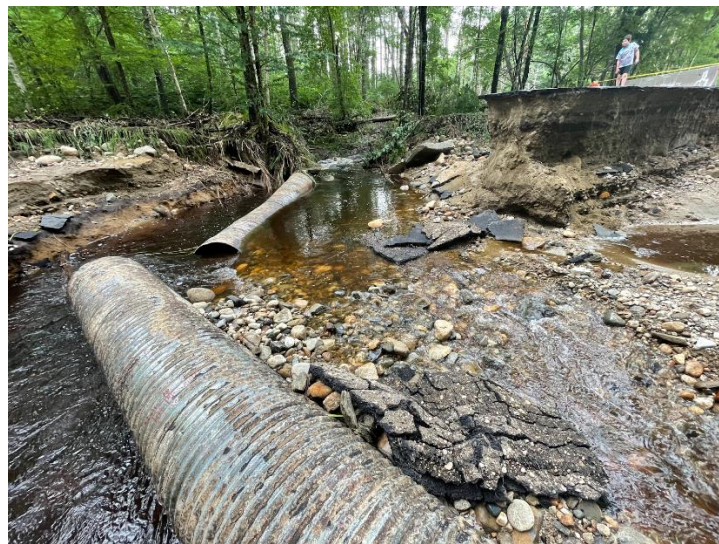
Another example of a major failure took place in Belchertown in July 2021. In this case, a 3-foot-wide culvert became clogged when debris from rainfall overtopped a beaver dam. This undersized culvert, once blocked, forced water around the culvert and completely washed out a portion of East Road, leaving behind a large trench where the road used to be and a split-in-half culvert pipe (*Washed Out Undersized Culvert*, 2022). Though an extreme case, undersized culverts are prone to severe consequences due to blockages such as the one described. The aftermath is shown below in *Figure 2*. Many other examples of culvert failure can be found through a quick Google search.

**Figure 2** - Aftermath of East Road Culvert Failure, Belchertown, MA (*Washed Out Undersized Culvert*, 2022)

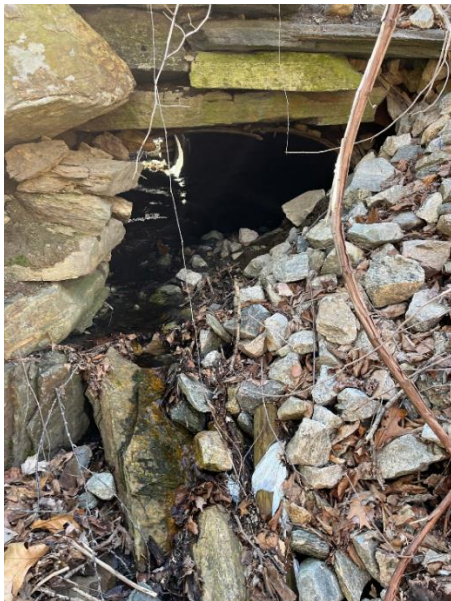
**Figure 6** - Culvert on West Sutton Rd, Sutton

Before elaborating on issues related to mapping and culvert assessments, it is important to note some natural issues that may occur. Refer to *Figure 6* above on the left; older culverts may become buried over time or fill with debris. In the example above, it is likely that these stones, called riprap, were placed intentionally on the slope above the culvert when the road above the construction was repaired, but unintentionally fell down the slope to block the culvert's outlet. This issue was observed in several of our other assessments, as well. Accessibility was brought up in several of our interviews and is one of the criteria the NAACC protocols consider. Location is another barrier that poses an assessment challenge. Some culverts may be inaccessible due to the presence of plant growth, as demonstrated in *Figure 7*, where the inlet pipe was difficult to find due to natural debris, or other culverts that might be located somewhere that requires one to trek through poison ivy, thorns, and mud. Considering the time of year in which assessments are done is also important. Flow conditions and accessibility depend on the season, and as such periods of snowmelt or snow in general either increase flow substantially or prevent it altogether. Culvert assessments ideally take place during the summer during low-flow conditions.

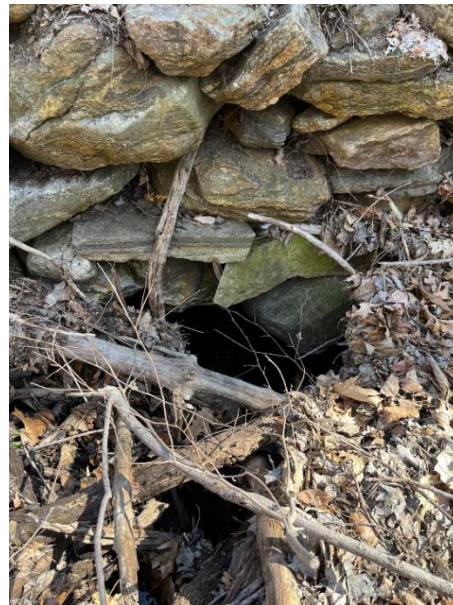
**Figure 7** - Culvert on Griggs Rd, Sutton

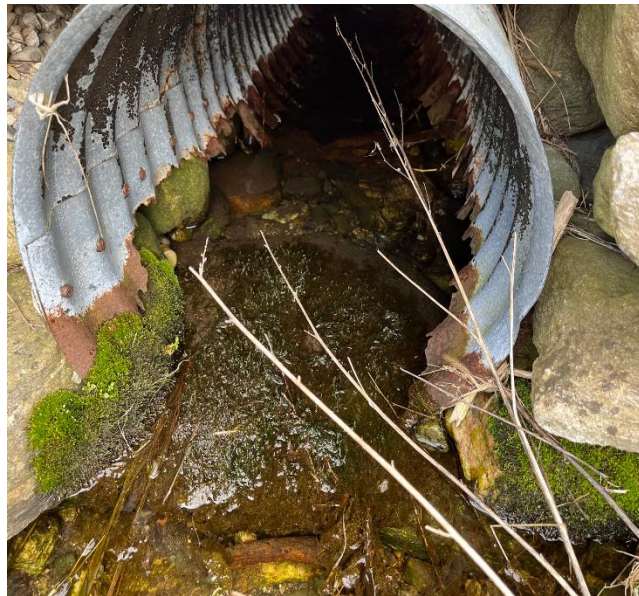
From our interviews, we found that most individuals thought of similar considerations to include in a culvert assessment prioritization plan. One aspect that was commonly brought up by most of our interviewees was the structural condition of the culverts. Culvert structure plays a critical role in a culvert's condition, as poor structural condition can cause sudden failure and collapse. Good working conditions means that the culvert is in great condition, having no noticeable structural defects. Oftentimes, this was found solely in new culverts. Fair condition generally pertains to culverts that, though some wear and tear may be present, do not pose a significant risk of flooding. Poor conditions suggest that failure is imminent due to significant defects, such as if the bottom of the culvert was missing due to rust or other factors, as shown in *Figure 8*.

**Figure 8** - Poor Condition Culvert on Douglas Road in Sutton, MA

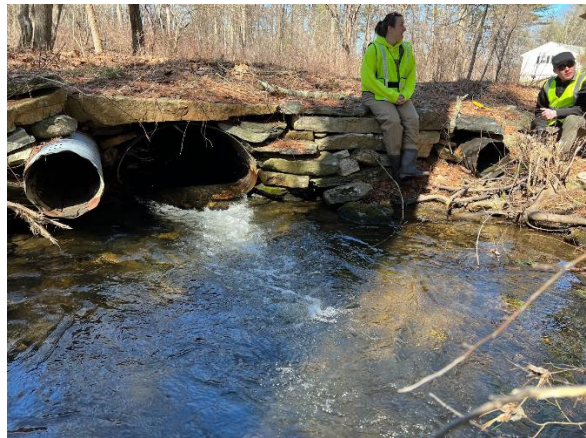
Another important consideration addressed for a prioritization plan from our interviews was aquatic and terrestrial passage and connectivity. Aquatic passage is important in terms of fish movement and if there are barriers along the way where the fishes are trying to go, then fish may not be able to migrate through a crossing. Stream connectivity refers to the flow and pathway of the stream water coupled with the aquatic and terrestrial passage. For example, if a culvert was perched such as in *Figure 9*, both terrestrial and aquatic organisms would not be able to pass through the culvert. Physical barriers such as fences, free falls, and deformation can also hinder aquatic and terrestrial organism movement as shown in *Figure 10* because if a fish or small terrestrial organism were to go through a culvert that has physical barriers, it is more likely to go back or get stuck and/or eventually die.

**Figure 9** - Perched Culvert on Mendon Road in Sutton, MA

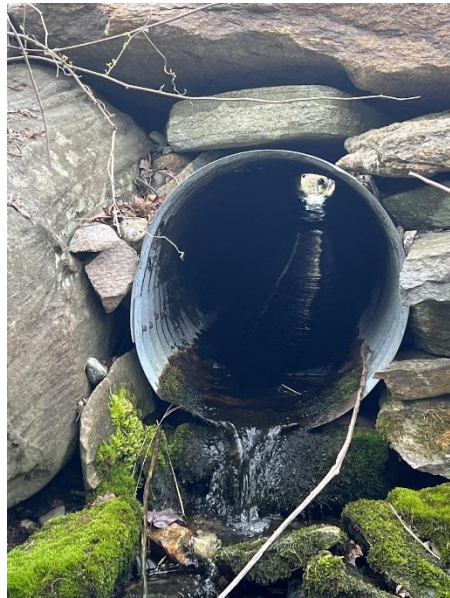
**Figure 10** - Example of Free Fall from a Culvert on Douglas Road in Sutton, MA
