Site Visit Report

Date:January 11, 2024Client:Sutton Planning BoardProject:15 Pleasant Valley RoadContractor:Coastal Construction Corp.Contractor Contact:Rian Kearney

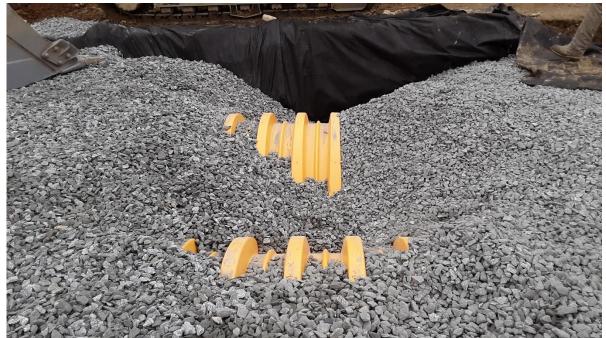
Photo 1: Chambers installed, geotextile fabric placed along the perimeter and one-and-a-half-inch crushed stone had been installed over the chambers.

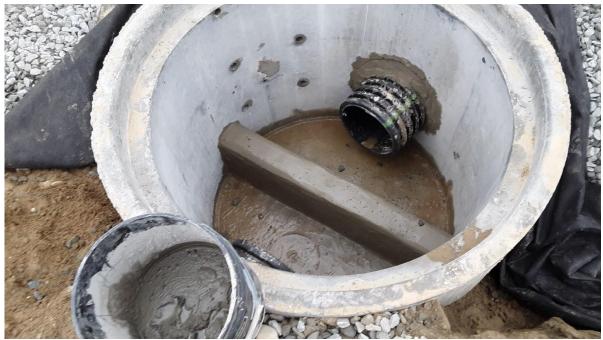
Photo 2: A weir wall had been built within the outlet control structure.
