Site Visit Report

Date:	September 21, 2022	Prepared By:	Daniel Sheehan
Client:	Douglas, Sutton and Uxbridge Planning Boards	Arrived on site:	1:00 PM
Project:	Blackstone Logistics Center	Left site:	1:30 PM
Contractor:	ARCO	Site Conditions:	Dry to damp
Contractor Contact:	David Ruyffelaert	Weather:	65°, Overcast

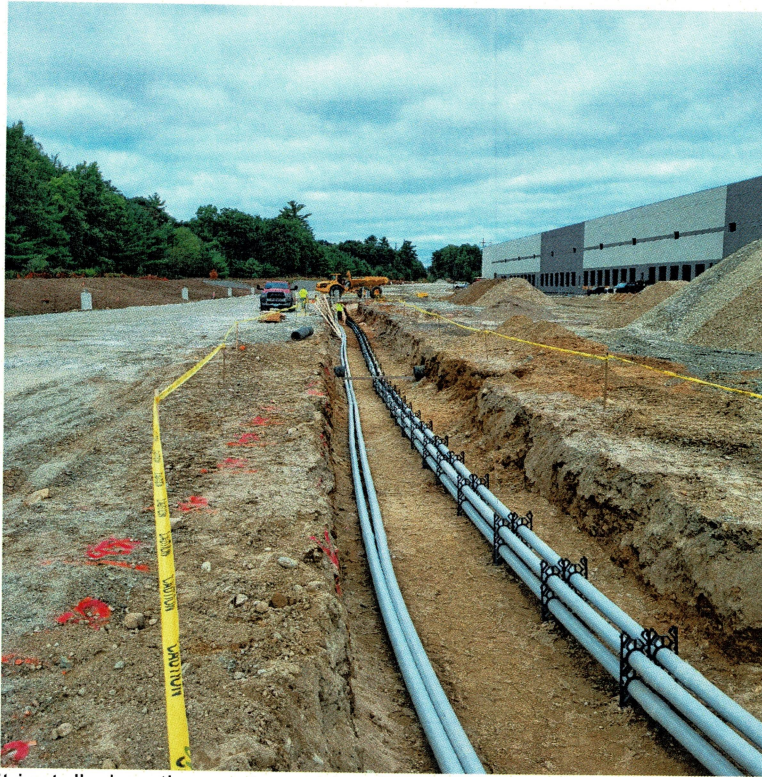
Photo 1: Electrical conduit installed on the western side of the building with drain pipe segment temporarily removed.

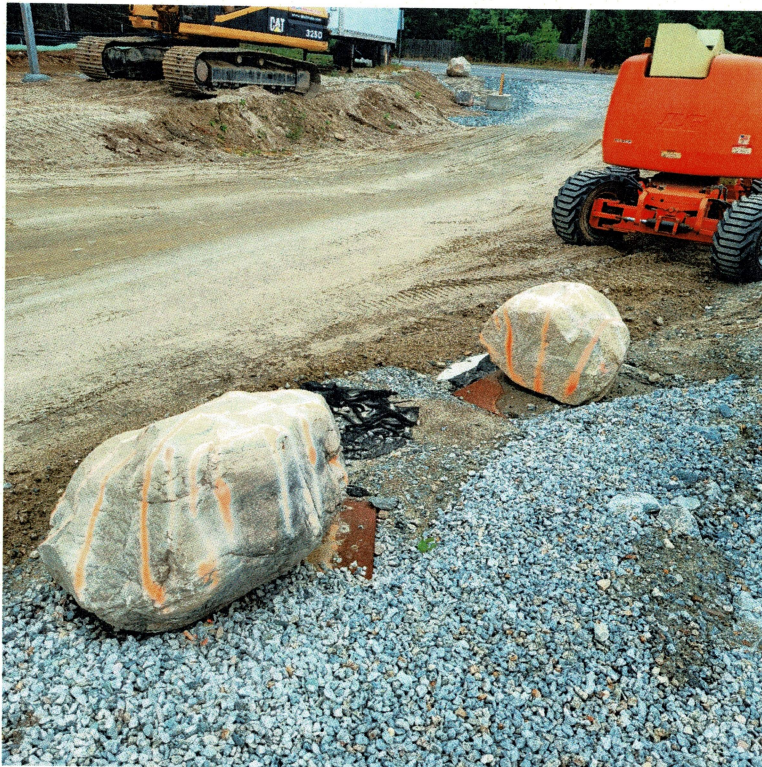
- Water Quality Unit: WQI-2
 - GEI was not notified that the drainage work was performed. Nevertheless, the contractor informed me that WQI-2 was installed and placed on a crushed stone bedding and the connecting pipe runs between CB-36 and CB-35 were installed. However, the outlet piping to Infiltration Basin-2 was not installed yet. The contractor informed me that once the sewer force main was installed beyond the drain line they intended on installing the remaining outlet piping to FE-14.

Photo 2: WQI-2 and CB-36 installed and backfilled around the structures.

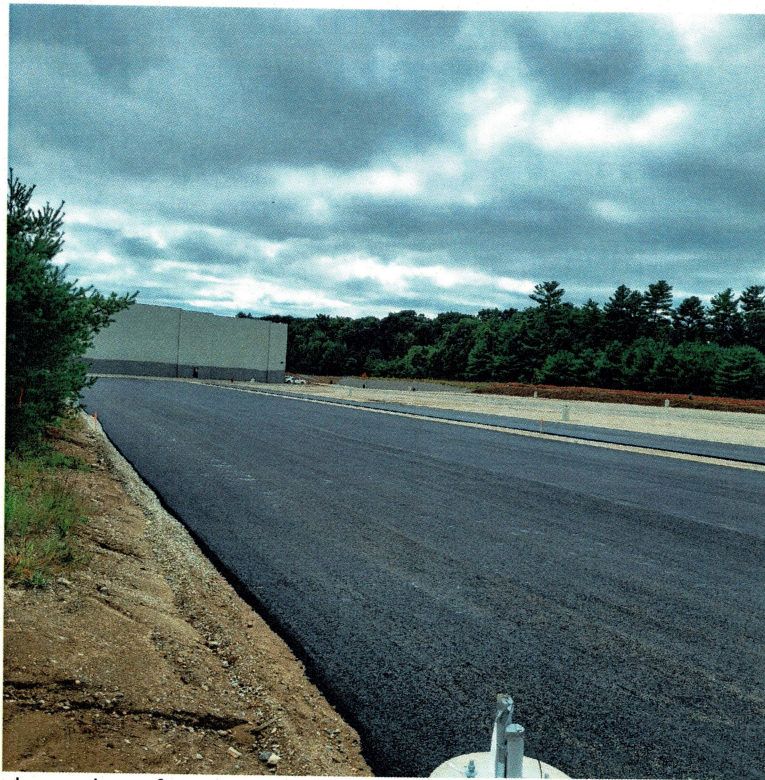
- Building construction continues.
- A portion of the northern parking lot was paved with binder asphalt. The contractor informed me that due to the northern parking lot not having gravel density testing performed yet, their inspector had terminated binder paving operations which will resume once gravel density testing was performed.
- The northern 2H:1V slope was showing signs of grass germination.
- Electrical conduits were installed along the western side of the building and the contractor was preparing forms to encase the conduit in concrete. To perform this work, a drainpipe near DCB-19 segment was temporarily removed and will be reinstalled once the conduit is encased in concrete.
- I-beams were installed throughout the site for the installation of proposed sound barriers.

Photo 3: General overview of northern parking area partially paved with binder course pavement.

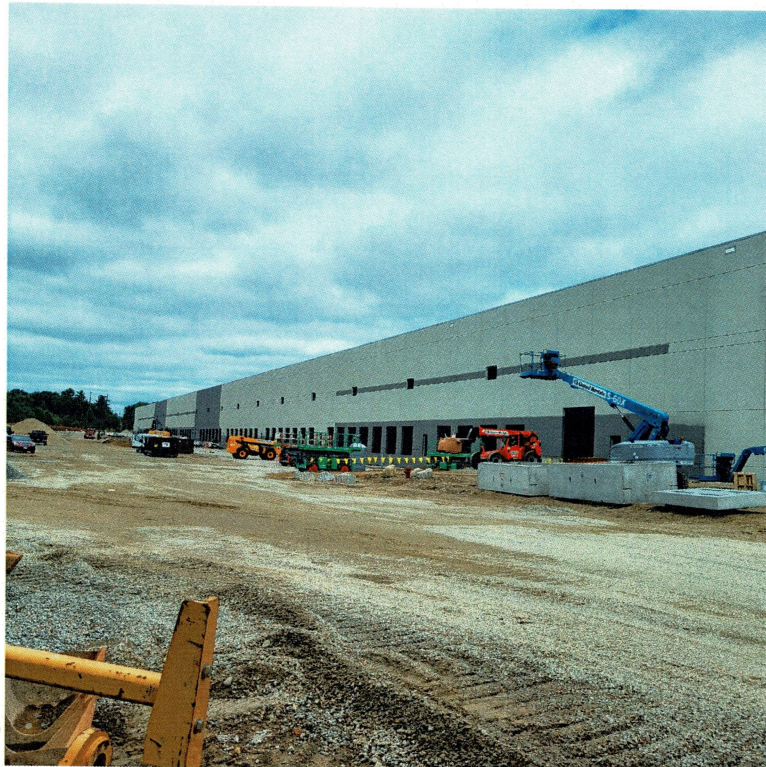
Photo 4: General condition of building construction along the western side of the building.
