Site Visit Report

Date: October 27, 2022 Prepared By: Olivia Caton **Client:** Sutton Planning Board Arrived on site: 11:45 AM **Project:** Stockwell Farm Left site: 2:45 PM Contractor: S.V.S. Construction **Site Conditions:** Drv **Contractor Contact:** Michael Wadden Weather: 63°, Clear

Graves Engineering Inc. (GEI) was on-site at the request of the Planning Board and the contractor to observe the top course paving of Stockwell Farm. I observed the following:

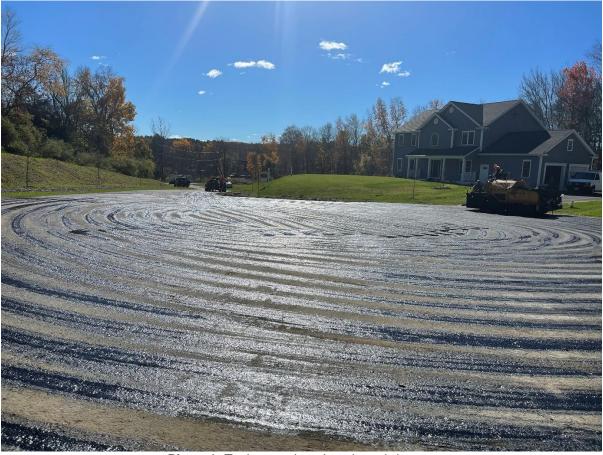
The binder was in a satisfactory condition. A tack-coat of bitumen was placed by a truck with a tack wagon. The paving contractor placed the asphalt at a minimum loose thickness of 1-7/8 inches to provide for at least 1-1/2 inches of compacted asphalt. Facing towards Stockwell Farm, approximately two-thirds of the perimeter of the cul-de-sac was paved beginning at the left edge of the roadway. The cul-de-sac was paved in a horizontal pattern, following along the perimeter. The left side of the roadway was paved from the cul-de-sac to the intersection with Leland Hill Road in a continuous line, then the right side. The loose pavement thickness was checked continuously and the temperature of each load was checked; a representative sampling of spot readings is listed in the table below. The asphalt was rolled with 3-5-ton and 1-ton rollers. The contractor placed approximately 142 tons of State Top. A copy of the last weight slip is attached.

Photo 1: Tack-coat placed on the cul-de-sac.

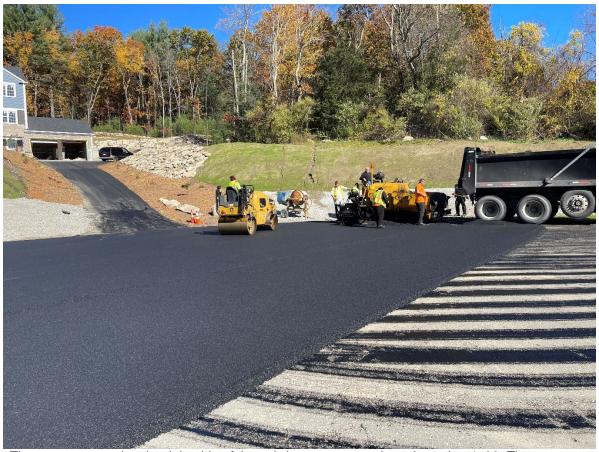
Photo 2: The contractor paving the right side of the cul-de-sac at approximately station 4+00. The contractor can also be seen compacting the asphalt with a 3-5-ton roller.

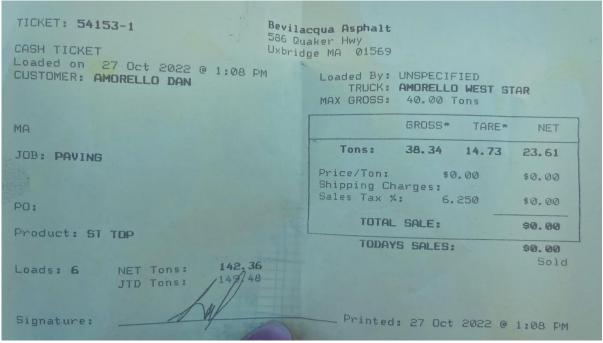
Photo 3: Last weight slip.
