Site Visit Report

Date: November 16, 2023
Client: Sutton Planning Board
Project: Unified Parkway
Contractor: Walsh Contracting Corp.
Contractor Contact: John Walsh

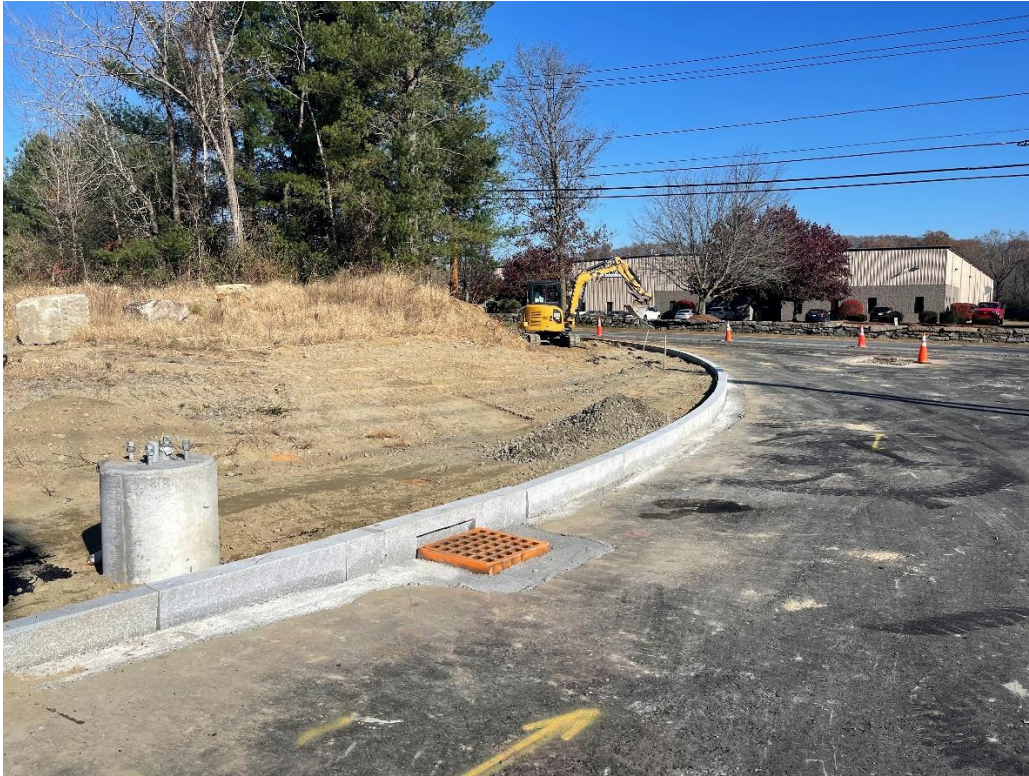
Photo 1: Vertical granite curbing had been installed at the Providence Road entrance.

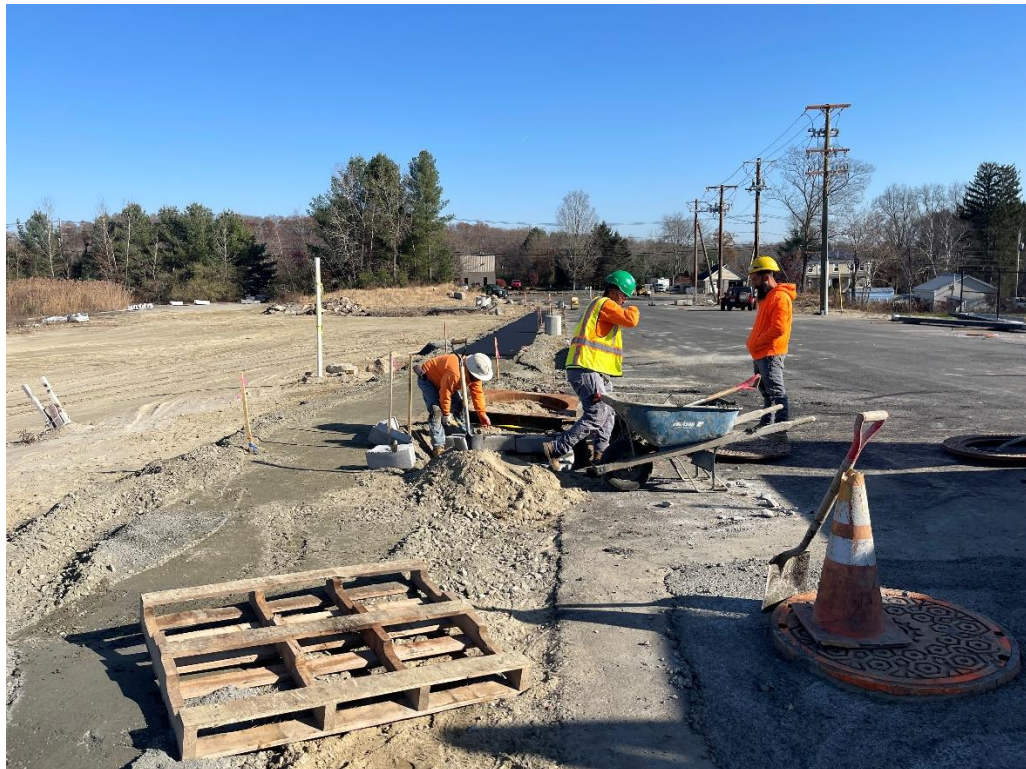
Photo 2: The contractor raising the casting of the electrical manhole at station 3+75.

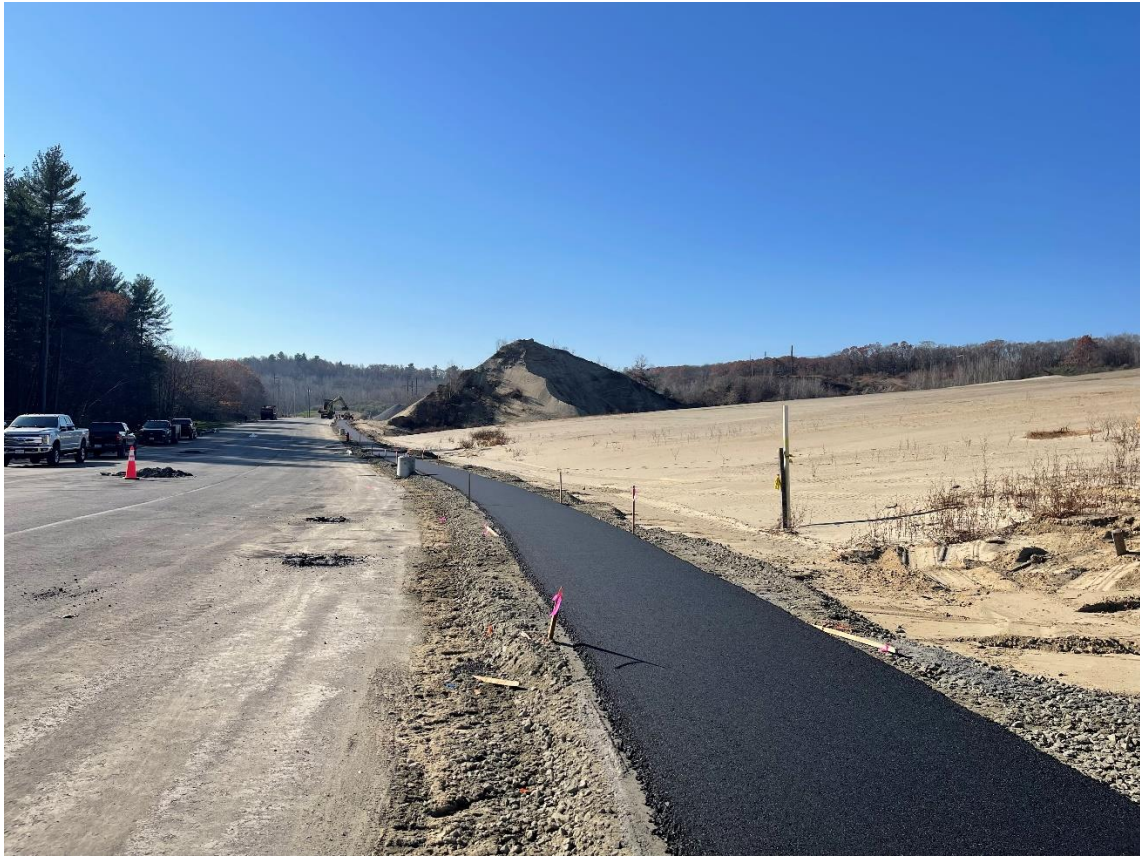
- Dense grade crushed stone had been placed and compacted along the location of the sidewalk between stations 0+00 and 35+50 to a width of five feet.
- The binder course asphalt of the sidewalk between stations 0+00 and 13+00 had been paved and compacted. The compacted thickness of the sidewalk was measured with a tape measure along the sides of the sidewalk, and was found to be at least 1.5 inches throughout. The paving contractor was waiting for additional asphalt trucks to arrive to continue paving.

Photo 3: The binder course asphalt of the sidewalk between stations 1+00 and 13+00 had been paved and compacted.

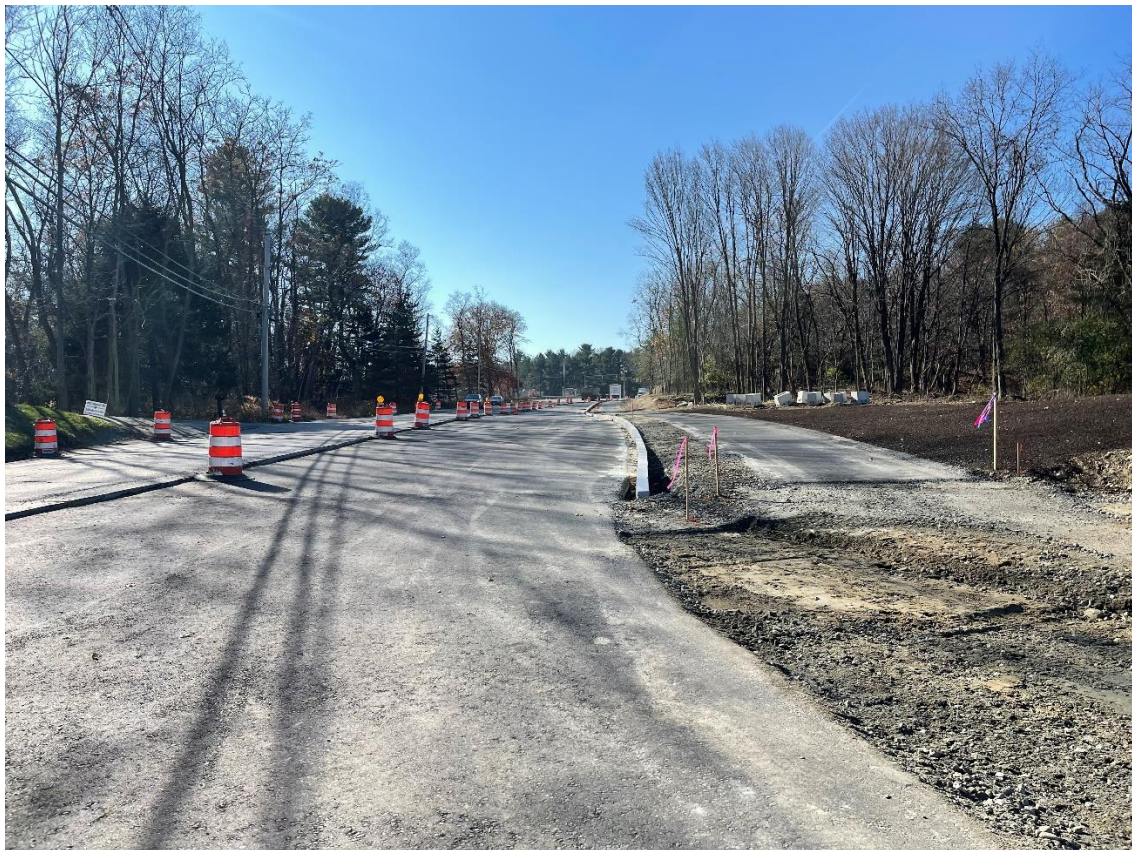
- The binder course asphalt of the sidewalk on the western side of the subdivision entrance had been paved.
- Vertical granite curbing had been installed along the western side of the roadway improvements.
- Construction barrels were placed along either side of the existing roadway to direct traffic.

Photo 4: The binder course asphalt of the sidewalk along Boston Road had been paved, and vertical granite curbing installed. Barrels were placed on either side of the existing roadway.
